File In Section: Product Recalls
Bulletin No.: 10091B
Date: June 2010

Recall Bulletin

SUBJECT: Voltage Regulator Internal Low Resistance Short

MODELS: 2010 Chevrolet Express
2010 GMC Savana
2500/3500/4500 Series

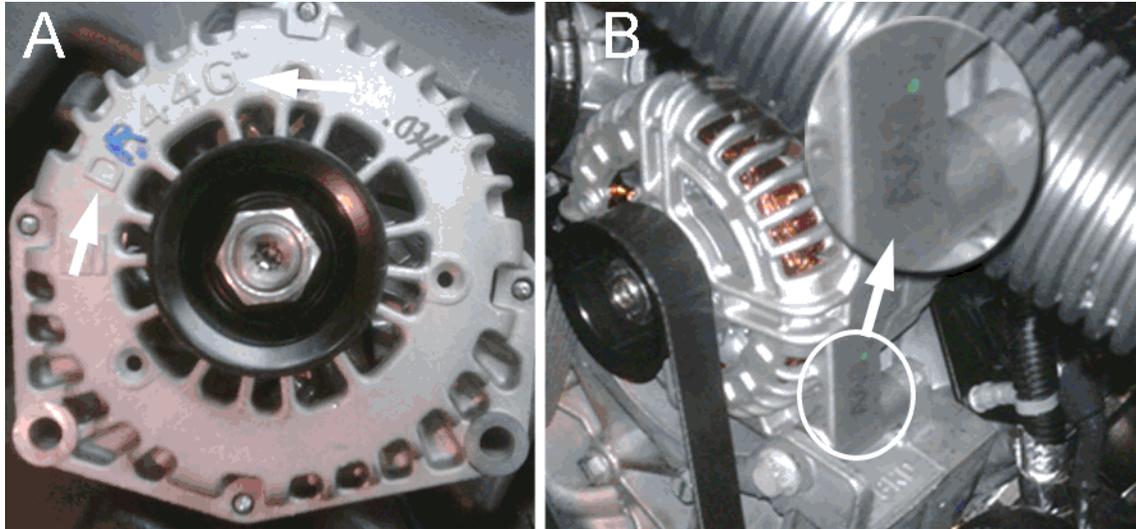
The vehicle build record on these 190 vehicles will show the vehicle is equipped with a K68 105 amp generator; however, some of these vehicles may have been built with a KD9/KG3 145 amp generator in error.

1. Determine if the vehicle was built with a KD9/KG3 145 amp generator (A). The KD9/KG3 generator will have DR44G lettering on the casing. Refer to the illustration to determine if the KD9/KG3 145 amp generator is installed on the vehicle.
 - If the vehicle is equipped with a KD9/KG3 145 amp generator (A), remove and discard the generator. Proceed to Step 2.
 - If the vehicle is NOT equipped with a KD9/KG3 145 amp generator, the vehicle will be equipped with a K68 generator. A K68 generator (B) will have an AA4 ink stamped on the left side of the casing. If the vehicle is equipped with a K68 generator, no further action is required.
2. Remove and discard the KD9/KG3 generator. Refer to *Generator Replacement* in SI.
3. Install a K68 generator. Refer to *Generator Replacement* in SI.

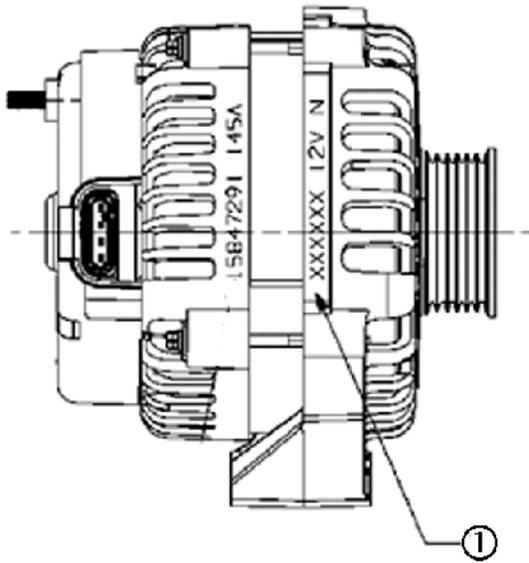
2426929

Generator Build Date Location is at the 11 o'clock position on gasoline engines and at the 2 o'clock position for diesel engines. (1) Gasoline Engine Generator Build Date Location shown.

1. Determine build date of the generator. Refer to the illustration for build date location.

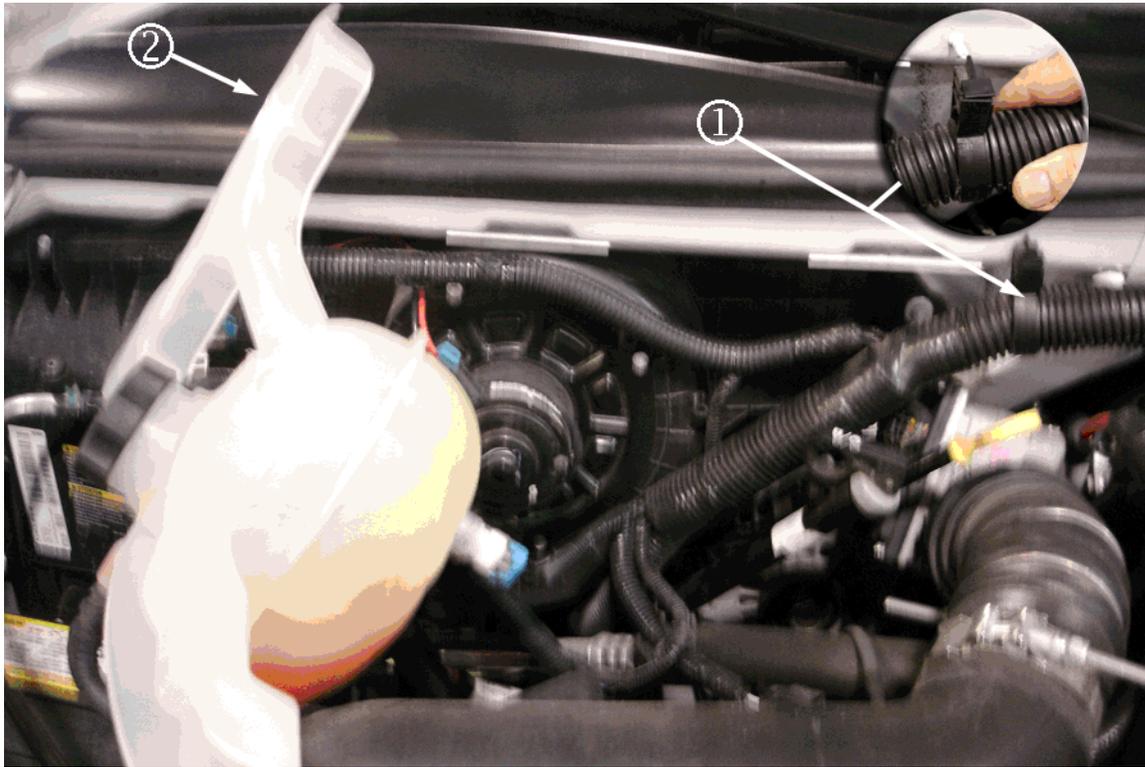
2426927

- A. Disconnect wire harness (1) from the stud as shown in illustration.
 - B. Remove coolant surge tank fastener (2) and set coolant surge tank to the passenger side of engine compartment as shown in illustration.

- C. Clean generator in the 2 o'clock area with a shop towel.
 - D. Use a pencil to shade the generator build date code.
 - If the generator build date is January 12, 2010 or later, remove the generator and replace it with a new one. Proceed to step 2.

- If the generator build date is BEFORE January 12, 2010, replacement of the generator is NOT required. No further action is required.
2. Remove the generator and auxiliary generator, if required, from the vehicle. Refer to *Generator Replacement and/or Auxiliary Generator Replacement* in SI.
