File In Section: Product Recalls
Bulletin No.: 10091A
Date: April 2010

PRODUCT SAFETY RECALL

SUBJECT: Voltage Regulator Internal Low Resistance Short

MODELS: 2010 Chevrolet Express
2010 GMC Savana
2500/3500/4500 Series Equipped with 145 Amp Generator (RPO KG3/KD9)

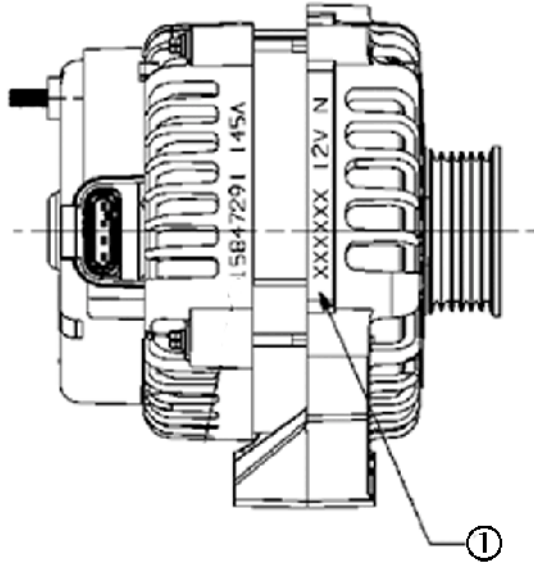
2426929

Generator Build Date Location is at the 11 o'clock position on gasoline engines and at the 2 o'clock position for diesel engines. (1) Gasoline Engine Generator Build Date Location shown.

1. Determine build date of the generator. Refer to the illustration for build date location.
