Recall Bulletin

PRODUCT SAFETY RECALL

SUBJECT: Voltage Regulator Internal Low Resistance Short

MODELS: 2010 Chevrolet Express
 2010 GMC Savana

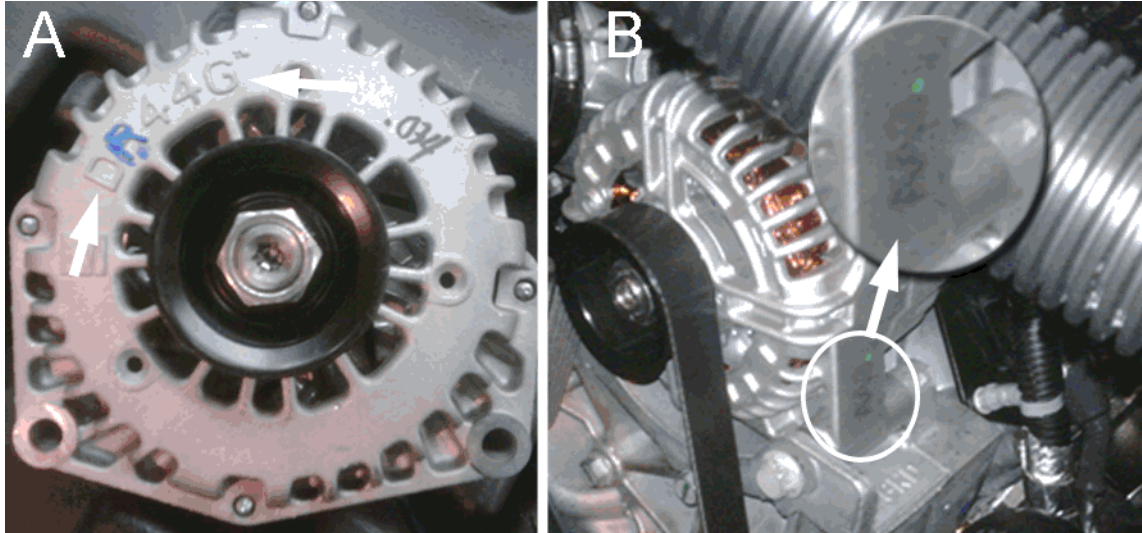
The vehicle build record on these 151 vehicles will show the vehicle is equipped with a K68 105 amp generator; however, some of these vehicles may have been built with a KD9/KG3 145 amp generator in error.

1. Determine if the vehicle was built with a KD9/KG3 145 amp generator (A). The KD9/KG3 generator will have DR44G lettering on the casing. Refer to the illustration to determine if the KD9/KG3 145 amp generator is installed on the vehicle.
 - If the vehicle is equipped with a KD9/KG3 145 amp generator (A), remove and discard the generator. Proceed to Step 2.
 - If the vehicle is NOT equipped with a KD9/KG3 145 amp generator, the vehicle will be equipped with a K68 generator. A K68 generator (B) will have an AA4 ink stamped on the left side of the casing. If the vehicle is equipped with a K68 generator, no further action is required.
2. Remove and discard the KD9/KG3 generator. Refer to *Generator Replacement* in SI.
3. Install a K68 generator. Refer to *Generator Replacement* in SI.

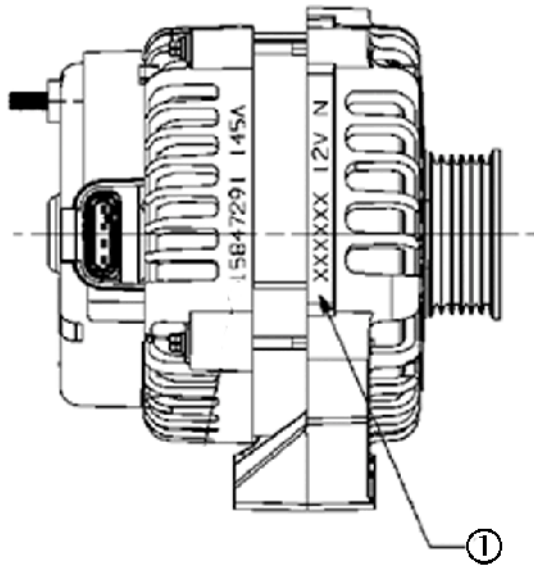
2426929

Generator Build Date Location is at the 11 o'clock position on gasoline engines and at the 2 o'clock position for diesel engines. (1) Gasoline Engine Generator Build Date Location shown.

1. Determine build date of the generator. Refer to the illustration for build date location.
