PRODUCT SAFETY RECALL

SUBJECT: Voltage Regulator Internal Low Resistance Short

MODELS: 2010 Chevrolet Express
2010 GMC Savana

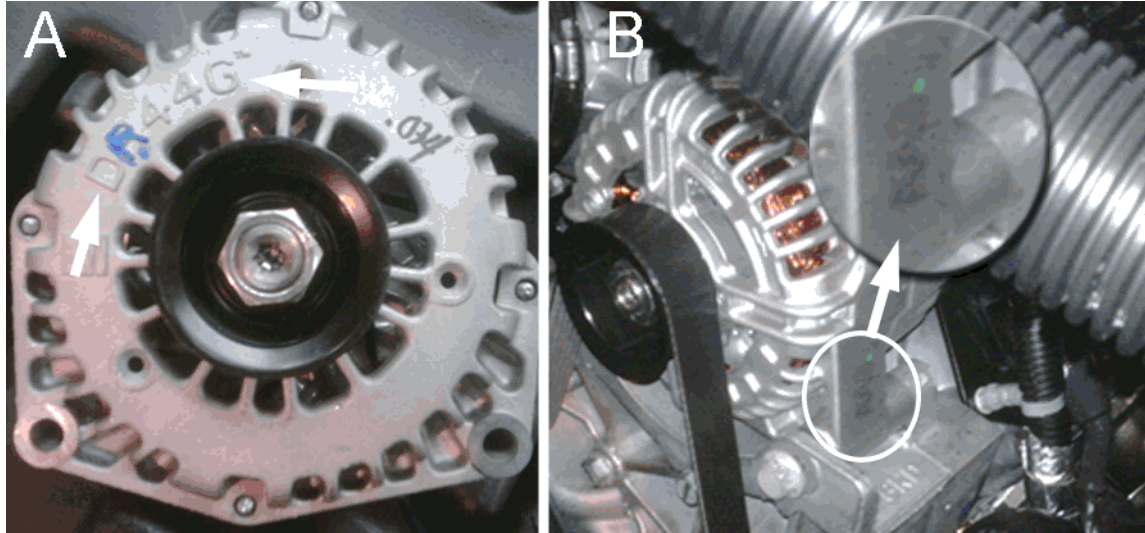
The vehicle build record on these 151 vehicles will show the vehicle is equipped with a K68 105 amp generator; however, some of these vehicles may have been built with a KD9/KG3 145 amp generator in error.

1. Determine if the vehicle was built with a KD9/KG3 145 amp generator (A). The KD9/KG3 generator will have DR44G lettering on the casing. Refer to the illustration to determine if the KD9/KG3 145 amp generator is installed on the vehicle.
 - If the vehicle is equipped with a KD9/KG3 145 amp generator (A), remove and discard the generator. Proceed to Step 2.
 - If the vehicle is NOT equipped with a KD9/KG3 145 amp generator, the vehicle will be equipped with a K68 generator. A K68 generator (B) will have an AA4 ink stamped on the left side of the casing. If the vehicle is equipped with a K68 generator, no further action is required.
2. Remove and discard the KD9/KG3 generator. Refer to *Generator Replacement* in SI.
3. Install a K68 generator. Refer to *Generator Replacement* in SI.

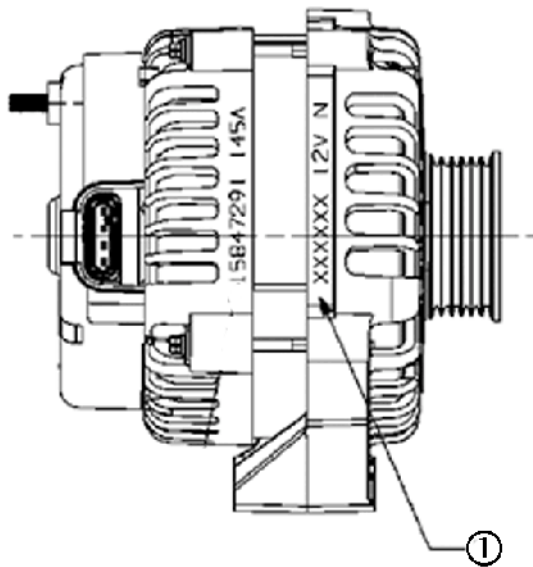
2426929

Generator Build Date Location is at the 11 o'clock position on gasoline engines and at the 2 o'clock position for diesel engines. (1) Gasoline Engine Generator Build Date Location shown.

1. Determine build date of the generator. Refer to the illustration for build date location.
