**TECHNICAL INSTRUCTIONS  
FOR  
SAFETY RECALL A0G  
SKID CONTROL ECU CALIBRATION UPDATE  
2003 MODEL YEAR SEQUOIA**

***UPDATED April 28, 2021***

On certain 2003 Model Year Toyota Sequoia vehicles, the center position of the Steering Angle Sensor (SAS) may not be stored correctly due to improper logic of the Skid Control ECU programming. If this occurs, in most cases the VSC/TRAC warning light will illuminate. However, in limited situations the Vehicle Stability Control (VSC) system could activate at low speed (approximately 9 mph) for a few seconds after acceleration from a stopped position, and the vehicle may not accelerate as quickly as the driver expects.

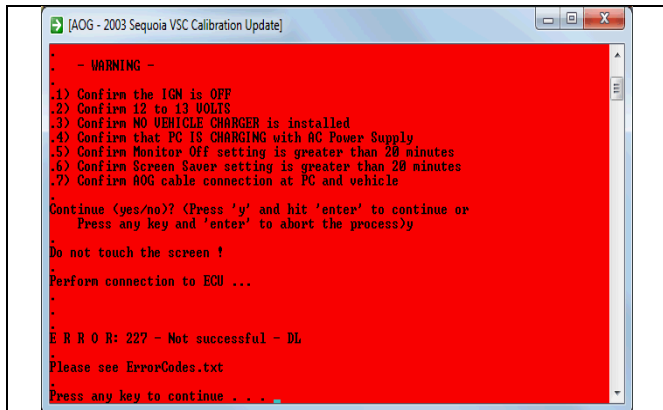
### Error Code 227: XDL Connection timeout:

No battery power (13.8 V)  
Iso-K-cable not connected  
IGN OFF/ON not switch in 20 seconds interval

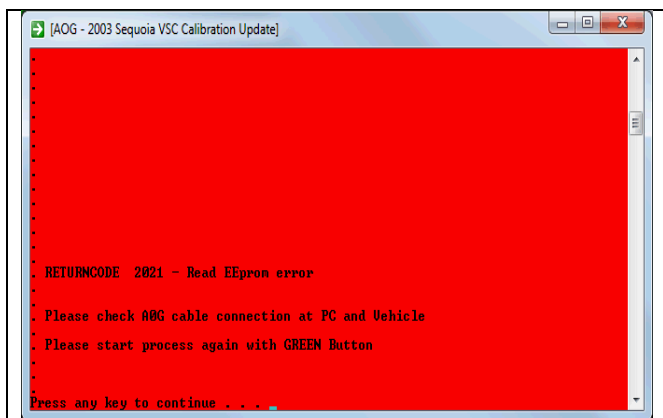
### Error Code 2021: Forced error by turn IGN Off

Poor AOG cable connection  
IGN turned off during reprogramming

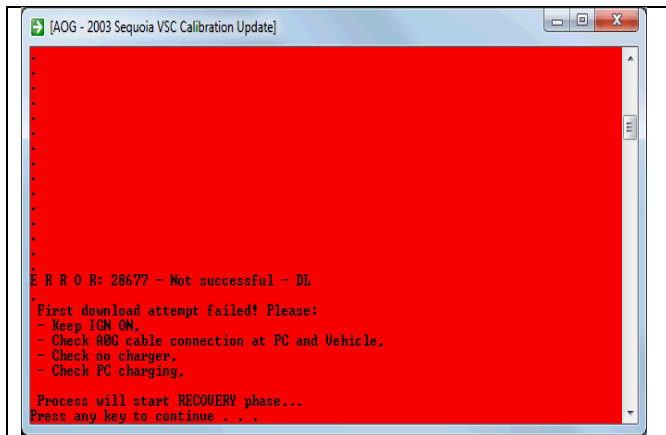
## Error Code: 28677: DLT not successful

Communication error (IGN turned off during reprogramming)
