**TECHNICAL INSTRUCTIONS**  
**FOR**  
**SAFETY RECALL A0G**  
**SKID CONTROL ECU CALIBRATION UPDATE**  
**2003 MODEL YEAR SEQUOIA**

**TECHNICAL INSTRUCTION REVISION NOTICE:**

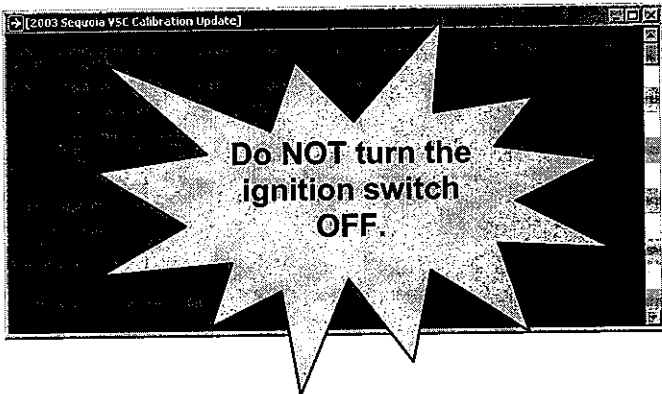
**RETURNCODE 156: Wrong Calibration ID Number:**

This Skid Control ECU is not part of this safety recall.

If you received a red error screen proceed to the next page to perform the VSC Failure Recovery.

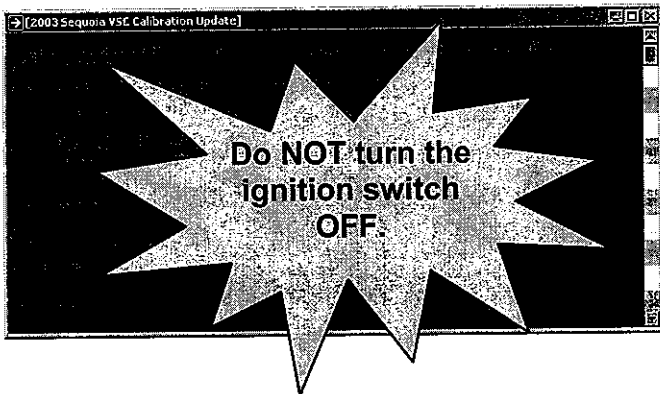
**RETURNCODE 156: Wrong Calibration ID Number:**

This Skid Control ECU is not part of this safety recall.

If you received a red error screen proceed to the next page to perform the VSC Failure Recovery.

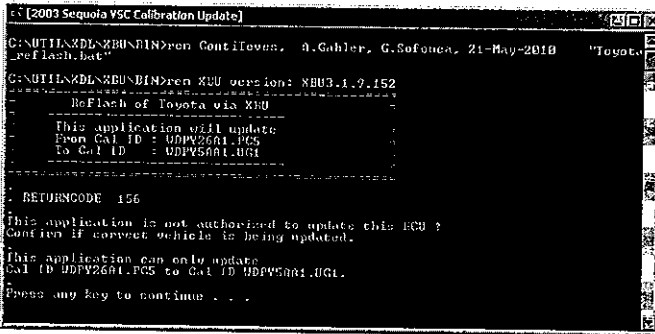
**RETURNCODE 156: Wrong Calibration ID Number:**

This Skid Control ECU is not part of this safety recall.
