NHTSA SAFETY RECALL

EHC CONTACT IMPROVEMENT - Recall #10X-XXX

IDENTIFICATION: Applies to all 2004 Motorcycles for which Service Bulletin SB1078 has not been performed, or EHC Adapter Board Kit 173-000037-00 has not been installed.

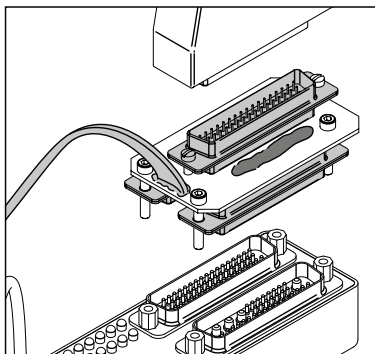
Figure 1

NOTE: It is not necessary to perform this recall procedure if Service Bulletin SB1078 has already been performed, or if EHC Adaptor Board Kit 173-000037-00 has been installed on the motorcycle (dielectric grease already included in connectors) (see Figure 1).
