**PRODUCT CAMPAIGN BULLETIN**

**APPLICABILITY:** 2010 Legacy / Outback  
**SUBJECT:** CVT Transmission Fluid Cooler Inlet Hose

**NUMBER:** WVQ-27  
**DATE:** June 2010

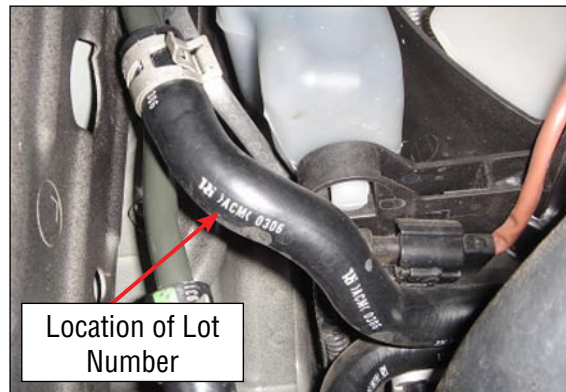
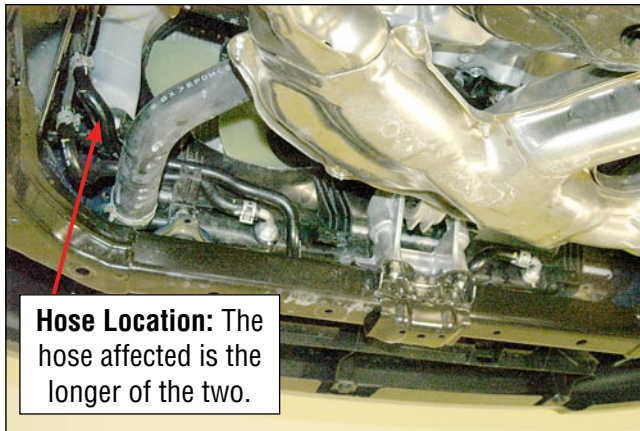
### **Lot Number Inspection**

The lot number is stamped on the hose with white paint.

The following images are for illustration purposes only. The lot number depicted is not actually affected.

The lot number can be viewed with the hood opened, or with the vehicle on a lift.

Check the lot numbers on the inlet cooler hose (the longer of the two hoses) to determine if the hose needs to be replaced. If the “lot number” is found to be any of those listed below, the hose must be replaced with a new one. If the “lot number” is not listed, the hose was manufactured to specifications and replacement is not necessary.
