Service Bulletin No. 345

MODEL D Series Coaches	TYPE Field Change Program	SECTION/GROUP 15-Wheel	DATE
SUBJECT ARVINMERITOR WHEEL ADAPTER CAPSCREWS ON UWE AXLES			
CONDITIONS

Ref. MCI NHTSA Recall No.: 10V-199

Inspect for Under-Tightened Hub/Rotor/Adapter Plate Bolts on Meritor Front Non-Drive Steer Axles and Tag Axles Equipped with Unitized Wheel Ends Installed on Motor Coach Industries (MCI) Coaches

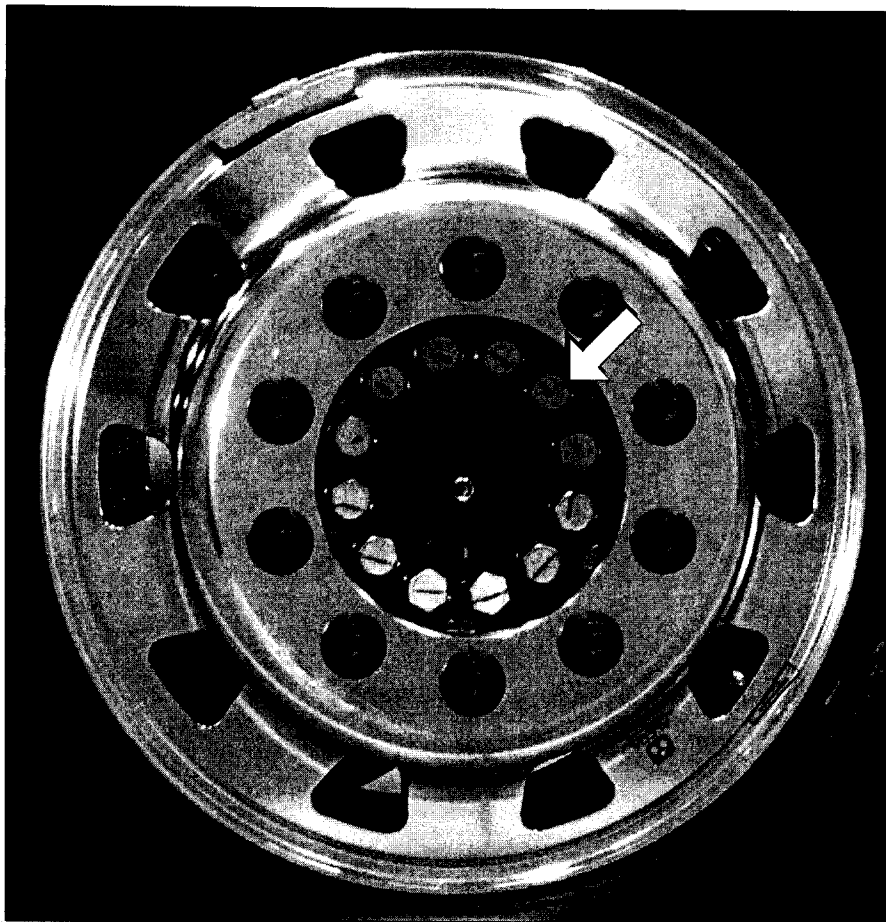
Figure 1.

1. Open the engine doors. Position the ENGINE RUN and ENGINE START switches on the engine compartment remote control box to the OFF position. Check both sides of the tires.
2. Locate the twelve (12) wheel adapter capscrews on the front axle (refer to Figure 1).

3. Using a torque wrench with a dial indicator, check and record the torque value of all twelve (12) wheel adapter capscrews on the MCI Coach–UWE Bolt Torque–Inspection Chart.

Upon inspection, if one (1) capscrew is found at a torque less than 150 ft-lbs, the capscrew needs to be replaced with p/n 15-02-1047, and properly torqued. Discard existing capscrew.

Upon inspection, if two (2) or more capscrews are found at a torque less than 150 ft-lbs, all twelve (12) capscrews need to be replaced with Kit p/n 15-02-1060, and properly torqued.

4. Using a torque wrench, tighten all twelve (12) capscrews to 250 to 300 ft–lbs, in a star pattern. Apply torque seal from the face of the capscrew to the face of the wheel adapter.
5. Proceed to the opposite side of the front axle. Repeat Steps 2. to 4. in their entirety.
6. Proceed to the tag axle. Repeat Steps 2. to 4. in their entirety to both sides of the tag axle.
7. Position the ENGINE RUN and ENGINE START switches on the engine compartment remote control box to the ON position. Close the engine doors.

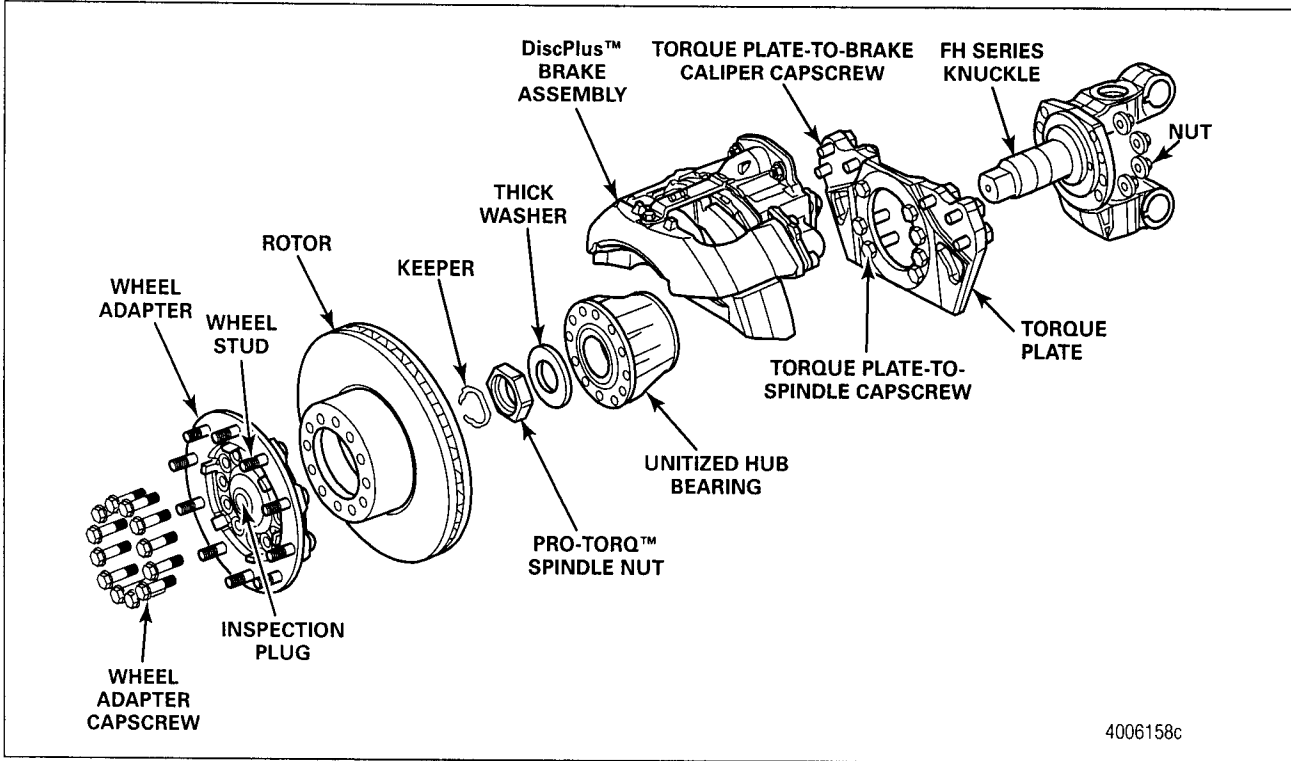
3. Use a torque wrench with a dial indicator to check hub/rotor/adapter plate bolt torque on all 12 bolts on each unitized wheel end. The bolt torque must not be less than 150 lb-ft (203 N•m). Record the torque on the Inspection Sheet included in this bulletin.

- If hub/rotor/adapter plate bolt torque on any one of the 12 bolts on each unitized wheel end is less than 150 lb-ft (203 N•m): Replace the bolt using ArvinMeritor part number 10X1711. Discard the bolts that were removed. Do not reuse old bolts. Record the bolt replacement on the Inspection Sheet included in this bulletin.

- If any two or more bolts in the same bolt circle on a wheel end are less than 150 lb-ft (203 N•m): Replace all 12 bolts on the unitized wheel end using ArvinMeritor part number 10X1711. Remove, replace and tighten each bolt one at a time to maintain the correct clamp load on the wheel end. Discard the bolts that were removed. Do not reuse old bolts. Record the bolt replacement and torque in the Inspection Sheet included in this bulletin.

4. Use a click torque wrench to tighten all remaining bolts and any replacement bolts in a star pattern to 275 ± 25 lb-ft (373 ± 34 N•m). Record the torque on the Inspection Sheet included in this bulletin. When you have tightened all of the bolts, recheck the torque of all 12 bolts in a star pattern.

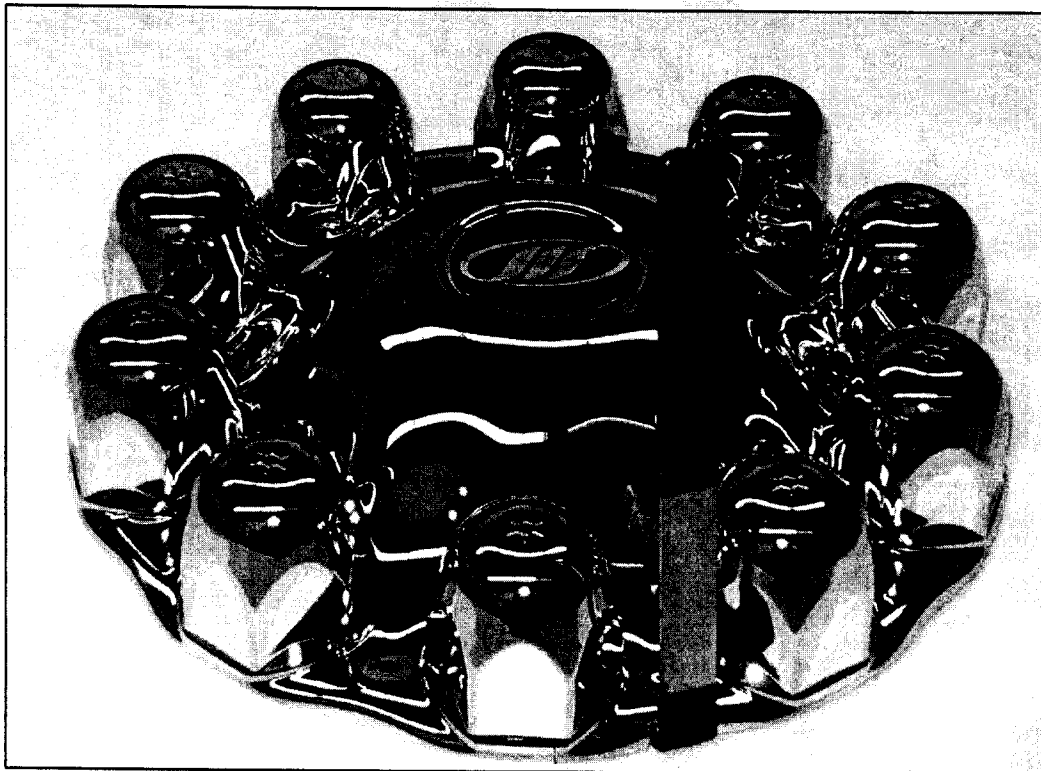
Figure 1. Front / tag axle one-piece hub cover with removal tool.

2. Locate the one piece hub cover on the front axle wheel end. Visually locate the notch on the side of the hub cover. Insert the hub cover removal tool, reference p/n 15-01-1216, into the notch on the side of the hub cover (refer to Figure 1). Using the removal tool, in a rotating action carefully separate the hub cover away from the wheel face. Place aside to be re-installed at a later step in this procedure.

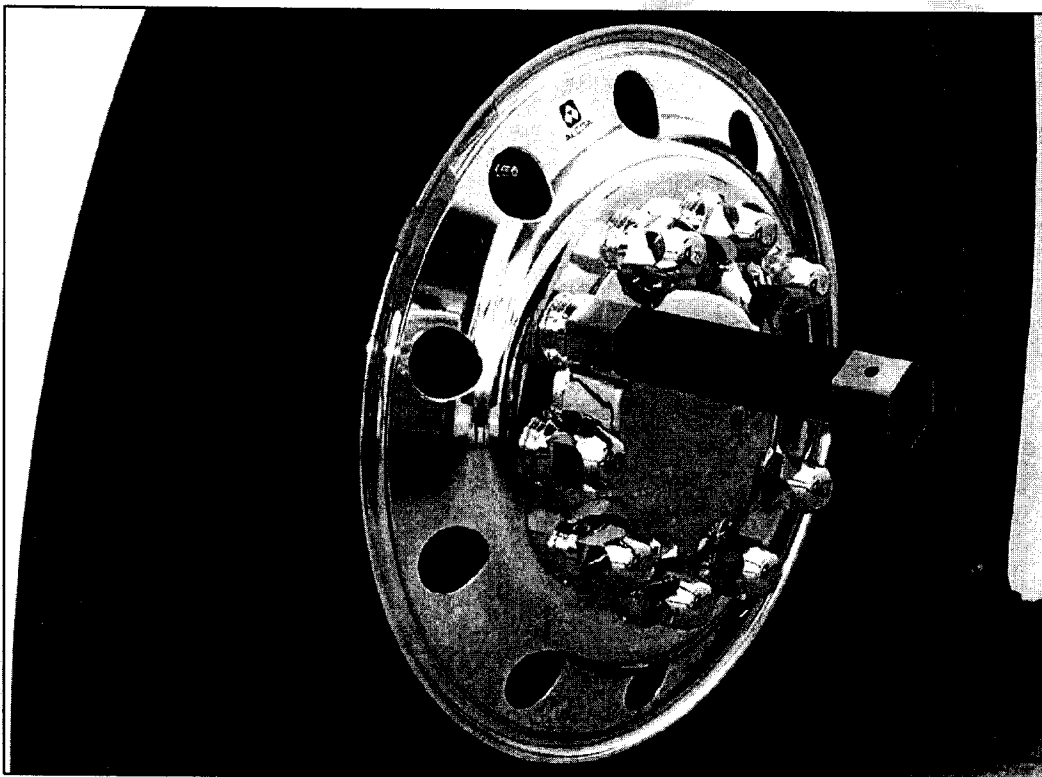
Figure 2. Front / tag axle 11-piece hub cover with removal tool.

3. Locate the 11-piece hub cover on the front axle wheel end. Insert the removal tool on a lug nut cover (refer to Figure 1). Using the removal tool, in a back and forth action carefully separate the lug nut cover from the lug nut. Repeat to remaining nine (9) lug nut covers until the center hub cover is released. Place aside to be re-installed at a later step in this procedure.

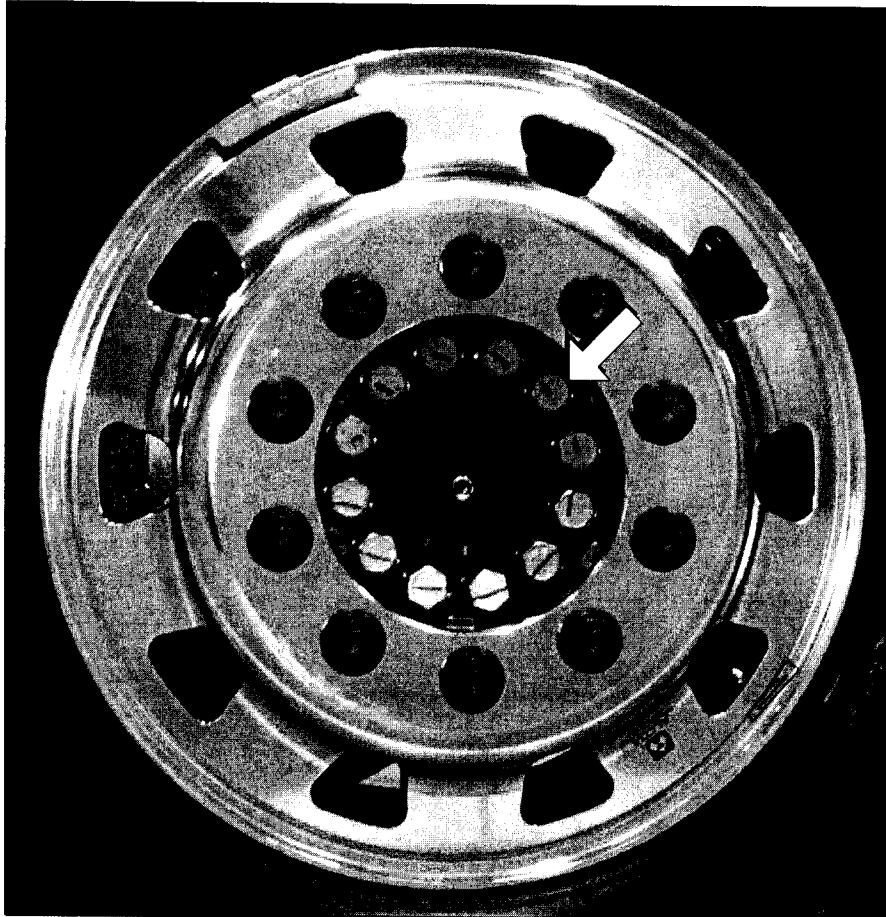
Figure 3.

4. Locate the twelve (12) wheel adapter capscrews on the front axle (refer to Figure 3).

5. Using a torque wrench with a dial indicator, check and record the torque value of all twelve (12) wheel adapter capscrews on the MCI Coach-UWE Bolt Torque-Inspection Chart.

Upon inspection, if one (1) capscrew is found at a torque less than 150 ft-lbs, the capscrew needs to be replaced with p/n 15-02-1047, and properly torqued. Discard existing capscrew.

Upon inspection, if two (2) or more capscrews are found at a torque less than 150 ft-lbs, all twelve (12) capscrews need to be replaced with Kit p/n 15-02-1060, and properly torqued.

6. Using a torque wrench, tighten all twelve (12) capscrews to 250 to 300 ft-lbs, in a star pattern. Apply torque seal from the face of the capscrew to the face of the wheel adapter.
7. Proceed to the opposite side of the front axle. Repeat Steps 4. to 6. in their entirety.
8. Proceed to the tag axle. Repeat Steps 4. to 6. in their entirety to both sides of the tag axle.
9. If coach is so equipped, use a short handle rubber mallet and controlled force on the lug nut feature in a counter-clockwise patten to re-install the hub covers. When hub cover is fully installed, there is no gap between the hub cover and the wheel face.
10. Position the ENGINE RUN and ENGINE START switches on the engine compartment remote control box to the ON position. Close the engine door.

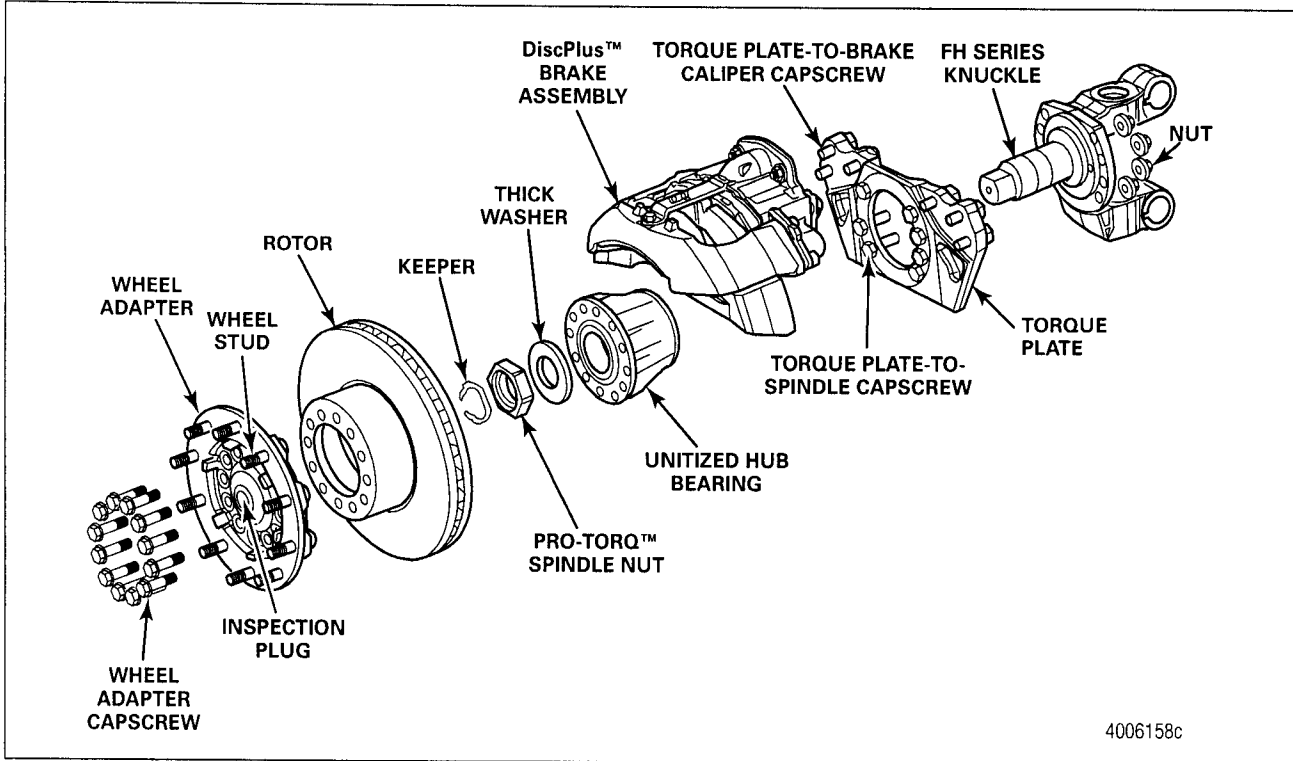
3. Use a torque wrench with a dial indicator to check hub/rotor/adapter plate bolt torque on all 12 bolts on each unitized wheel end. The bolt torque must not be less than 150 lb-ft (203 N•m). Record the torque on the Inspection Sheet included in this bulletin.

- If hub/rotor/adapter plate bolt torque on any one of the 12 bolts on each unitized wheel end is less than 150 lb-ft (203 N•m): Replace the bolt using ArvinMeritor part number 10X1711. Discard the bolts that were removed. Do not reuse old bolts. Record the bolt replacement on the Inspection Sheet included in this bulletin.

- If any two or more bolts in the same bolt circle on a wheel end are less than 150 lb-ft (203 N•m): Replace all 12 bolts on the untized wheel end using ArvinMeritor part number 10X1711. Remove, replace and tighten each bolt one at a time to maintain the correct clamp load on the wheel end. Discard the bolts that were removed. Do not reuse old bolts. Record the bolt replacement and torque in the Inspection Sheet included in this bulletin.

4. Use a click torque wrench to tighten all remaining bolts and any replacement bolts in a star pattern to 275 ± 25 lb-ft (373 ± 34 N•m). Record the torque on the Inspection Sheet included in this bulletin. When you have tightened all of the bolts, recheck the torque of all 12 bolts in a star pattern.
