Technical Bulletin

Section Title: Suspension
 TSB No. TS 01 05240R

SUBJECT: SAFETY RECALL CAMPAIGN: NR- FRONT SUSPENSION LOWER LINK, INSPECTION AND REPAIR.
MODEL(S): EQUATOR (A6I640)
YEAR: 2010

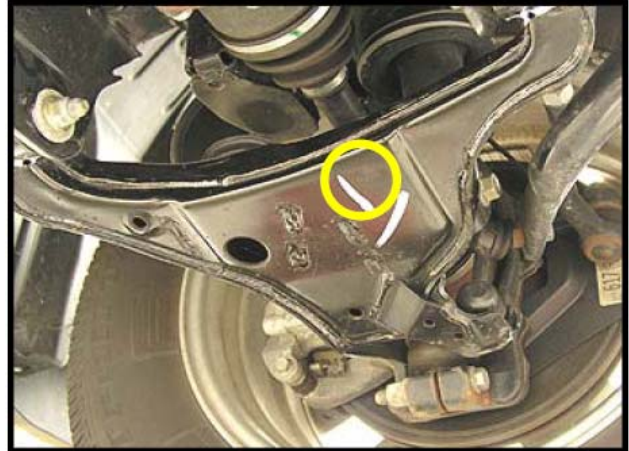
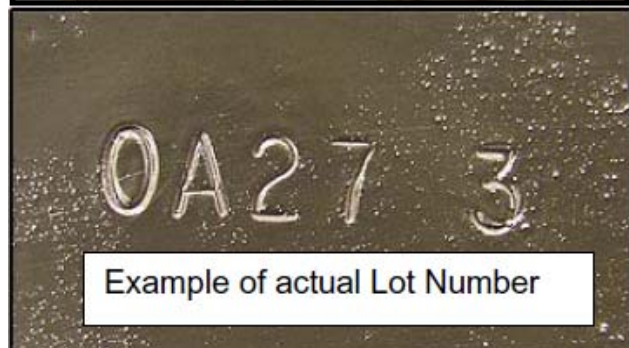
1. Raise the vehicle on a lift.
2. Look for the “Lot Number” stamped into the underside of the front lower suspension arm assembly and write it down (this must be written on the repair order).

3. Check the first three positions from the left.
 - If **any** of the lower links have **A** or **Y** or **Z** in the first three positions of the lot number the vehicle must not be sold until after recall repairs have been performed.
 - If **any** of the lower links do not have a clearly identifiable letter in the first three positions of the lot number the vehicle must not be sold until after recall repairs have been performed.
 - If the lot number is missing on any of the lower links, the vehicle must not be sold until after recall repairs have been performed.
4. Vehicles passing the inspection and determined as “OK”, can be released using the Short Campaign Completion submission procedure found in the Campaign Bulletin SC-48. If one or both the lower links were determined as being “NG”, please proceed to step 5 of this instruction.
