SERVICE PROCEDURE

**G-10507
JUNE 2010**

**SUBJECT: SAFETY RECALL
SEAT BACK REINFORCEMENT ROD on certain CE
and RE model buses built 2/22/10 thru 3/16/10 with
passenger flip seat feature code 48UAH or 48UAU.**

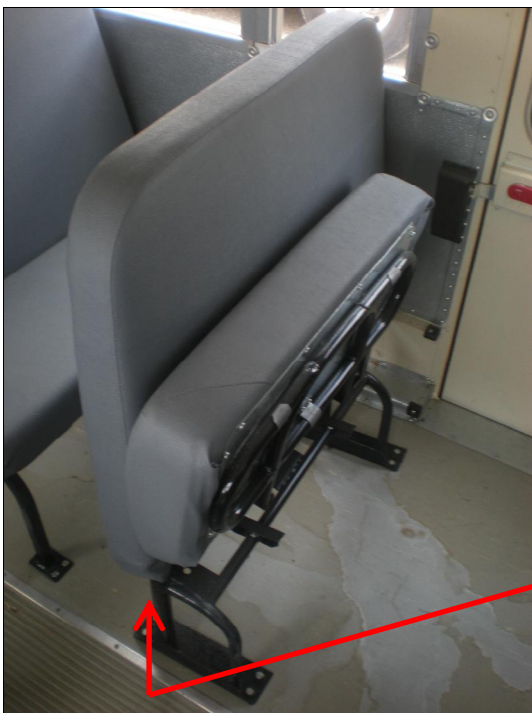
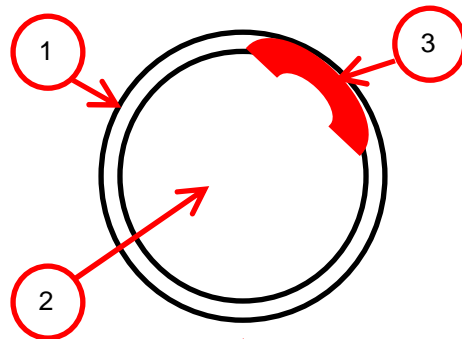
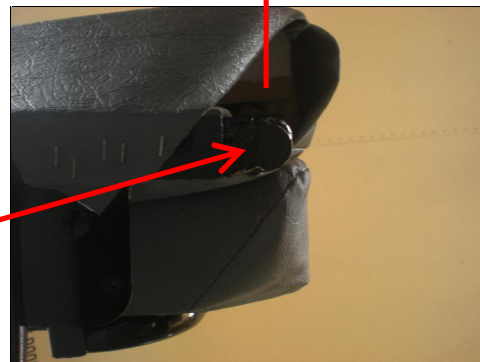
The weld that retains the reinforcement rod inside the flip seat back frame tube may fail allowing the rod to fall out of the frame. Without the reinforcement rod the strength of the seat may be reduced possibly increasing the risk of property damage, personal injury, or death in the event of a crash.

1. Overview: This procedure will involve the inspection of the reinforcement rod retaining welds and, if necessary, replacement of the seat frame.
2. Inspect the two reinforcement rod retaining welds on each flip seat on the bus.
 - a. Lie on the bus floor and look straight up at the corner of the flip seat back frame tube. The bottom of the reinforcement rod is not covered with upholstery but is recessed so a flashlight is needed for the inspection.
 - b. Inspect the length and width of the weld that retains the reinforcement rod in the flip seat back frame tube. At a minimum, the weld needs to be 1/16" wide and 1/2" long.

1. **Seat back frame tube.**
2. **Reinforcement rod.**
3. **Retaining weld. Minimum 1/16" wide x 1/2" long.**

- c. Repeat the inspection procedure on the other reinforcement rod retaining weld located on the opposite side of the seat back.
3. If both welds are of sufficient length and width, no repair is required and service procedure is complete. If either weld is not sufficient, the seat frame will need to be replaced.

4. To replace the seat frame:
 - a. Remove the flip seat assembly from the bus by removing the floor mounting fasteners.
 - b. Remove the flip seat bottom subassembly from the seat and install it on the new frame.
 - c. Remove the seat back upholstery and foam from the frame and install it on the new frame.
 - d. Install the new flip seat assembly into the bus. Torque fasteners to 19-20 lb-ft.
