File In Section: Product Recalls  
Bulletin No.: 10153A  
Date: July 2010

# Recall Bulletin

**SUBJECT:** Heated Windshield Washer Module Short Circuit – Permanently Disable and Remove Module

**MODELS:** 2006-2009 Buick Lucerne  
2008-2009 Buick Enclave  
2006-2009 Cadillac DTS  
2007-2009 Cadillac Escalade, Escalade ESV, Escalade EXT  
2008-2009 Cadillac CTS  
2007-2009 Chevrolet Avalanche, Silverado, Suburban, Tahoe  
2009 Chevrolet Traverse  
2007-2009 GMC Acadia, Sierra, Yukon, Yukon XL  
2006-2009 HUMMER H2  
2007-2009 Saturn OUTLOOK  
Equipped with Heated Washer Fluid System (RPO XA7/CHW)

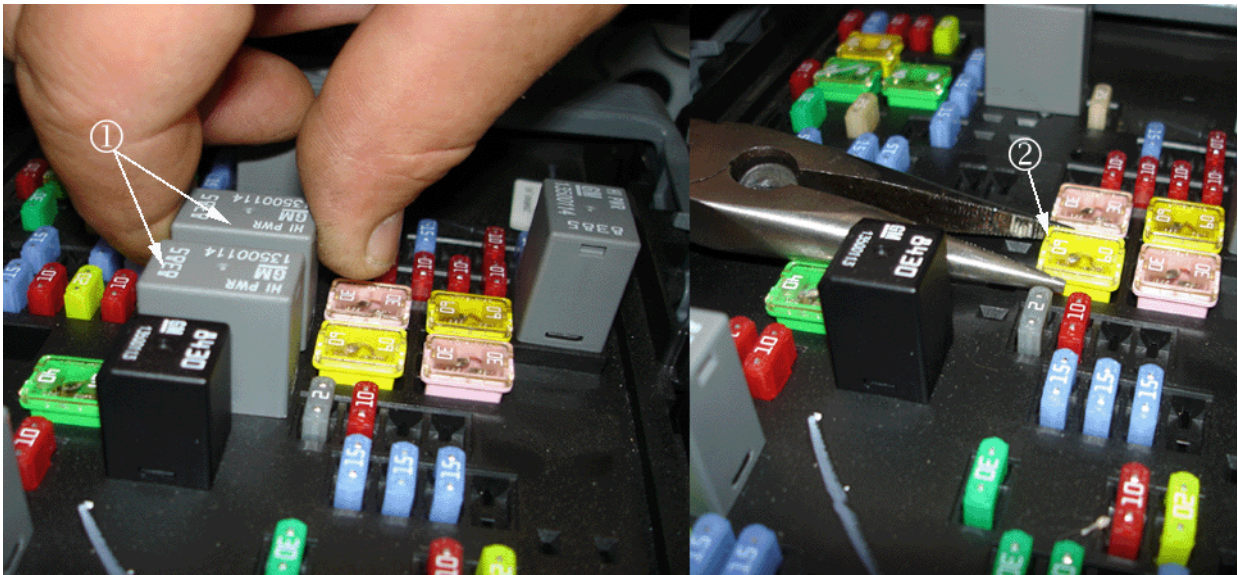
2182450

3. Remove the UBEC cover and locate the 60 amp heated windshield washer fuse.

**Note:** Remove the two relays (1) next to the fuse to gain access to the fuse.

4. Remove the 60 amp heated windshield washer fuse (2) using needle-nose pliers.
5. Discard the 60 amp heated windshield washer fuse.

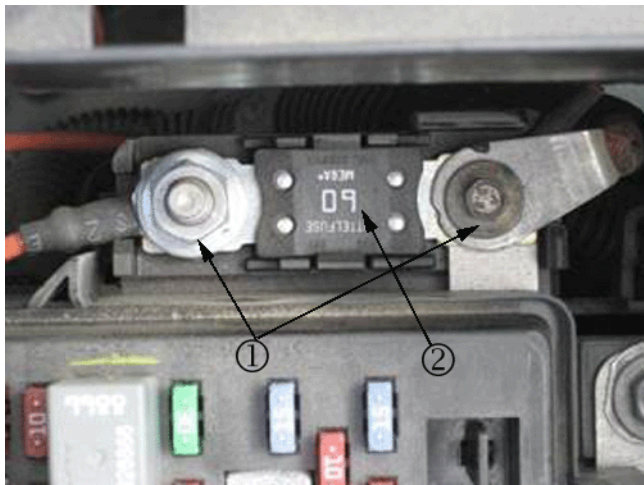
2182535

2. Locate the under-hood bussed electrical center (UBEC).
3. Remove the UBEC cover and locate the 60 amp heated windshield washer Mega fuse.

4. Remove the two nuts (1) for the Mega fuse (2). Refer to the picture.
5. Remove the 60 amp heated windshield washer Mega fuse.
6. Discard the 60 amp heated windshield washer Mega fuse.
7. Install the two nuts back into the two studs.
8. Refer to *Windshield Washer Solvent Heater Removal* in this bulletin. After completing the *Windshield Washer Solvent Heater Removal* service procedure, proceed to step 9 in this section of the bulletin.
9. Connect the negative battery cable. Refer to *Battery Negative Cable Disconnection and Connection* in SI.
10. Test the operation of the windshield wiper system.
  - 10.1 Ensure the wiper system functions in low and high positions.
  - 10.2 Verify that the windshield wiper/washer switch functions. The windshield wiper system should provide wiper fluid to the windshield.
