# Safety Recall Circular

Code: **97S8**

**Subject: 2009 Routan  
Power Sliding Door Wiring Harness Assembly**

**October 18, 2010**

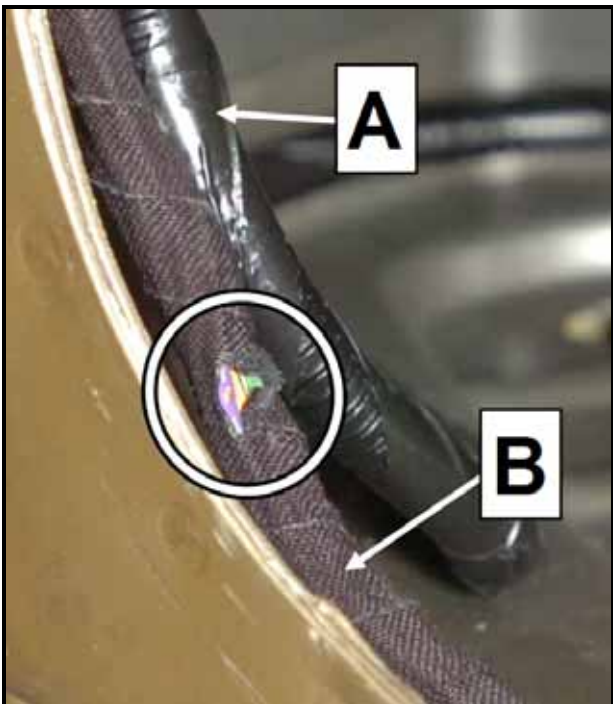
⇐ Inspect drive motor wiring harness -A- and door track wiring harness -B- for a wire chafe condition -circle-

Tip: Wire chafe condition -circle- is only an example

Wire chafe conditions may differ in appearance and may be present on either one or both harnesses

Repair vs. Replace Summary Chart			
Harness	Condition	Work	Go to Section
Sliding Door Harness	One or two wires damaged	Repair harness	D
Sliding Door Harness	More than two wires damaged	Replace harness	B
Sliding Door Harness	Chain link disconnected or damaged	Replace harness	B
Drive Motor harness	up to 4 wires damaged	Repair harness	D

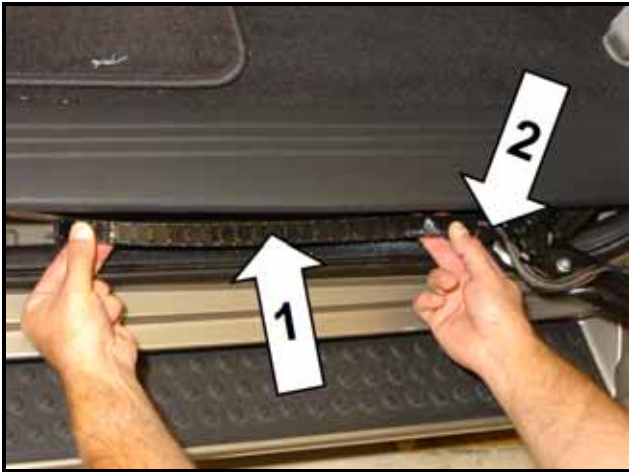
- ⇐ Inspect chain link track -arrow 1- for broken links, damaged wires, or the chain link track being disconnected from lower hinge bracket -arrow 2-
  - If there is no damage to either wiring harness or the chain link track, **go to Section C**
  - If no more than two wires are damaged on the power sliding door wiring harness and/or if up to four wires are damaged on the drive motor wiring harness, **go to Section D** for wiring repairs
  - If chain link track is disconnected or damaged, and/or more than two wires on the power sliding door wiring harness(es) are damaged, **go to Section B** to replace the harness(es)

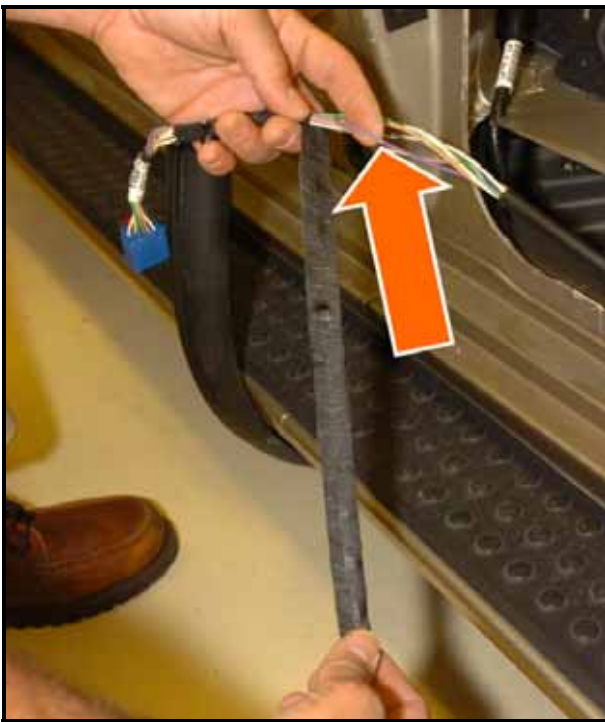
- ⇐ Carefully unwrap power sliding door wiring harness, as shown, starting at the front end (in-car position) of the black plastic split tube to expose chaffed wires -arrow-
