Safety Recall Circular

Code: **97S8**

**Subject: 2009 Routan
Power Sliding Door Wiring Harness Assembly**

October 20, 2010

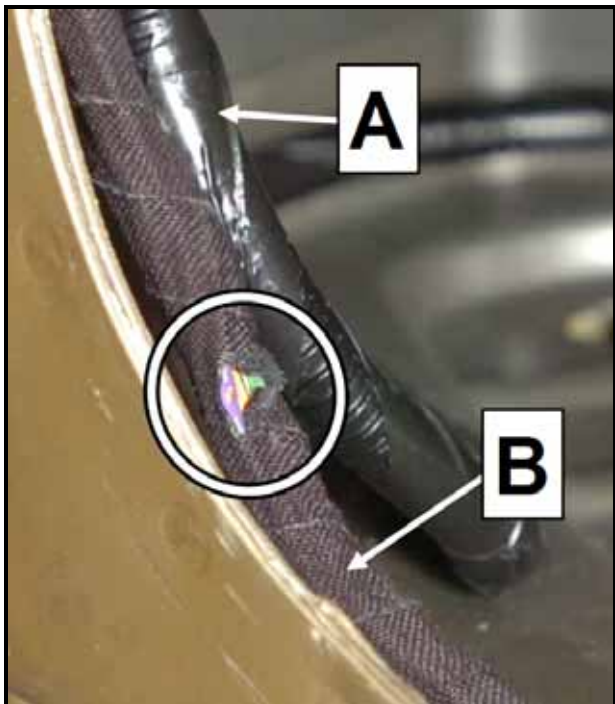
⇐ Inspect drive motor wiring harness -A- and door track wiring harness -B- for a wire chafe condition -circle-

Tip: Wire chafe condition -circle- is only an example

Wire chafe conditions may differ in appearance and may be present on either one or both harnesses

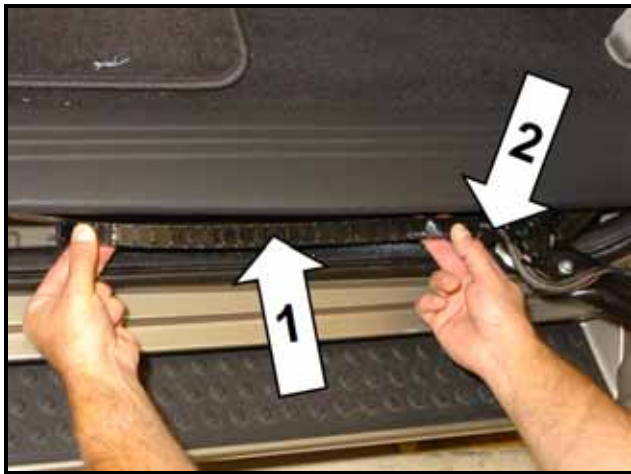
- ⇐ Inspect chain link track -arrow 1- for broken links, damaged wires, or the chain link track being disconnected from lower hinge bracket -arrow 2-
 - If there is no damage to either wiring harness or the chain link track, **go to Section C**
 - If no more than two wires are damaged on the power sliding door wiring harness and/or if up to four wires are damaged on the drive motor wiring harness, **go to Section D** for wiring repairs
 - If chain link track is disconnected or damaged, and/or more than two wires on the power sliding door wiring harness(es) are damaged, **go to Section B** to replace the harness(es)

Harness	Condition	Work	Go to Section
Sliding Door Harness	One or two wires damaged	Repair harness	D
Sliding Door Harness	More than two wires damaged	Replace harness	B
Sliding Door Harness	Chain link disconnected or damaged	Replace harness	B
Drive Motor harness	up to 4 wires damaged	Repair harness	D
