Safety Recall Circular

Code: **97S8**

**Subject: 2009 Routan
Power Sliding Door Wiring Harness Assembly**

October 20, 2010

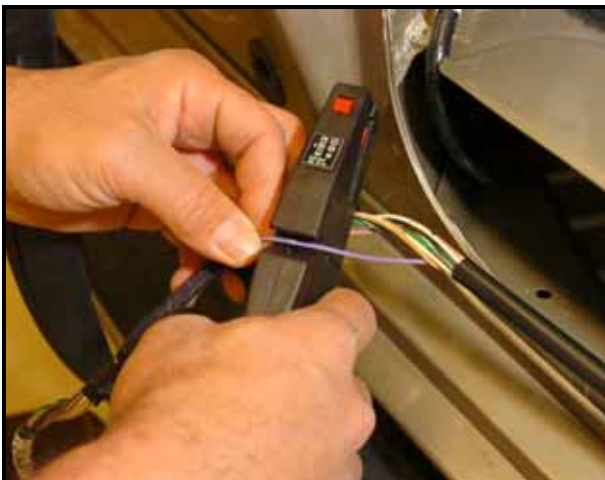
- ⇐ Carefully unwrap power sliding door wiring harness, as shown, starting at the front end (in-car position) of the black plastic split tube to expose chaffed wires -arrow-
