PROCEDURE

Modify the sound insulation on both the left-hand side and right-hand side as outlined below:

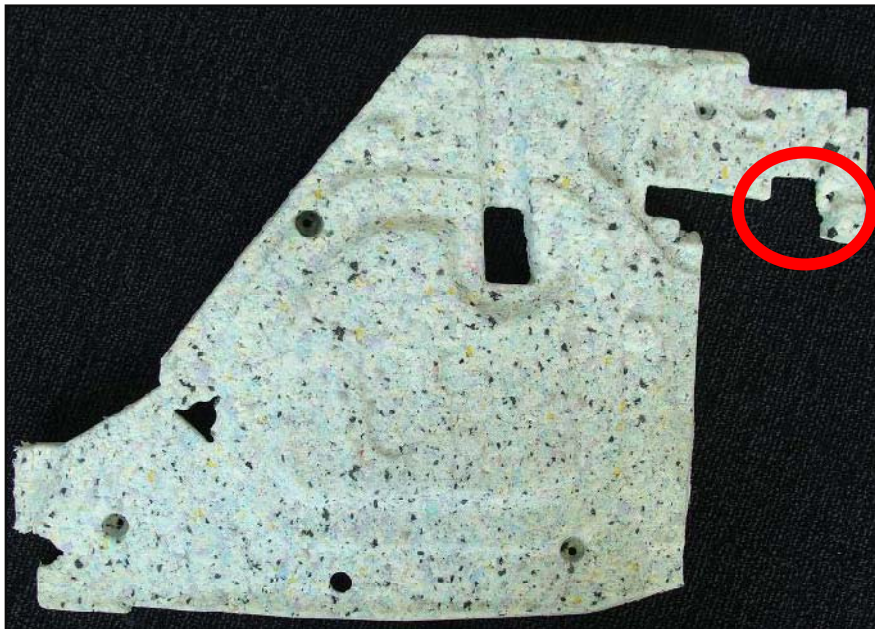
It is of utmost importance that the safety belt anchorage insulation point is not damaged in the area indicated by the red circle for both sides

1. Disconnect the battery.
2. Remove the rear side panel and refer to ISTA repair instructions REP 51 43 000.
3. Remove the sound insulation.
4. Place the sound insulation on an adequate underlay, and cut the sound insulation with a sharp razor knife along the red line (1) and (2) as shown.

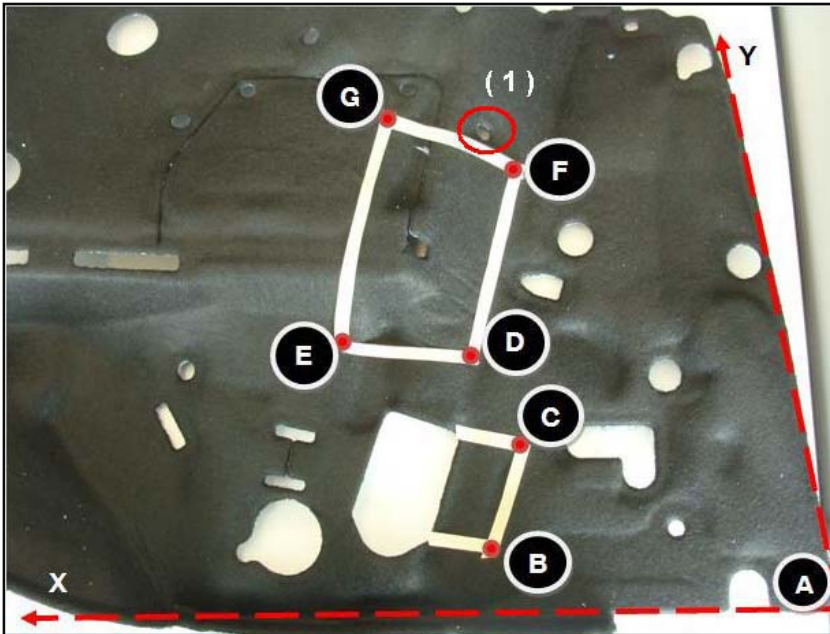
It is of utmost importance that the referenced dimensions are closely followed, and that the safety belt anchorage point (1) is not damaged!

5. Refer to the dimensions from the table. Cut along the points (B) through (G) as shown in the picture.

Point (A) is the reference starting point.

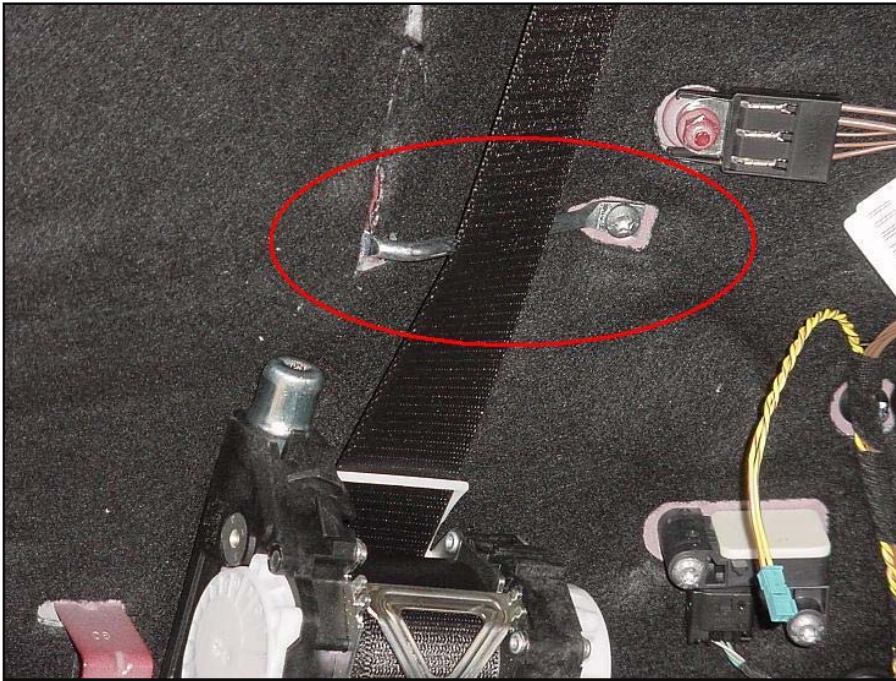
The safety belt should be routed along the outside of the guide bar, not behind it.

8. Reinstall the new seat belt.
