| <b>VOLVO</b> | | | | <b>TITLE:</b><br>Recall 227: Torque Gearshift Lever Stud Assembly | | <b>GROUP:</b><br>43 | <b>NO:</b><br>227 |
| | | | | Certain Model Year 2010 S40 & V50 Vehicles Equipped with M66 Manual 6-Speed Transmissions, Certain Model Year 2010 & 2011 C30 Vehicles Equipped with M66 Manual 6-Speed Transmissions | | <b>ISSUING DEPARTMENT:</b><br>Warranty | |

**Title** Recall 227: M66, Not possible to engage, disengage, or shift gears

TJ No 22815

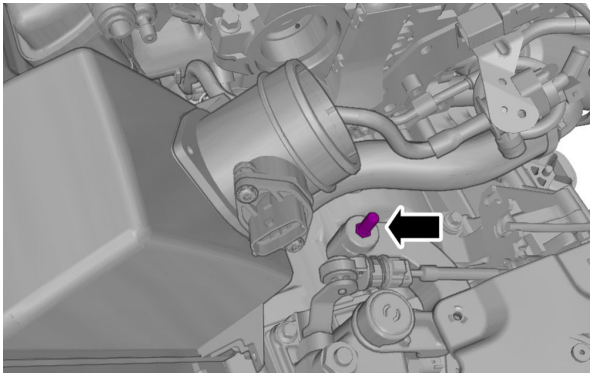
Volvo has identified that the gearshift lever stud assembly may not have been tightened to the correct specification during assembly. If the shift lever cable or stud assembly becomes loose, it may not be possible to engage, disengage, or shift gears. This condition can increase the risk of a vehicle crash.

4. Torque:  
Gear shift lever stud assembly, 20Nm (14.75 lbf-ft)
