PRODUCT CAMPAIGN BULLETIN

APPLICABILITY: 2010MY Subaru Legacy & Outback
SUBJECT: Steering Column Electrical
 Roll Connector

NUMBER: WVR-28
DATE: June 2010

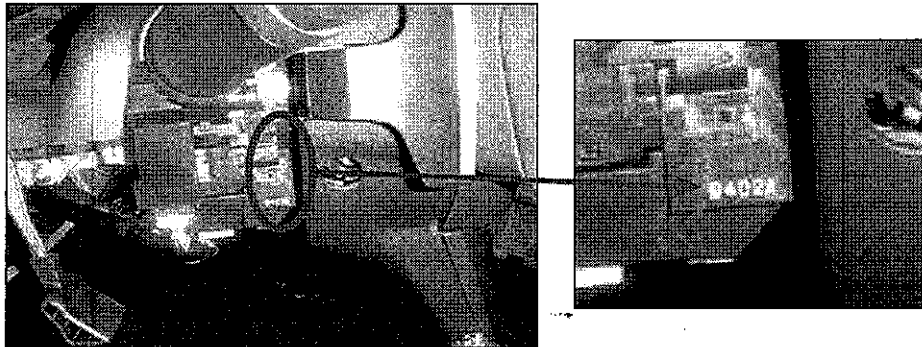
4) Confirm the steering roll connector lot number located on the left side of the connector.

Target Lot Numbers: **9X13A or before.**

If the lot number indicates a production date of October 13, 2009 (9X13A) or before, replacement of the steering roll connector is required. Proceed as follows.

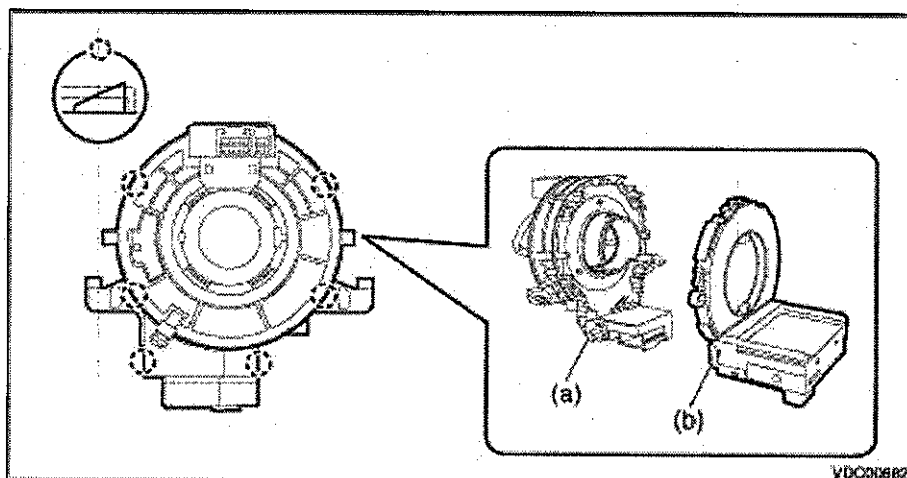
IMPORTANT: Do not rotate the inner ring after removing the steering angle sensor. If you rotate the steering angle sensor 360 degrees, the VDC system will not work properly.

Release the claws and remove the steering angle sensor (b) from roll connector (a).

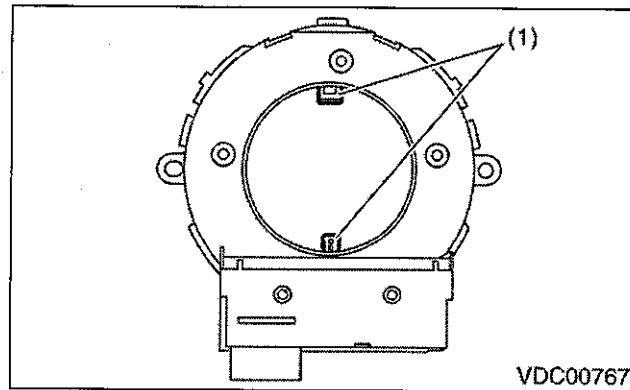
CAUTION: Do not rotate the steering angle sensor protrusions (call out "1", as shown).
