Technical Bulletin

Section Title: Body, Cab and Accessories
 TSB No. TS 00 06290

SUBJECT: SAFETY RECALL CAMPAIGN: SG, COUNTERMEASURE OF INSTRUMENT PANEL CENTER LOWER BOX.
MODEL(S): KIZASHI (A6B424)
YEAR: 2010 (BUILT BETWEEN OCTOBER 13, 2009 TO JUNE 17, 2010)

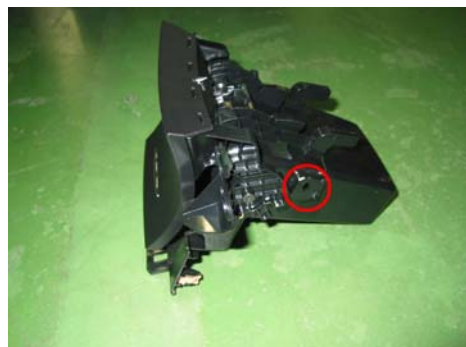
CONDITION: The hinged door on the instrument panel center lower box may not remain closed in the event of a crash.

CAUSE: Improper design of the latch mechanism.

Part Number	Description	Qty.	Notes
73890-57L01-RX0	Box, I/P Ctr Lower	1	Pictured below without counter lock

CORRECTION: Please replace the instrument panel center lower box with a new replacement part. This will be performed at no charge to the customer for parts or labor.
