TRW Automotive  
Commercial Steering Systems

IGEN 3 Intermediate Shaft Weld Location  
Inspection Procedure

# TRW IGEN3 Intermediate Steering Shaft Assembly

# RECALL

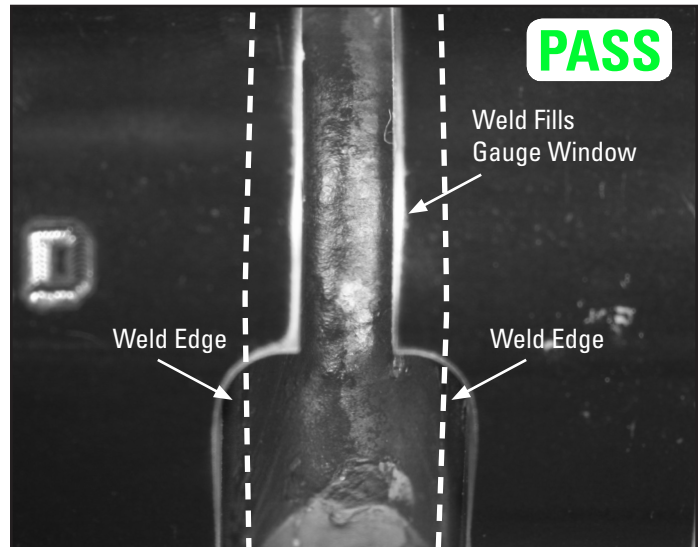
Figure 4

2. Visually inspect the position of the weld bead in reference to the small gauge window (3/16" width). The full circumference of weld seam must be inspected in the gauge window. **Figure 4**  
**Look for the following criteria:**

- The weld bead must completely fill the gauge window.
- No joint line between the 2 tubes should be visible, the edges where the tubes join should be covered by the weld.
- The parent tube should not be visible in the narrow section of the gauge window.

- 2a. **Part Passes** if the weld bead completely fills the narrow gauge window **Figure 4**. Mark the parts that pass inspection with yellow or white paint mark adjacent to the part number stamp. **Figure 1**

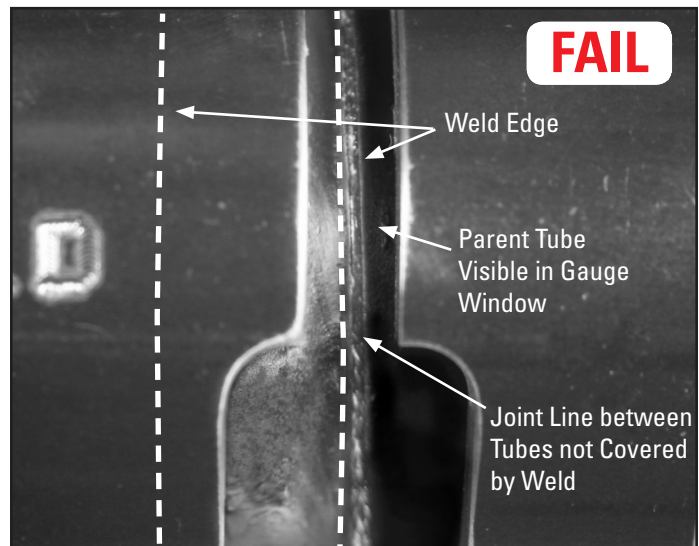
Figure 5

- 2b. **Part Fails** if any of the following are seen in the inspection. **Figure 5**
  - The weld bead does not completely fill the narrow gauge window.
  - The parent tube is partially visible in narrow gauge window.
  - The joint line between the 2 tubes is visible at any point around the circumference of the shaft. **Figure 5**

Remove intermediate shaft and replace.

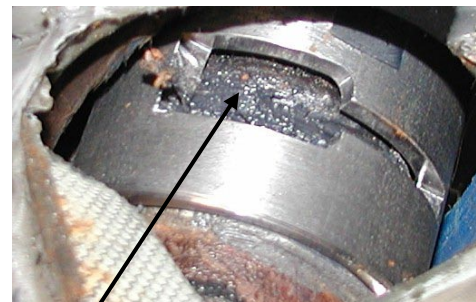
Weld shown through TRW inspection tool from underneath driver's floor

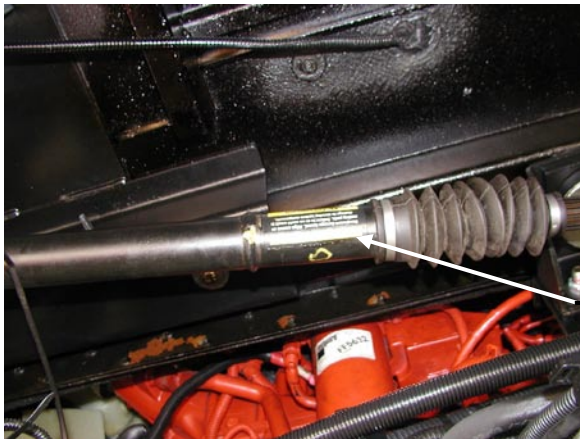
Date Code Location

5. The lower shaft TRW date code identification stamped on the shaft is located on steering gear end of the shaft. Turn the steering wheel to rotate shaft for stamped number to be visible.
