CERTAIN 2010 MODEL YEAR TRANSIT CONNECT VEHICLES — HEADLINER PUSHPIN REPLACEMENT

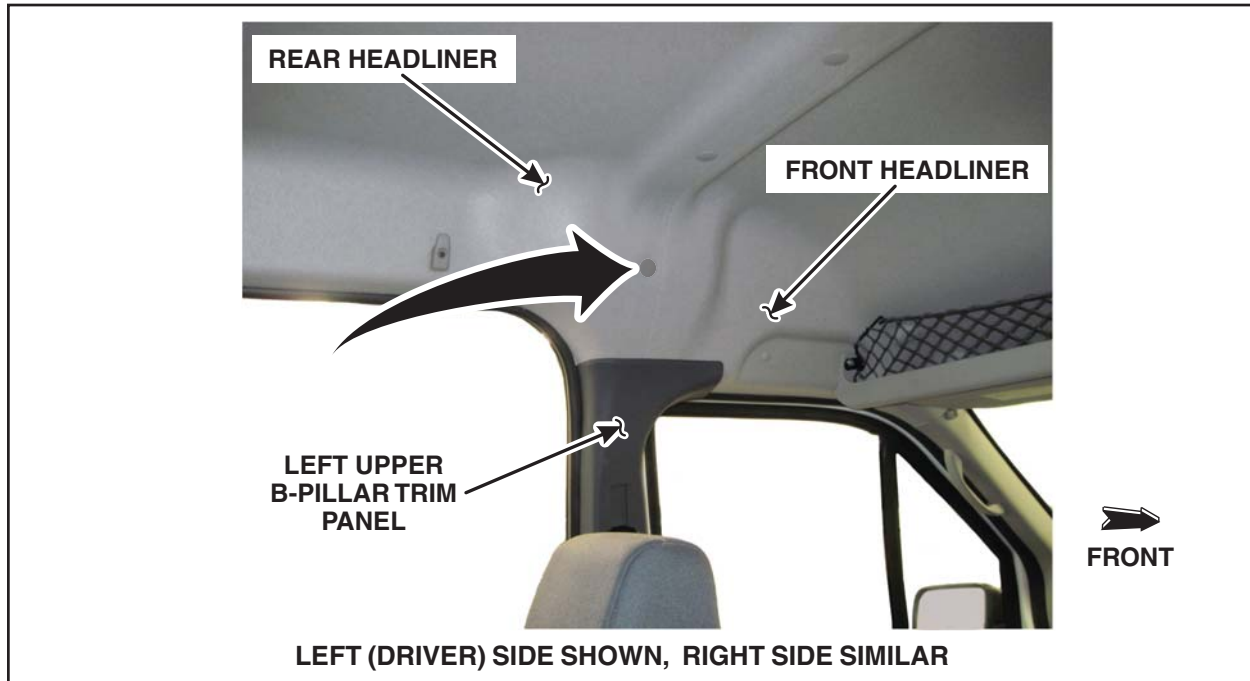
FIGURE 1

On some of the affected vehicles, the headliner pushpin at the B-pillar may not absorb sufficient energy to conform to the requirements specified by Federal Motor Vehicle Safety Standard (FMVSS) No. 201 - Occupant Protection in Interior Impact.

1. Remove the existing headliner pushpins (one per side) located directly above the right and left upper B-pillar trim panels. See Figure 1.
2. Install the revised pushpins.
