# Technical BULLETIN

## SAFETY RECALL

### 2009 VMX17Y/YC

### FACTORY MODIFICATION CAMPAIGN – APS/TPS Wiring

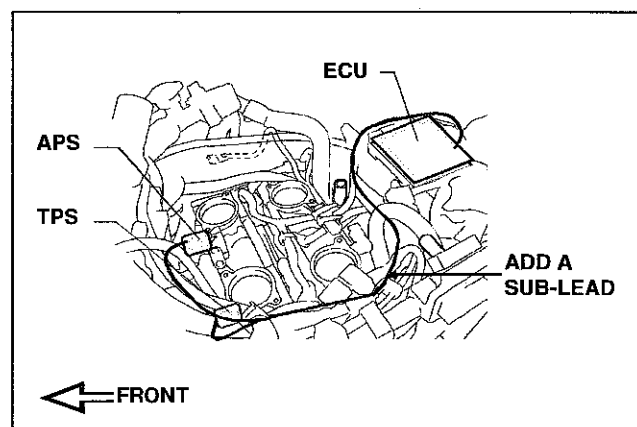
Yamaha Motor Corporation, U.S.A. has decided that a defect which relates to motor vehicle safety exists in certain 2009 VMAX (VMX17Y/YC) model motorcycles. In affected motorcycles, there could be excessive electrical resistance in the ground wire for the Accelerator Position Sensor (APS) and Throttle Position Sensor (TPS) due to an insufficiently crimped connection. Excessive resistance can cause incorrect signals to be sent to the Engine Control Unit (ECU) which could lead to unstable engine idle speed and/or keep idle speed from falling below about 3000 rpm when the throttle is released, preventing a proper return to idle that could result in an accident with injury or death.

To correct this defect, Yamaha is initiating a Factory Modification Campaign. Affected motorcycles must have an additional sub-lead wire installed that bypasses the problem area of the wire harness to prevent the excessive resistance.
