# Technical BULLETIN

## SAFETY RECALL

### 2009 VMX17Y/YC

### FACTORY MODIFICATION CAMPAIGN – APS/TPS Wiring

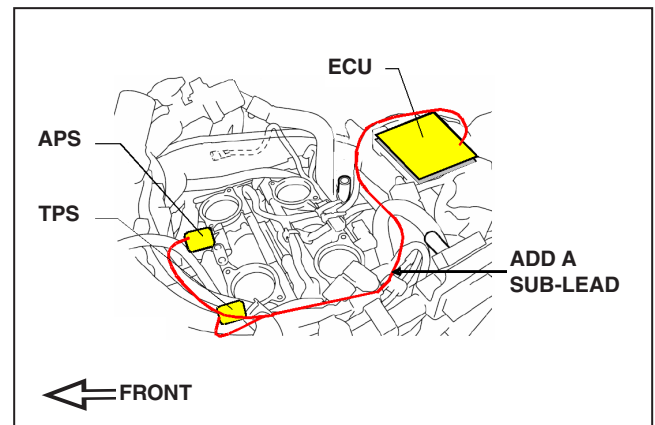
Yamaha Motor Corporation, U.S.A. has decided that a defect which relates to motor vehicle safety exists in certain 2009 VMAX (VMX17Y/YC) model motorcycles. In affected motorcycles, there could be excessive electrical resistance in the ground wire for the Accelerator Position Sensor (APS) and Throttle Position Sensor (TPS) due to an insufficiently crimped connection. Excessive resistance can cause incorrect signals to be sent to the Engine Control Unit (ECU) which could lead to unstable engine idle speed and/or keep idle speed from falling below about 3000 rpm when the throttle is released, preventing a proper return to idle that could result in a crash with injury or death.

To correct this defect, Yamaha is initiating a Factory Modification Campaign. Affected motorcycles must have an additional sub-lead wire installed that bypasses the problem area of the wire harness to prevent the excessive resistance.
