**BMW Motorrad
USA
Service Information Bulletin**

****Notice of recall 10V-328****

Subject: Retrofitting Arrester Cables for Left Siren Speaker

Model: R 1200 RT-P (K26, 0388) with option code 0113 Authority equipment package.

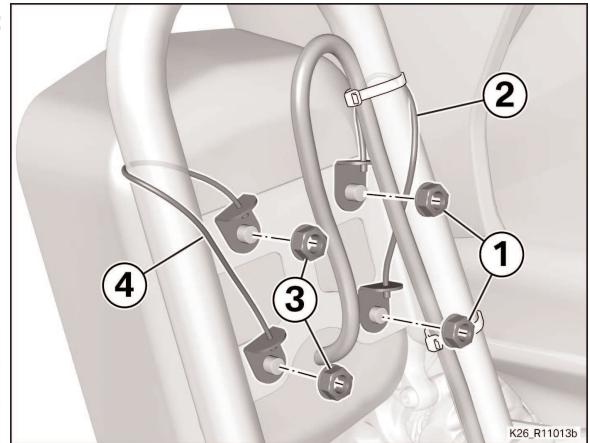
Details: Under extreme dynamic loading when the motorcycle is being ridden, the bracket of the siren loudspeaker on the left protection bar can break. In order to keep the siren speaker safely attached to the motorcycle if the bracket breaks, 2 arrester cables are attached to the siren speaker and the left protection bar.

Securing siren speaker with arrester cables:

- Remove nuts (1).
- Hold arrester cable (2) in position and locate it with nuts (1).
- Remove nuts (3).
- Hold arrester cable (4) in position and locate it with nuts (3).
- Tighten nuts (1) and (3) alternately.

Tightening torques	
Siren speaker to protection bar	
1/4" - 20 UNC	8 Nm

Because of the nature of how the speaker will settle into place, it is necessary to apply the torque sequence 4 times.
