**SUBJECT: Suspension Inspection and Repair for
Broom Bear Sweepers mounted on
International 4300 Chassis**

DATE: 08/02/2010

NUMBER: SB-0078

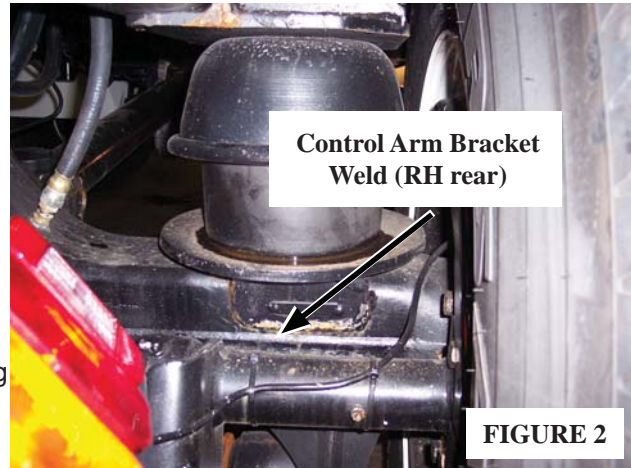
FIGURE 2

- Welds at four (4) lower control arm brackets located at the left and right axle housing. (FIGURE 2)
- Welds at the rear axle tower located on the top of the center axle housing (FIGURES 3 and 4)
- Welds must meet the criteria described in the attached Addendum.

1. Visually inspect the front and rear weld attachment of the left and right suspension control arm brackets to the axle housing. (FIGURE 2 (RH is shown, LH is similar))

1. Grind out the old weld deposit before re-welding. Care should be taken to not grind too much from the surface of the axle housing, which could leave a thin wall for the re-weld.
2. Using a E7018 welding rod, re-weld the joint to the specifications shown in the attached "Chalmers Suspensions" drawing.
3. Clean and re-paint the weld area with suitable medium gloss black paint (obtain locally).

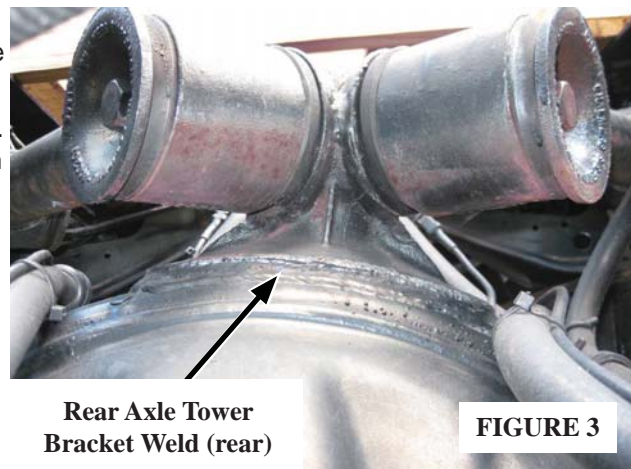
FIGURE 3

NOTE: Access to the rear axle tower bracket (FIGURE 3) may be gained by raising the hopper and installing the hopper stops.

2. Visually inspect the front and rear weld attachment of the tower brackets to the center axle housing. (FIGURES 3 and 4)
3. Complete the checklist provided in the attached addendum.
4. Welds not meeting the inspection criteria must be repaired.

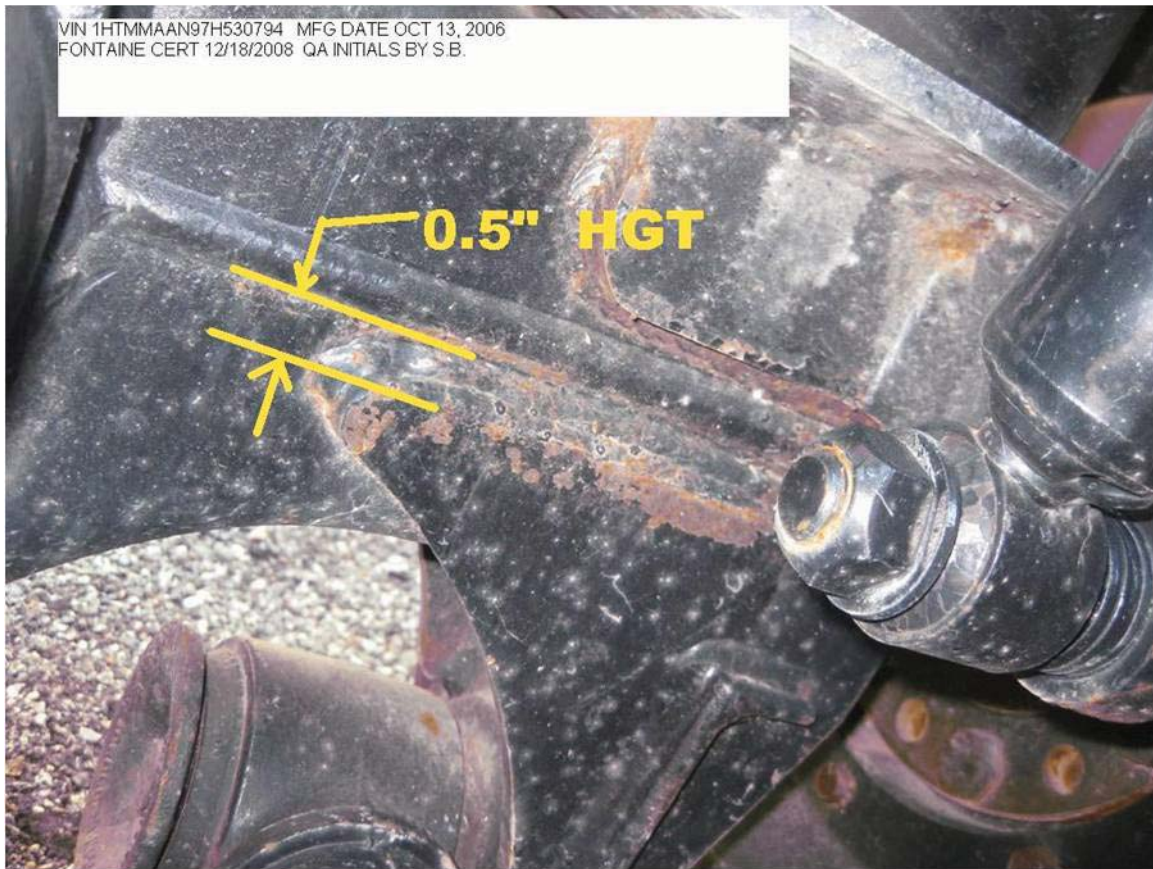
Ensure weld height is 0.450" minimum
Per the Chalmers print

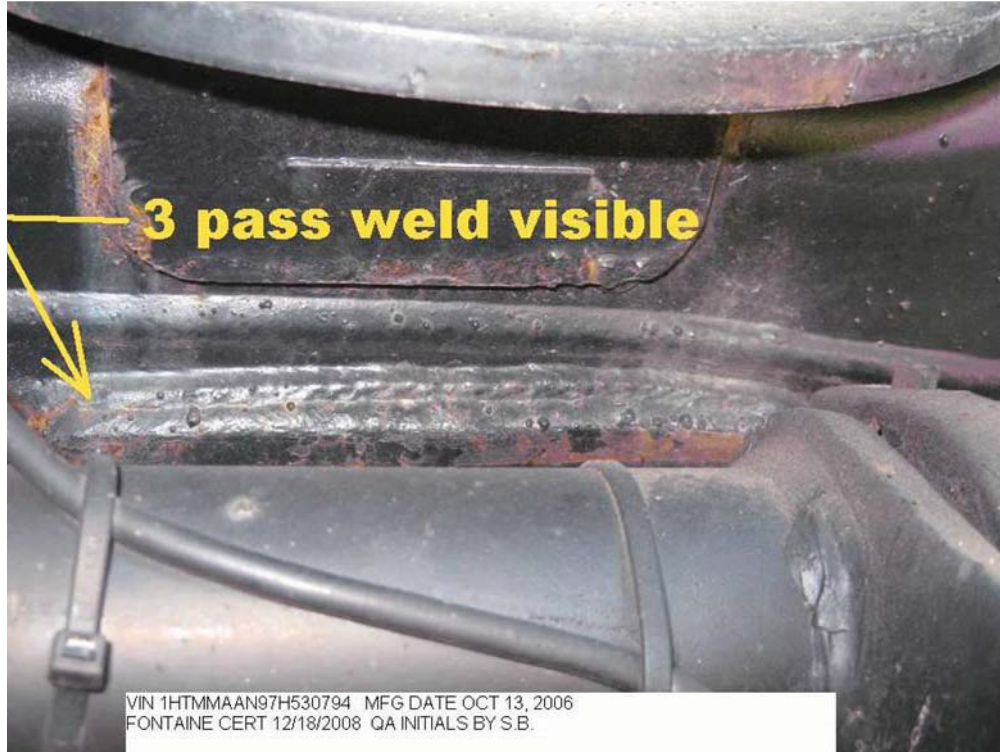
Ensure 3 weld passes are visible
Per the Chalmers print

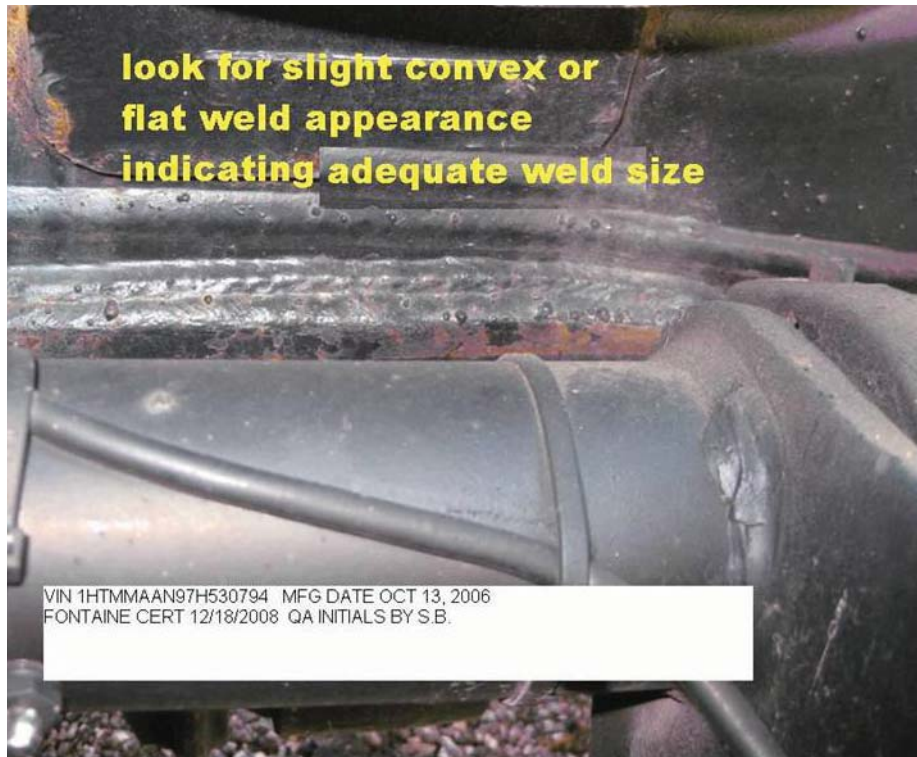
**Flat weld shape is desirable. Slight convex is acceptable.
Concave is not good and indicates there may not be enough
weld film thickness.**

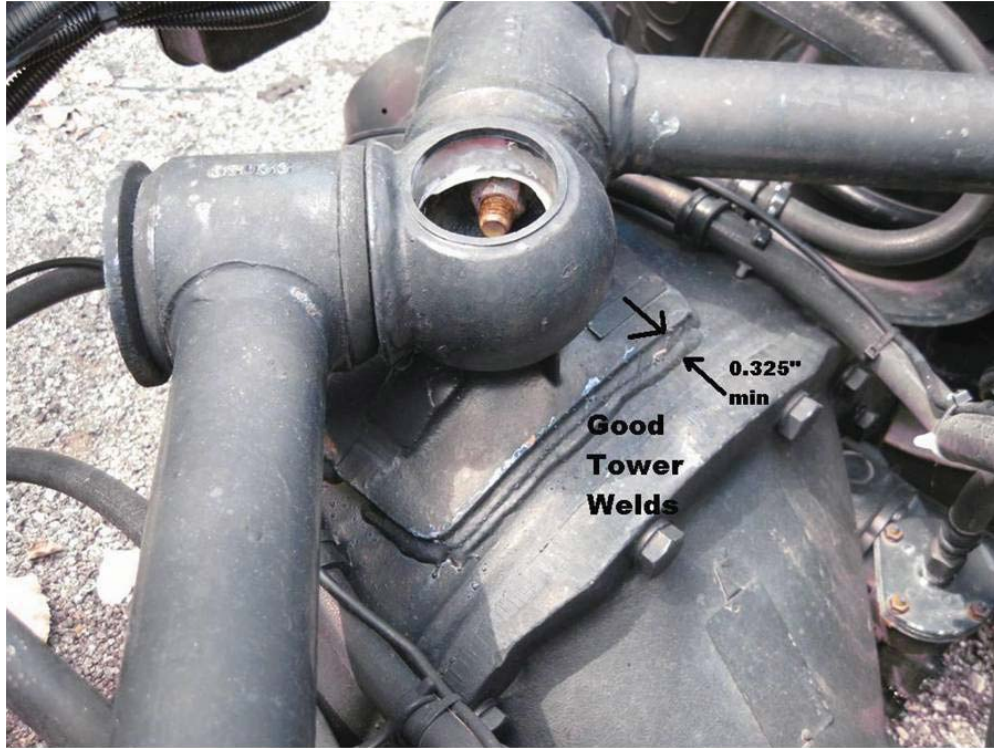
Shows acceptable 3/8" multi-pass weld
