Safety Recall: Shift Cable Socket Holder Is Incorrectly Installed

The repair is to reset the shift cable socket holder in the shift cable bracket. For repair, affected VIN, and warranty information, refer to Service Bulletin 10-036, *Safety Recall: Shift Cable Socket Holder Is Incorrectly Installed*.

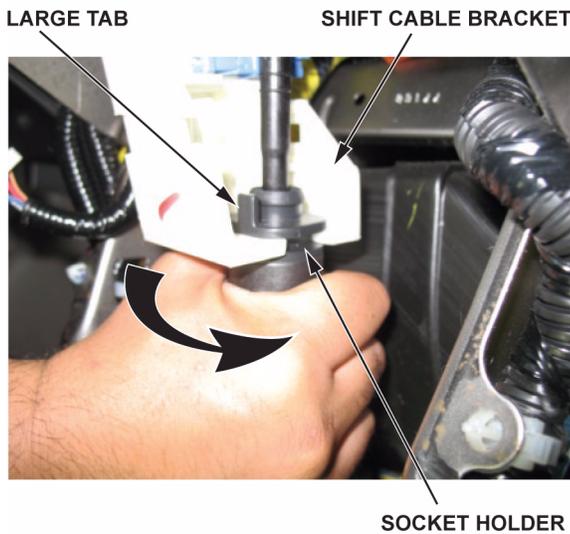
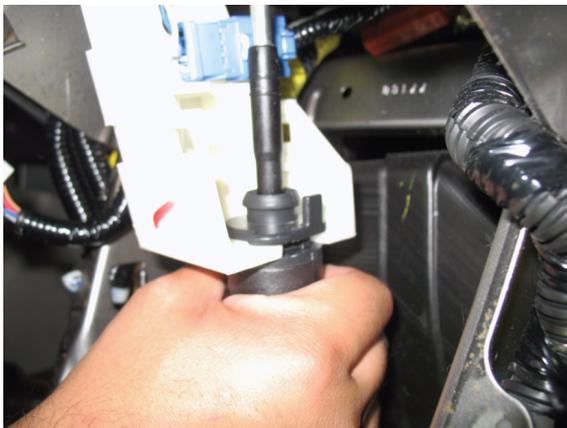
1. *SC models only*: Remove the center console.
2. Remove the dashboard center lower cover.
3. Remove the subwoofer.
4. With your hand on the shift cable socket holder, rotate the socket holder counterclockwise (until its large tab is over the open slot in the shift cable bracket), then remove it from the shift cable bracket.

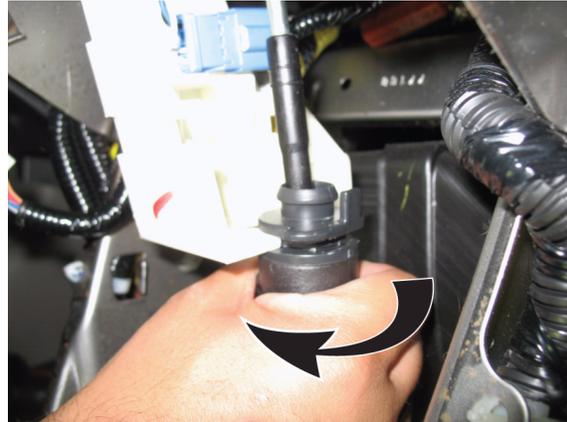
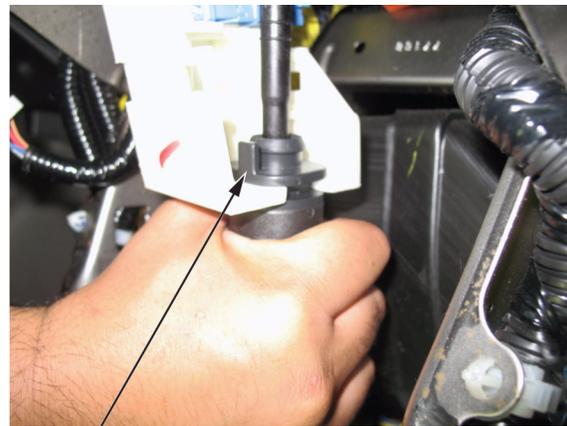
Correct installed position of large tab.

5. Reinsert the socket holder into the shift cable bracket, and rotate the socket holder 1/4 turn clockwise (the large tab moves toward you) to lock it on the bracket. You'll feel a slight bump as the socket holder locks into place.
