Re: 49 CFR Part 573; Recall of Mercedes-Benz G-Class (463) Turn Signal Grill Covers

RE: Recall Campaign– **Head Lamp and Front Turn Signal Grills, Model 463, Model Years 2002 - 2010**

Remove Directional Grill and Headlamp Grill

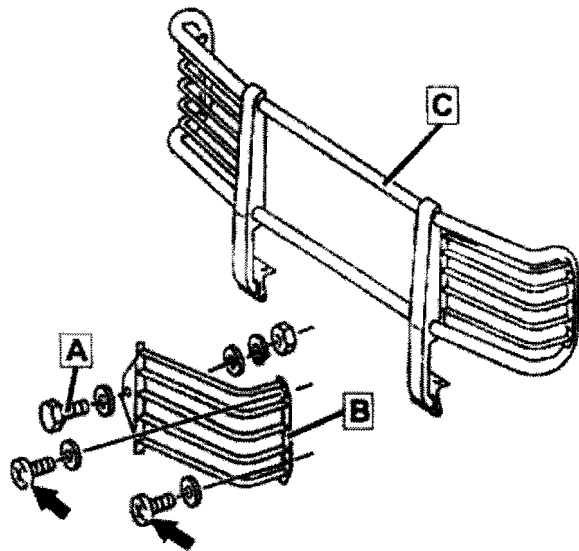
Figure 5

Daimler AG (DAG) has determined that the headlamps of the affected vehicles are equipped with a protective grill for protection of the headlamps during off-highway operation. Federal Motor Vehicle Safety Standard (FMVSS) 108 S7.8.5 specifies that a grill shall not be installed in front of the lamp. The affected vehicles meet all luminosity requirements of FMVSS 108 with the protective grill installed so there is no consequence to highway safety from the presence of the grill. The affected vehicles are also equipped with an allowable grill cover for front turn signal protection which affects compliance with FMVSS 108.

- Remove bolt (A, Figure 5) and two screws (arrows) then remove headlamp grill (B) from front brush guard (C). Repeat this step on opposite side.
