Campaign No. 2010110008, January 2011

SUBJECT: **Model 463, Model Years 2002 - 2010**  
**Remove Headlamp Grill, Replace Front Turn Signal Lenses**

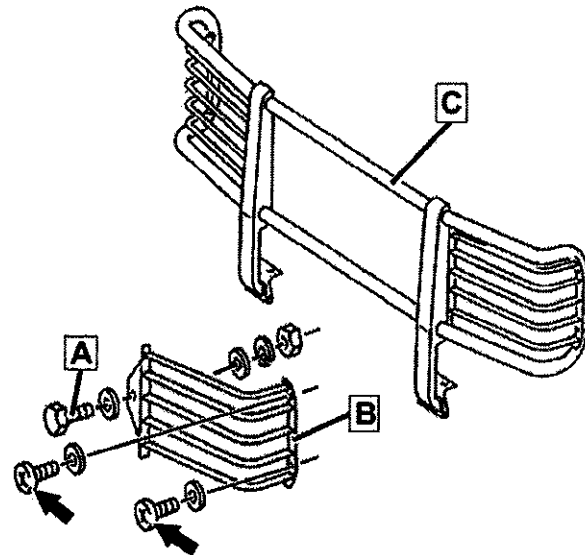
Figure 1

### 2. Remove headlamp grill (B, Figure 1):

- Remove bolt (A) and two screws (arrows) then remove headlamp grill (B) from front brush guard (C). Repeat this step on opposite side.
- Clean area of brush guard where headlamp grills (B) were installed.

- Brush guards must **not** be installed again
- All parts removed in this step **must** be returned to the QEC.
- Cost of parts removed in this step must be reimbursed to customer. Refer to parts reimbursement table on page 4.
- Cost of aftermarket (non Mercedes-Benz genuine) parts removed in this step must **not** be reimbursed to customer.

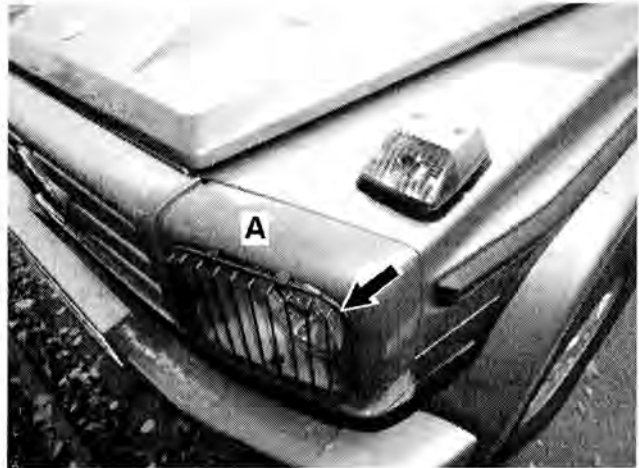
Figure 2

3. Replace headlamp trim (A, Figure 2):
  - Remove headlamp trim (A) with head lamp grill (arrow); refer to WIS: AR88.00-P-2100G.

- If equipped with brush guard, lower brush guard to access headlamp trim (refer to Practical Hints chapter in Operator's Manual).
  - For models with headlamp washers: Transfer washer nozzles from old headlamp trim (A) to new headlamp trim (A).
  - Be careful not to scratch paint when removing and installing headlamp trim (A).
- Install new trim (A) (without grill mounting holes) painted in same color as vehicle.

- All parts removed in this step **must** be returned to the QEC.
- Cost of parts removed in this step must be reimbursed to customer. Refer to parts reimbursement table on page 4.
- Cost of aftermarket (non Mercedes-Benz genuine) parts removed in this step must **not** be reimbursed to customer.
