MERCEDES-BENZ USA, LLC  
One Mercedes Drive, P.O. Box 350, Montvale, NJ 07645-0350  
Phone (201) 573-0600  
Fax (201) 573-0117  
MBUSA.com

## newschannel UPDATE

RE: **Recall Campaign**– Head Lamp and Front Turn Signal Grills, Model 463, Model Years 2002 - 2010

## Remove Directional Grill and Headlamp Grill

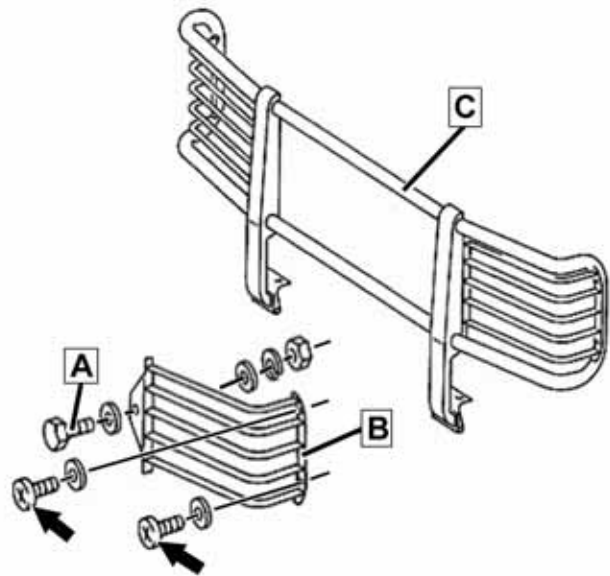
Figure 5

Daimler AG (DAG) has determined that the headlamps of the affected vehicles are equipped with a protective grill for protection of the headlamps during off-highway operation. Federal Motor Vehicle Safety Standard (FMVSS) 108 S7.8.5 specifies that a grill shall not be installed in front of the lamp. The affected vehicles meet all luminosity requirements of FMVSS 108 with the protective grill installed so there is no consequence to highway safety from the presence of the grill. The affected vehicles are also equipped with an allowable grill cover for front turn signal protection which affects compliance with FMVSS 108.

1. Remove bolt (A, Figure 5) and two screws (arrows) then remove headlamp grill (B) from front brush guard (C). Repeat this step on opposite side.
