RECALL CAMPAIGN BULLETIN

NTB10-096

VOLUNTARY SAFETY RECALL CAMPAIGN 2010 ARMADA 2ND ROW CENTER SEAT LATCH

APPLIED VEHICLES: 2010 Armada (TA60)

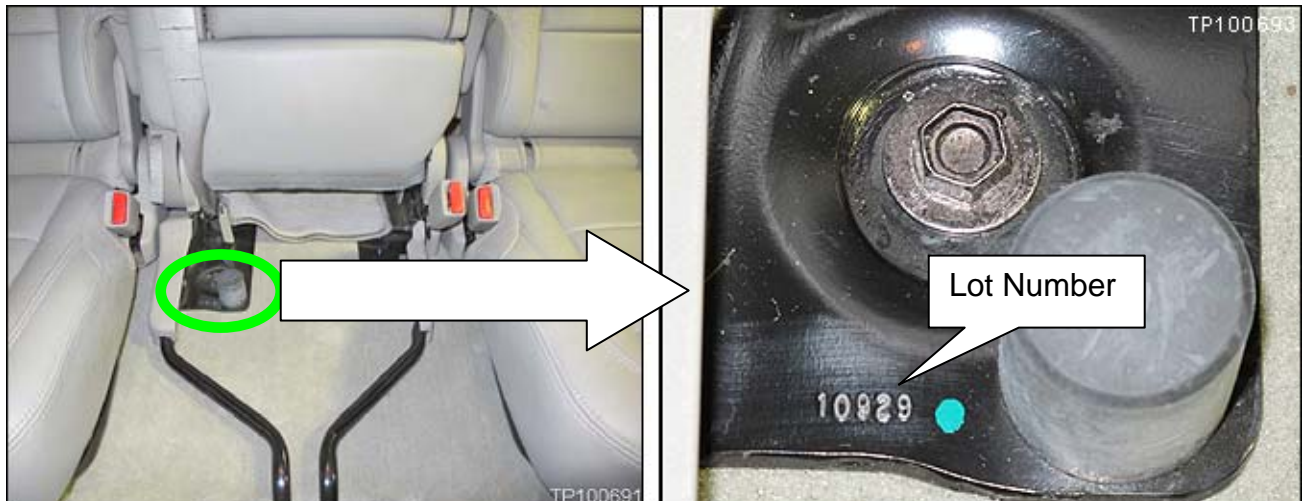
Figure 1

1. Fold the 2nd row center seat cushion forward (see Figure 1).
2. Locate the Lot Number (see Figure 1).
 - Lot Number is on the right side (passenger side) latch assembly foot.
 - If the lot number is **11420**, or it is **missing**, or it is **illegible**; go to 2nd Row Center Seat Latch Inspection on the next page.
 - If the lot number is **not** 11420; end – no further action is needed.
