RECALL CAMPAIGN BULLETIN

NTB10-096

VOLUNTARY SAFETY RECALL CAMPAIGN 2010 ARMADA 2ND ROW CENTER SEAT LATCH

CAMPAIGN ID #: PC059

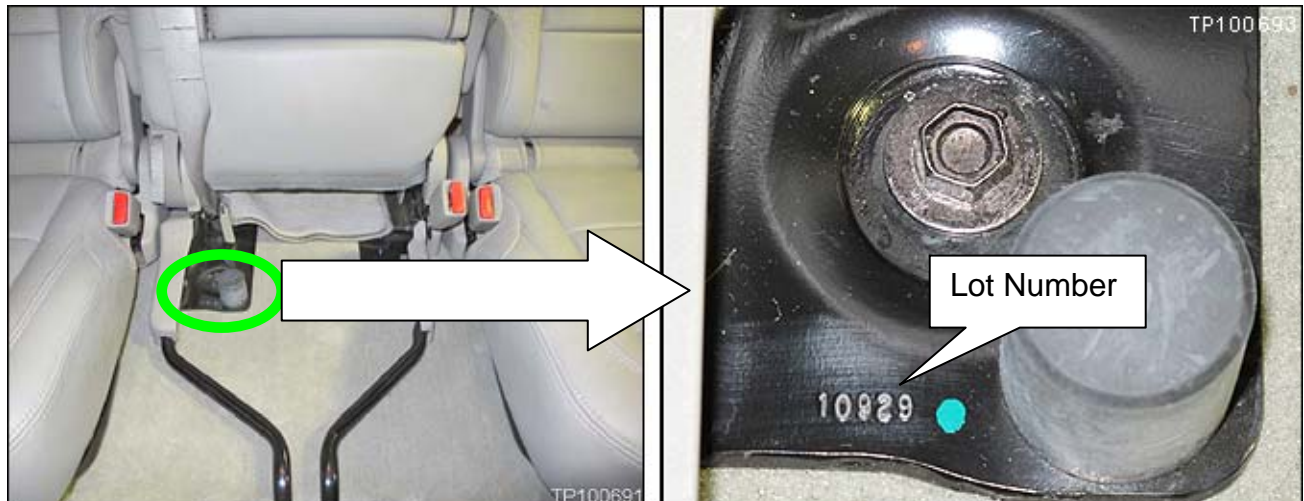
Figure 1

1. Fold the 2nd row center seat cushion forward (see Figure 1).
2. Locate the Lot Number (see Figure 1).
 - Lot Number is on the right side (passenger side) latch assembly foot.
 - If the lot number is **11420**, or it is **missing**, or it is **illegible**; go to 2nd Row Center Seat Latch Inspection on the next page.
 - If the lot number is **not** 11420; end – no further action is needed.

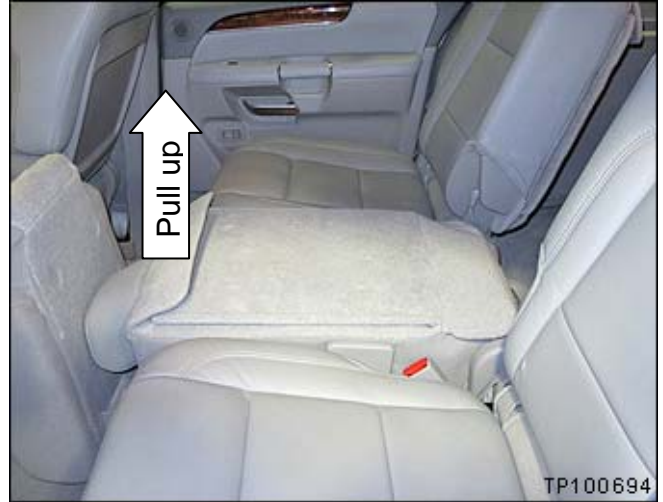
Figure 2

1. Pull the release strap to fold the seatback flat and latch it in place.
2. Pull UP on the seatback and make sure it stays latched in place.
 - If the seatback **does not stay latched (NG)**, go to 2nd Row Center Seat Latch Assembly Replacement on the next page.
 - If the seatback **stays latched (OK)**, go to Step 3 below.

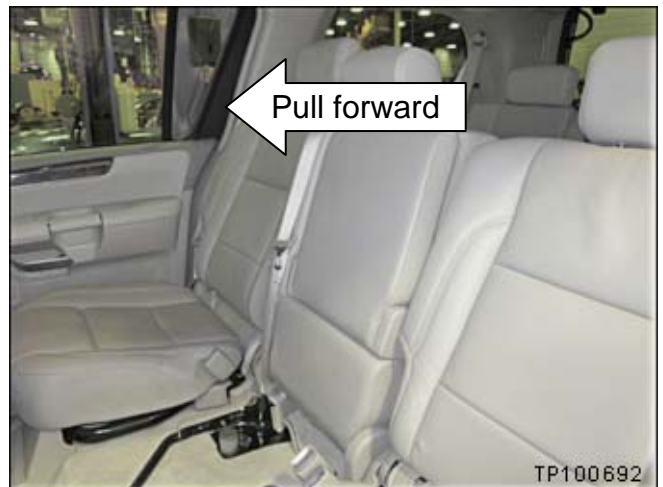
Figure 3

3. Pull the release strap to return the seatback to the upright position and latch it in place.
4. Pull forward on the seatback and make sure it stays latched in place.
 - If the seatback **does not stay latched (NG)**, go to 2nd Row Center Seat Latch Assembly Replacement on the next page.
 - If the seatback **stays latched (OK)** – end – no further action is needed.
