Service Bulletin No. 348

MODEL E4500 / J4500 Series Coaches	TYPE Field Change Program	SECTION/GROUP 3- Body	DATE Aug. 16, 2010
SUBJECT SE – GI WINDOW GLASS ASSEMBLY ADHESIVE DEBONDING			
CONDITIONS

Ref. NHTSA Recall No.: 10V-373

Ref. Transport Canada Recall No.: 10-270

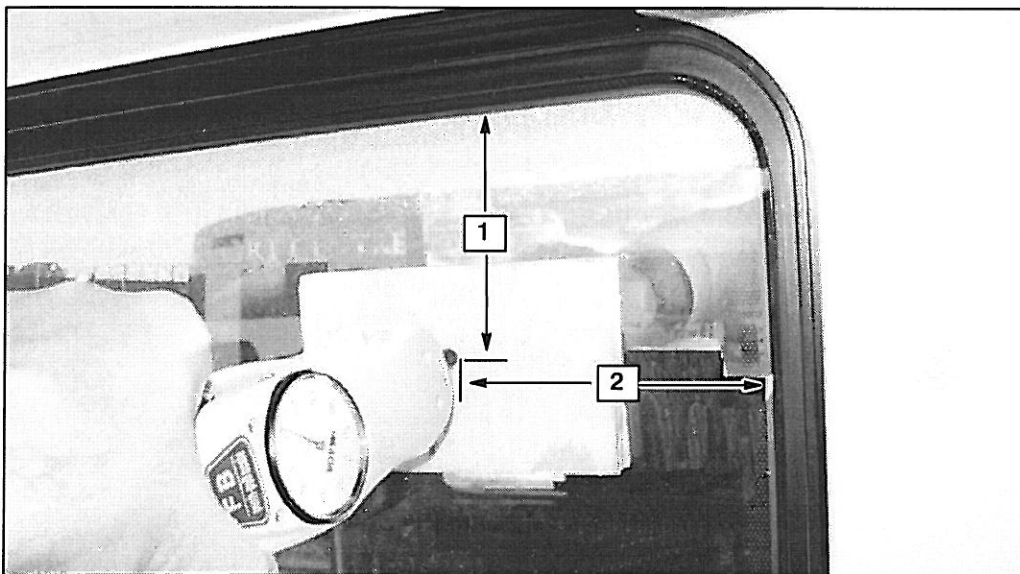
Figure 1.

3. Ensure window is in locked position.
4. From inside the coach, carefully position a 4.0 x 4.0 x 0.5 inch flat wood block flat against the glass surface, the center of which should be six (6) inches from both edges (as shown in Figure 1). Position a push / pull gauge at the center of the wood block and apply 50 lbs. push force against the glass, perpendicular to the glass surface, to accentuate any partial de – bonding that may exist.
5. Look for any evidence of de-bonding from the frame, as force is applied.

6. Repeat Steps 3. to 5. at the remaining three (3) corner locations of the window.
7. Repeat Steps 3. to 6. to remaining coach windows.
