File In Section: Product Recalls
Bulletin No.: 10243
Date: August 2010

Recall Bulletin

SUBJECT: Second Row Safety Belt Interference When Seat Back Returned to Upright Position

MODELS: 2009-2010 Buick Enclave
2009-2010 Chevrolet Traverse
2009-2010 GMC Acadia
2009-2010 Saturn OUTLOOK

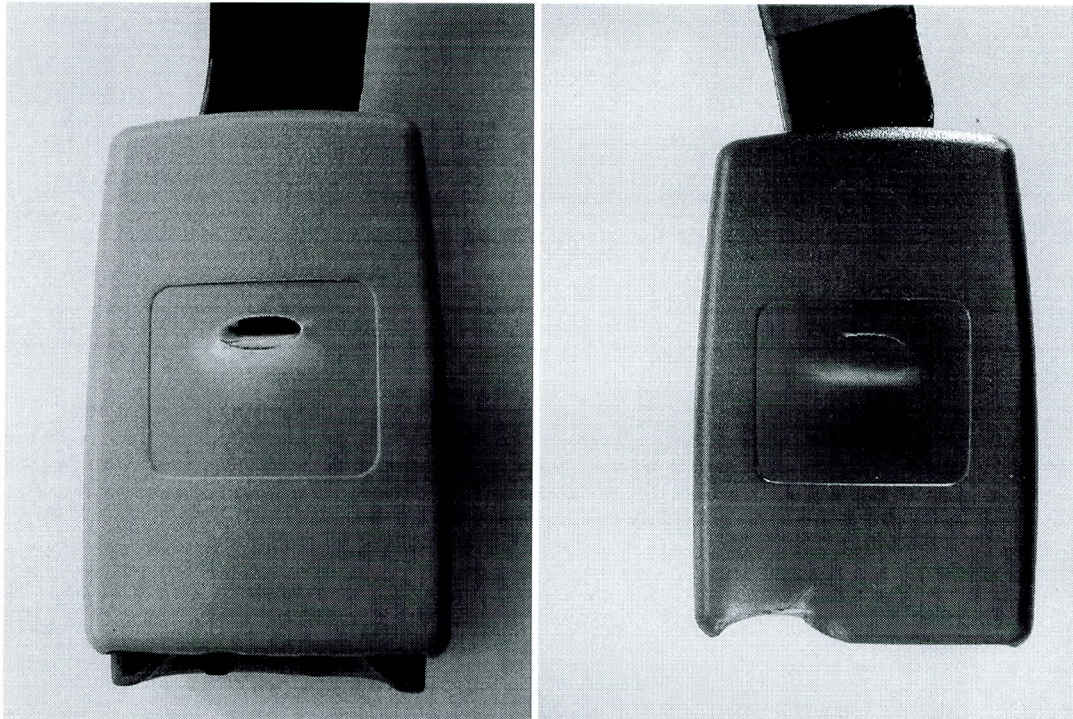
2513825

Note: Test the operation of the belt buckle. Latch the buckle and pull on the seat belt to ensure the seat belt functions properly.

2. Verify proper functioning of the belt buckles and visually inspect each buckle/release button for damage. Refer to the illustration for an example of a damaged buckle.
 - If evidence of buckle damage such as a bent or cracked plastic housing is found, or if stressed witness marks are visible on the housing, replace the seat belt buckle. Refer to *Rear Seat Belt Buckle Replacement* in SI, and then continue on and complete the trim cover rework procedure below.
 - If no buckle damage is found, complete the trim cover rework below on the seat(s)

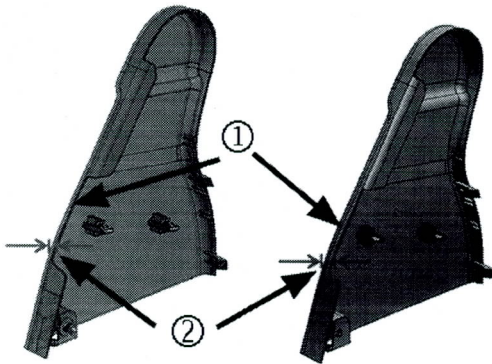
2509075

Note: The material to be removed is the standing ledge (1) in the notched-out opening, shown in the examples above. Depending on the design and seat configuration, approximately 3–5 mm (0.120–.200 in) of material (2) will need to be removed.
