# Recall Bulletin

## PRODUCT SAFETY RECALL

**SUBJECT:** Second Row Safety Belt Interference When Seat Back Returned to Upright Position

**MODELS:** 2009-2010 Buick Enclave  
 2009-2010 Chevrolet Traverse  
 2009-2010 GMC Acadia  
 2009-2010 Saturn OUTLOOK

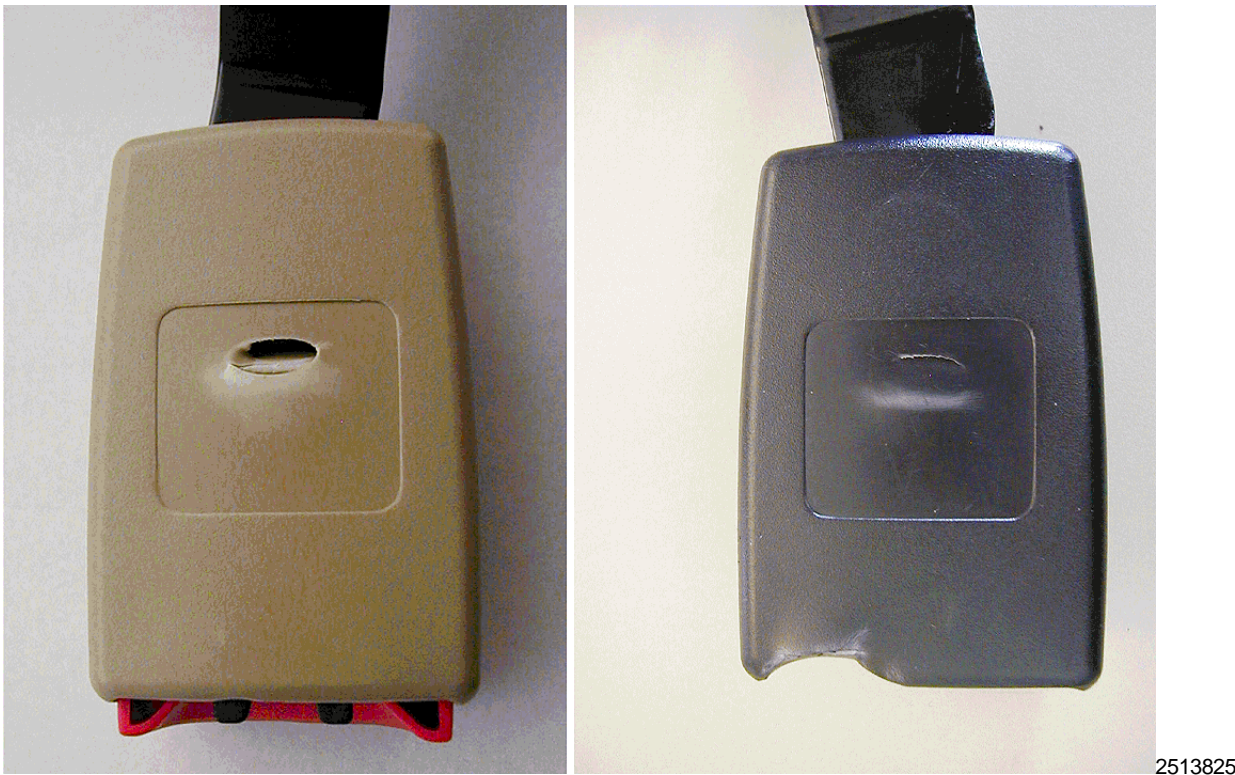
**Note:** Test the operation of the belt buckle. Latch the buckle and pull on the seat belt to ensure the seat belt functions properly.

2. Verify proper functioning of the belt buckles and visually inspect each buckle/release button for damage. Refer to the illustration for an example of a damaged buckle.
  - If evidence of buckle damage such as a bent or cracked plastic housing is found, or if stressed witness marks are visible on the housing, replace the seat belt buckle. Refer to *Rear Seat Belt Buckle Replacement* in SI, and then continue on and complete the trim cover rework procedure below.
  - If no buckle damage is found, complete the trim cover rework below on the seat(s)

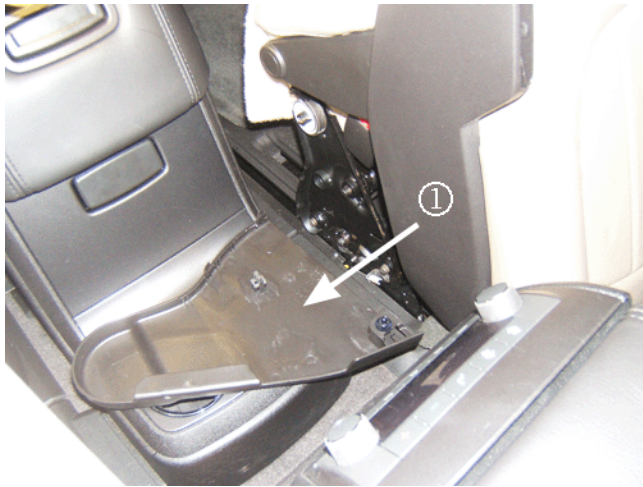
2509077

**Note:** The procedure below shows the rework being done on a left hand bucket seat trim cover. The same procedure should be done for the right hand bucket seat and both covers of the bench seat (60% and 40%).

3. Remove the rear seat recliner inner trim cover (1). Refer to *Rear Seat Recliner Outer Finish Cover Replacement - Inboard* in SI.

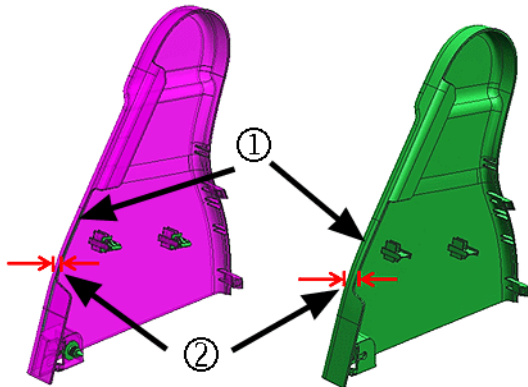
2509075

**Note:** The material to be removed is the standing ledge (1) in the notched-out opening, shown in the examples above. Depending on the design and seat configuration, approximately 3–5 mm (0.120–.200 in) of material (2) will need to be removed.

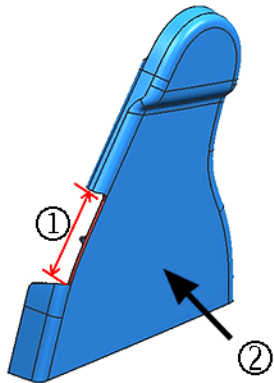
2509079

**Note:** Maintain the original notch out width (1) of approximately 82 mm (3.230 in) and remove the material until the surface edge is even with the vertical wall surface (2).
