File In Section: Product Recalls
Bulletin No.: 10243B
Date: September 2010

PRODUCT SAFETY RECALL

SUBJECT: Second Row Safety Belt Interference When Seat Back Returned to Upright Position

MODELS: 2009-2010 Buick Enclave
2009-2010 Chevrolet Traverse
2009-2010 GMC Acadia
2009-2010 Saturn OUTLOOK

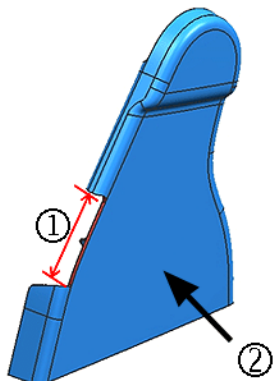
2509079

1. Determine if the recliner inner trim cover on second row seats have been modified. A modified cover will have a cutout section (1) where the belt buckle resides.
 - If all recliner inner trim covers have been modified, no further action is required.
 - If one or more recliner inner trim covers have NOT been modified, proceed to Step 2.
2. Inspect all 2nd row seat assemblies for proper function.

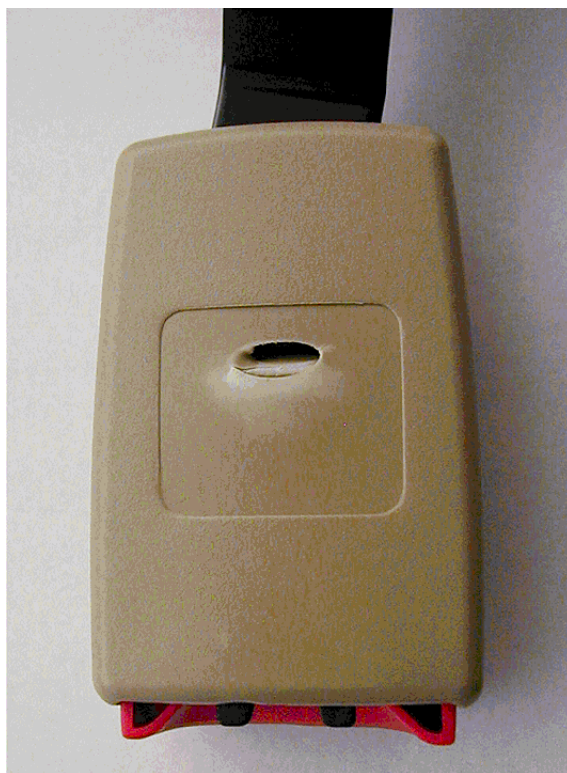
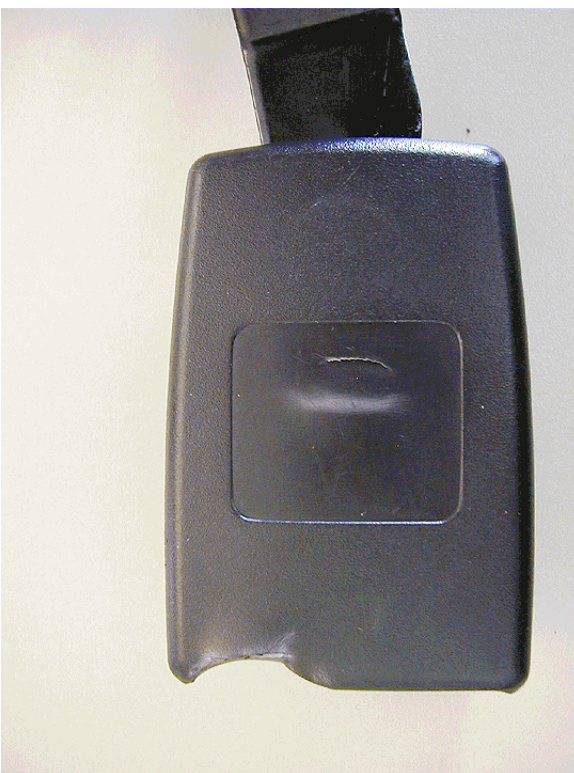
2513825

3. Verify proper functioning of the belt buckles and visually inspect each buckle/release button for damage. Refer to the illustration for an example of a damaged buckle.

- If evidence of buckle damage such as a bent or cracked plastic housing is found, or if stressed witness marks are visible on the housing, replace the seat belt buckle. Refer to *Rear Seat Belt Buckle Replacement* in SI, and then continue on and complete the trim cover rework procedure below.
- If no buckle damage is found, complete the trim cover rework below on the seat(s)

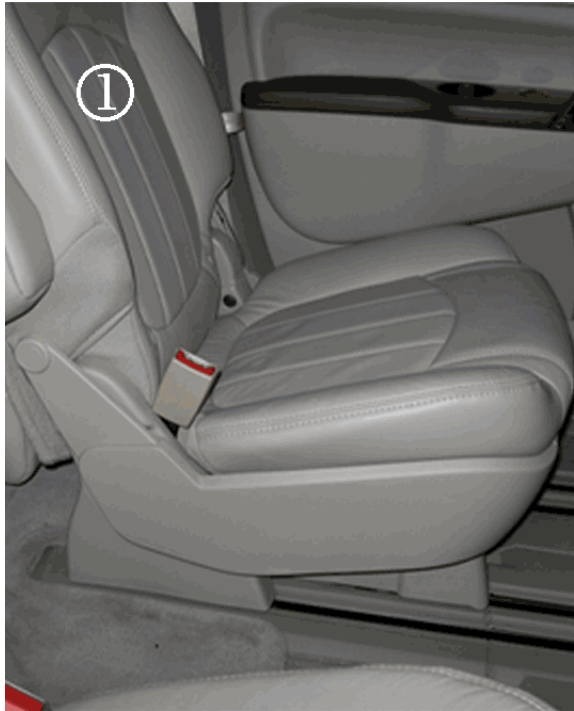
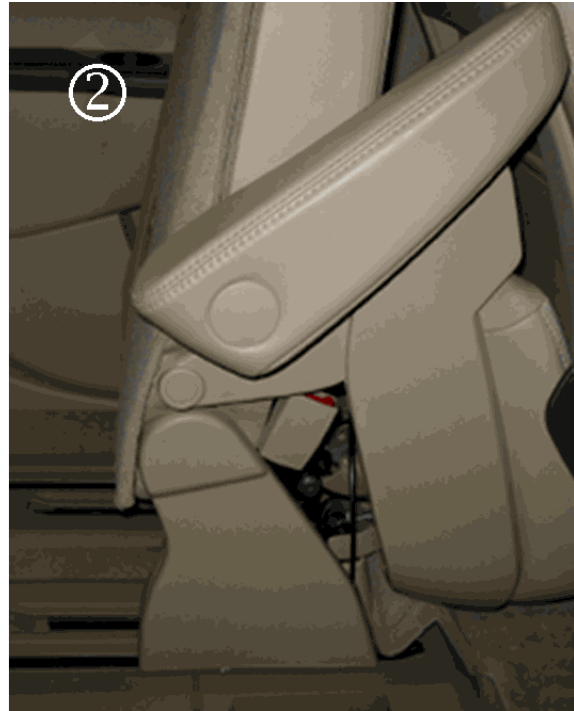
2523475

(1) Left hand bucket seat in its normal seating position. (2) Left hand bucket seat in smart slide position. This is the position that the seat must be in to remove the recliner inner trim cover.

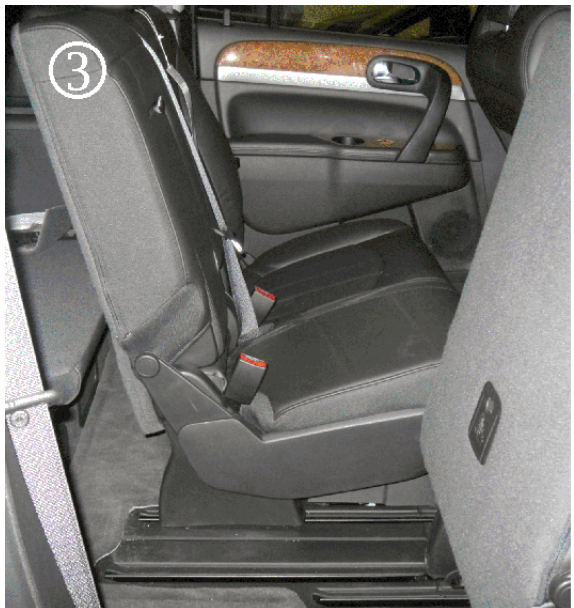
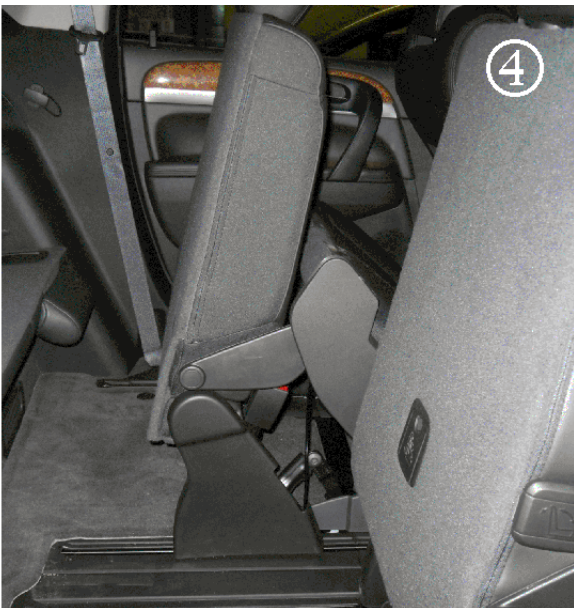
2523479

(3) Left hand 60 percent bench seat in its normal seating position. (4) Left hand 60 percent bench seat in the smart slide position. This is the position that the seat must be in to remove the recliner inner trim cover.

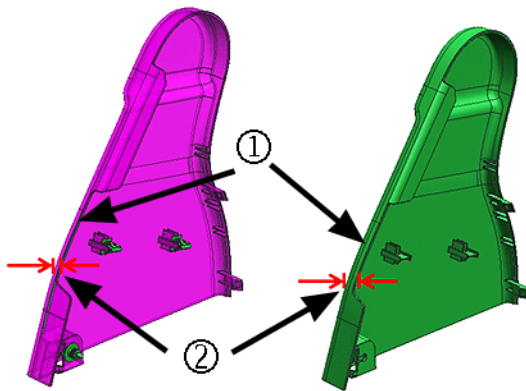
2509075

Note: The material to be removed is the standing ledge (1) in the notched-out opening, shown in the examples above. Depending on the design and seat configuration, approximately 12-15 mm (15/32-19/32 in) of material (2) will need to be removed so that the entire flange is removed all the way to the vertical wall of the cover.
