**SC0345**

## Brake Timing

MRU - 2008-2011

### SC0345, Brake Timing

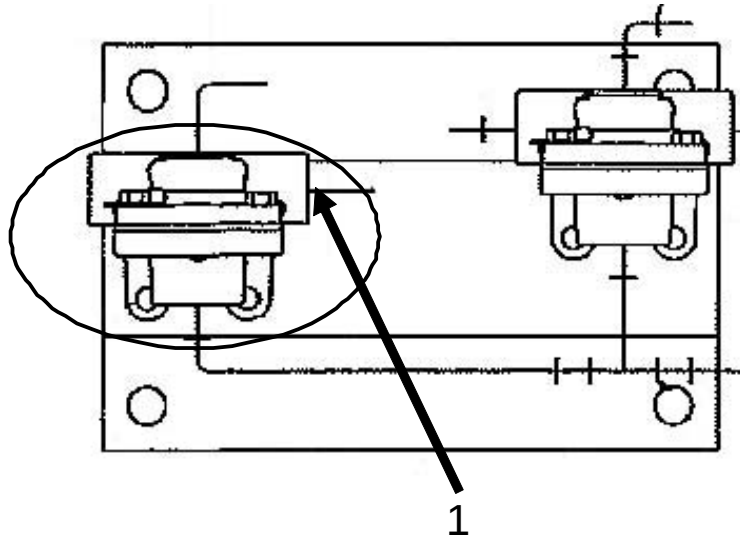
Figure 1 —

The QRVs are located inside the frame either on the driver's or passenger side at the rear. There will be two QRVs mounted to a bracket. The QRV with the airline in question is the one mounted on the "hat-section" of the bracket or the lowest mounted valve. The line will be ½" red nylon tubing, connected

to the side port (see figure 1). The position is labeled with the number 1.

4. Disconnect the air line and plug the open port in the QRV by using 63AX112.
5. Locate the front ABS modulator valve package on the engine cross member and the line that runs to the ABS modulator valve from the QRV that was disconnected in step 4. Disconnect this air line.
