10E-033
(4 pages)

PART 573 Defect and Noncompliance Report
Defect Report

Technical Service Bulletin
NSC22955401
Seat Shock Replacement

Service Bulletin No. 349

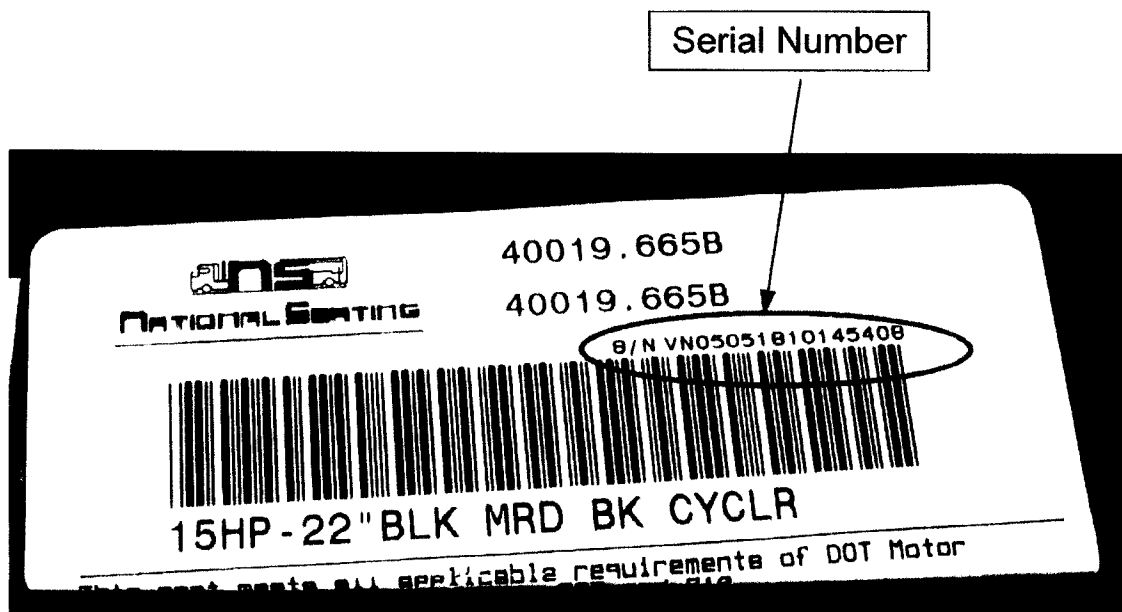
DOT Label

The serial number on the DOT label Identifies the date of manufacture of the seat.

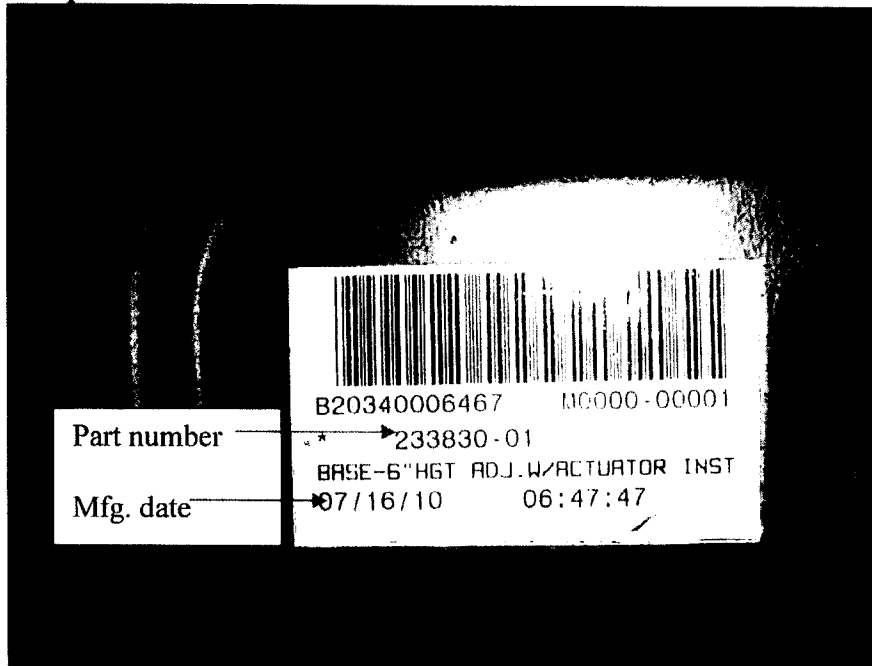
Seat Base part number: The seat base has a bar code tag on top of it that contains the part number and the date of manufacture. See example below.
