# Recall Bulletin

## FMVSS NONCOMPLIANCE RECALL

**SUBJECT:** Occupant Crash Protection Compliance – Unbelted Passenger

**MODELS:** 2009-2010 Cadillac CTS All Wheel Drive  
 2009-2010 Cadillac CTS-V

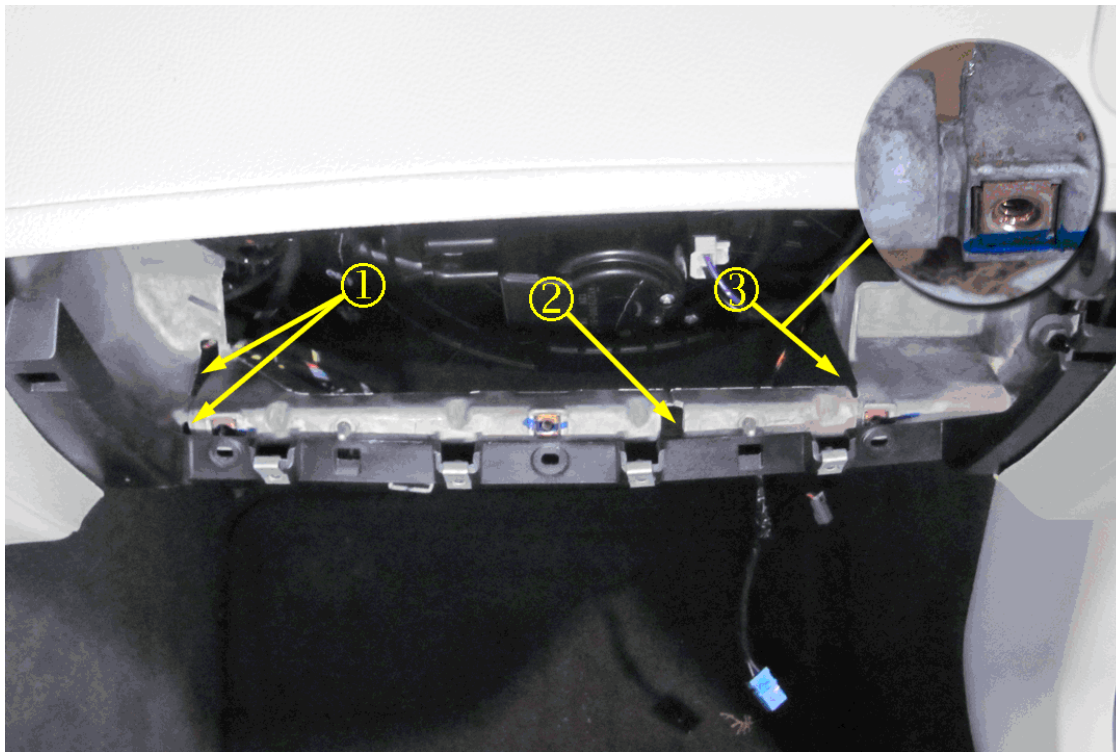
2531765

**Callouts (1), (2) (3) show cut out portions of the second design magnesium beam.**

6. Follow the production outboard passenger side cutout (3). Refer to the illustration. End the cut line 1-2 mm (3/64-5/64 in) before the front face (5) surface edge (3) of the instrument panel plastic retainer. Remove the three instrument panel plastic retainer screws to view the production outboard passenger side cutout (3). Re-install the screws after viewing the cutout.
