HYUNDAI Technical Service Bulletin

Group	CAMPAIGN
Number	10-01-032-1
Date	OCTOBER, 2010
Model	2011 SONATA (YF)

Subject **STEERING COLUMN INTERMEDIATE SHAFT CONNECTIONS INSPECTION (CAMPAIGN 097)**

THIS BULLETIN SUPERSEDES TSB 10-01-032 TO UPDATE PART NUMBERS LISTED ON PAGE 2.

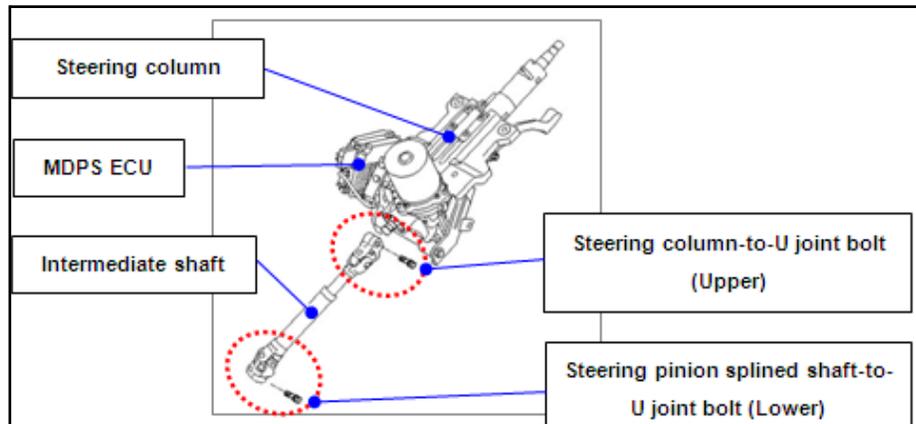
This bulletin provides the recall Campaign 097 procedure for inspecting to ensure that the steering column and the upper intermediate shaft universal joint (U joint), and the steering pinion splined shaft and the lower intermediate shaft U joint are properly connected and that both attaching bolts are tightened to the specified torque.

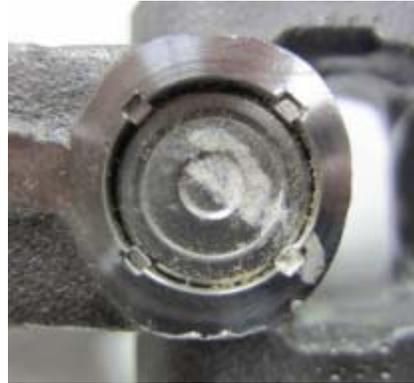
1. Inspect all 4 U-joint bearing caps. Turn the steering wheel to visually access them. Ensure they are properly fixed in the yoke by the four indentations. If the caps are loose, replace the steering intermediate shaft assembly.

NOTE: If the shaft is replaced, submit a claim (in addition to the campaign claim) under normal warranty.

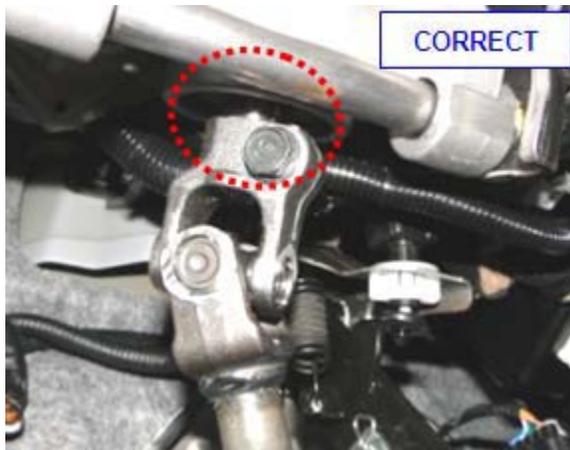
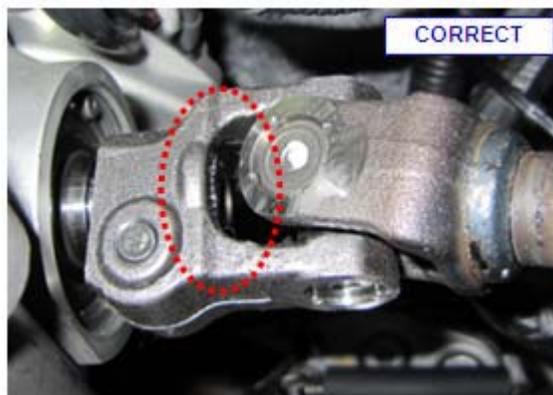
2. Visually check that the steering column and the U joint are properly connected as shown in the picture on the right.

NOTE: Look to verify that the end of the steering shaft protrudes about 1/8" into the void of the U-joint (see image). It is not seated properly if it does not protrude slightly.

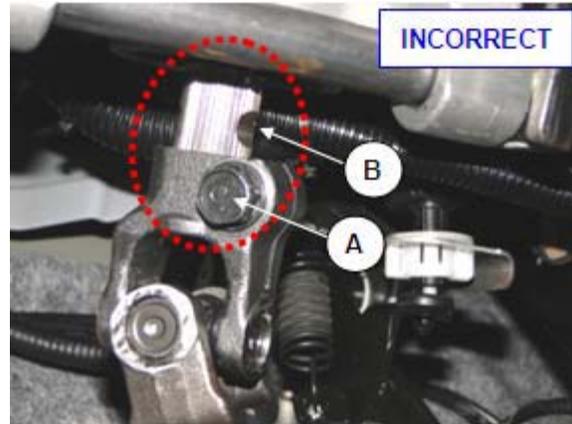
3. If the steering column and the U joint are improperly connected as shown in the picture on the right, re-connect the U joint to the steering column according to the steps below. If properly connected, go to step 8.

NOTE: The steering column-to-U joint bolt (A) must be fastened through the groove (B) in the end of the steering column.

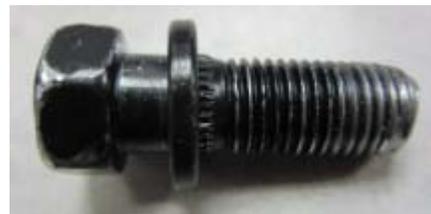
5. Inspect the bolt for damage/ stripping/cross-threading. Inspect the corresponding threads in the U-joint. Replace both if damage is found.

NOTE: If the bolt and intermediate shaft are replaced, submit a claim (in addition to the campaign claim) under normal warranty.

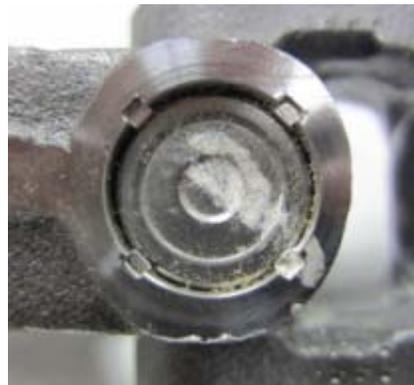
1. Pull back carpet to access lower end of steering intermediate shaft.
2. Inspect all 4 U-joint bearing caps. Turn the steering wheel to visually access them. Ensure they are properly fixed in the yoke by the four indentations. If the caps are loose, replace the steering intermediate shaft assembly.

NOTE: If the shaft is replaced, submit a claim (in addition to the campaign claim) under normal warranty.

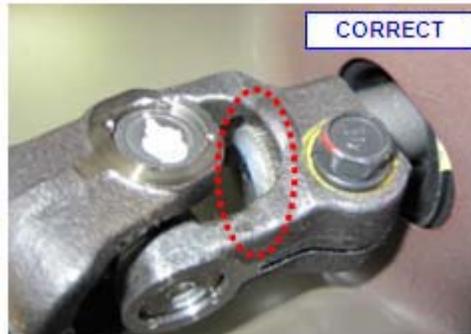
3. Visually check that the steering pinion splined shaft and the U joint are properly connected as shown in the picture on the right.

NOTE: Look to verify that the end of the splined shaft protrudes about 1/4" into the void of the U-joint (see image). It is not seated properly if it does not protrude slightly.

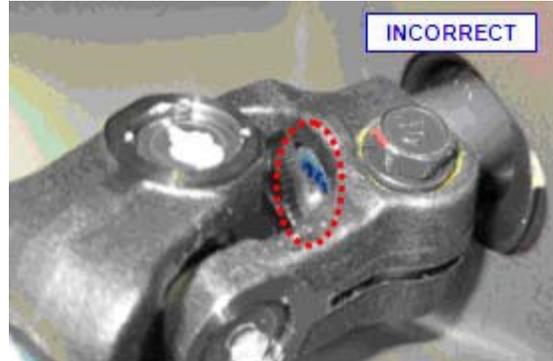
4. If the splined shaft and the U joint are improperly connected as shown in the picture on the right, re-connect the U joint to the steering column according to the below steps. If properly connected, go to step 9.

NOTE: The steering pinion splined shaft-to-U joint bolt must be fastened through the groove in the end of the splined shaft.

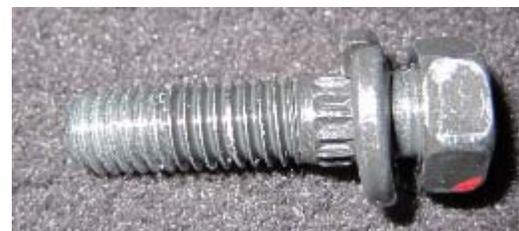
6. Inspect the bolt for damage/ stripping/cross-threading. Inspect the corresponding threads in the U-joint. Replace both if damage is found.

NOTE: If the bolt and intermediate shaft are replaced, submit a claim (in addition to the campaign claim) under normal warranty.
