HYUNDAI Technical Service Bulletin

Group	CAMPAIGN
Number	10-01-032
Date	SEPTEMBER, 2010
Model	2011 SONATA (YF)

Subject **STEERING COLUMN INTERMEDIATE SHAFT CONNECTIONS INSPECTION (CAMPAIGN 097)**

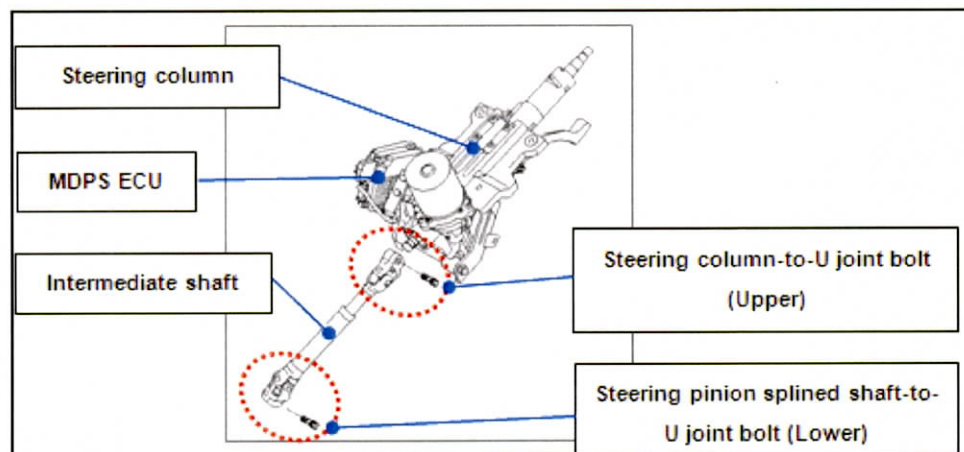
This bulletin provides the recall Campaign 097 procedure for inspecting to ensure that the steering column and the upper intermediate shaft universal joint (U joint), and the steering pinion splined shaft and the lower intermediate shaft U joint are properly connected and that both attaching bolts are tightened to the specified torque.

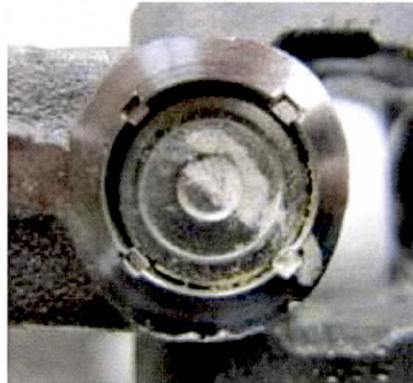
1. Inspect all 4 U-joint bearing caps. Turn the steering wheel to visually access them. Ensure they are properly fixed in the yoke by the four indentations. If the caps are loose, replace the steering intermediate shaft assembly.

NOTE: If the shaft is replaced, submit a claim (in addition to the campaign claim) under normal warranty.

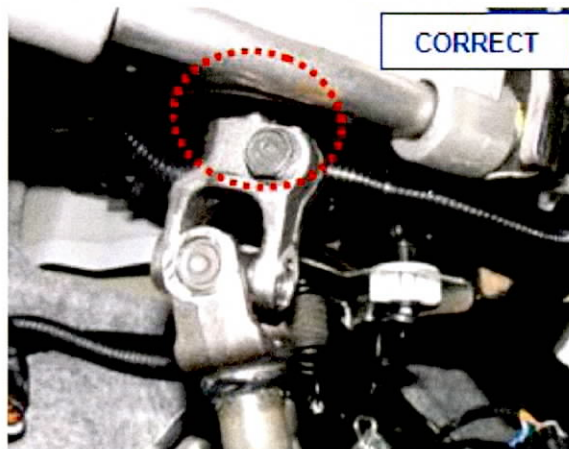
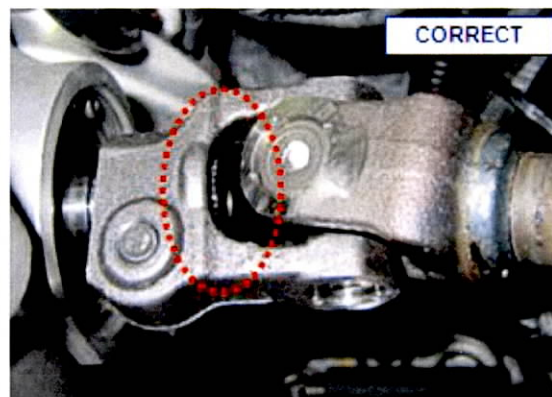
2. Visually check that the steering column and the U joint are properly connected as shown in the picture on the right.

NOTE: Look to verify that the end of the steering shaft protrudes about 1/8" into the void of the U-joint (see image). It is not seated properly if it does not protrude slightly.

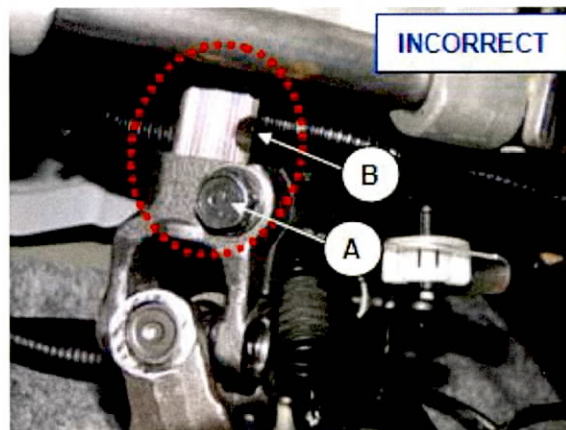
3. If the steering column and the U joint are improperly connected as shown in the picture on the right, re-connect the U joint to the steering column according to the steps below. If properly connected, go to step 8.

NOTE: The steering column-to-U joint bolt (A) must be fastened through the groove (B) in the end of the steering column.

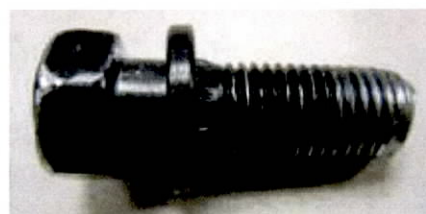
5. Inspect the bolt for damage/ stripping/cross-threading. Inspect the corresponding threads in the U-joint. Replace both if damage is found.

NOTE: If the bolt and intermediate shaft are replaced, submit a claim (in addition to the campaign claim) under normal warranty.

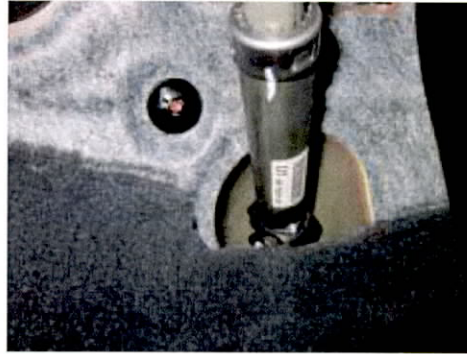
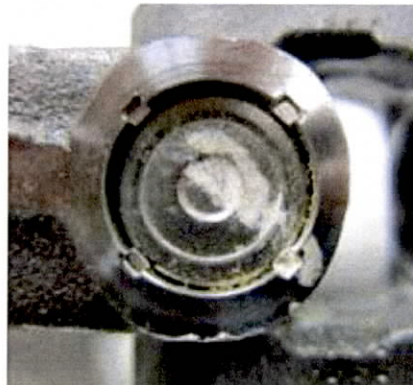
1. Pull back carpet to access lower end of steering intermediate shaft.
2. Inspect all 4 U-joint bearing caps. Turn the steering wheel to visually access them. Ensure they are properly fixed in the yoke by the four indentations. If the caps are loose, replace the steering intermediate shaft assembly.

NOTE: If the shaft is replaced, submit a claim (in addition to the campaign claim) under normal warranty.

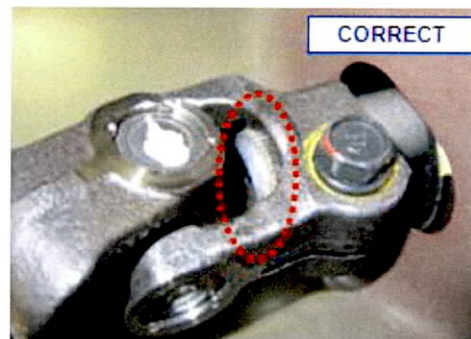
3. Visually check that the steering pinion splined shaft and the U joint are properly connected as shown in the picture on the right.

NOTE: Look to verify that the end of the splined shaft protrudes about 1/4" into the void of the U-joint (see image). It is not seated properly if it does not protrude slightly.

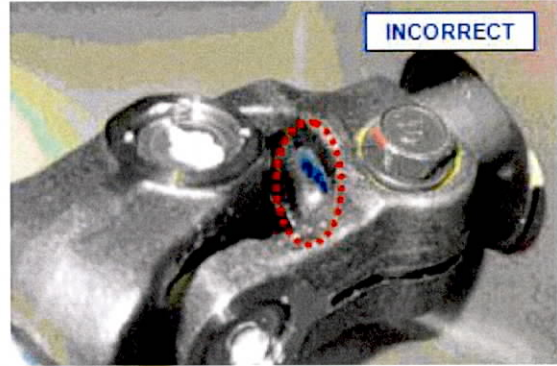
4. If the splined shaft and the U joint are improperly connected as shown in the picture on the right, re-connect the U joint to the steering column according to the below steps. If properly connected, go to step 9.

NOTE: The steering pinion splined shaft-to-U joint bolt must be fastened through the groove in the end of the splined shaft.

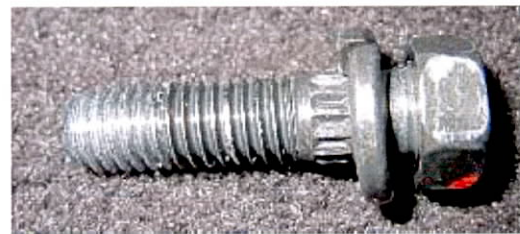
6. Inspect the bolt for damage/ stripping/cross-threading. Inspect the corresponding threads in the U-joint. Replace both if damage is found.

NOTE: If the bolt and intermediate shaft are replaced, submit a claim (in addition to the campaign claim) under normal warranty.
