RE: NHTSA Recall 10V-426, Hyundai Recall 097

SUBJECT: Recall Campaign 097 - 2011 MY Sonata Steering Column Intermediate Shaft Connections Inspection - TSB# 10-01-032-1

Group	CAMPAIGN
Number	10-01-032-1
Date	OCTOBER, 2010
Model	2011 SONATA (YF)

Subject STEERING COLUMN INTERMEDIATE SHAFT CONNECTIONS INSPECTION (CAMPAIGN 097)		Date OCTOBER, 2010	
		Model 2011 SONATA (YF)	
CIRCULATE TO:	<input type="checkbox"/> GENERAL MANAGER	<input checked="" type="checkbox"/> PARTS MANAGER	<input checked="" type="checkbox"/> TECHNICIAN
<input checked="" type="checkbox"/> SERVICE ADVISOR	<input checked="" type="checkbox"/> SERVICE MANAGER	<input checked="" type="checkbox"/> WARRANTY MGR	<input type="checkbox"/> SALES MANAGER

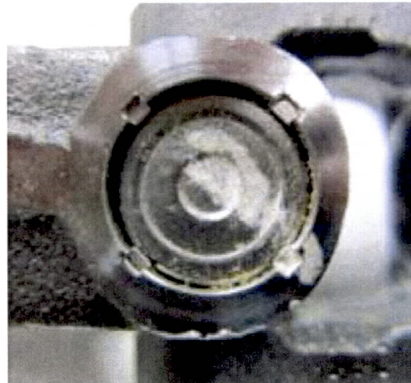
1. Inspect all 4 U-joint bearing caps. Turn the steering wheel to visually access them. Ensure they are properly fixed in the yoke by the four indentations. If the caps are loose, replace the steering intermediate shaft assembly.

NOTE: If the shaft is replaced, submit a claim (in addition to the campaign claim) under normal warranty.

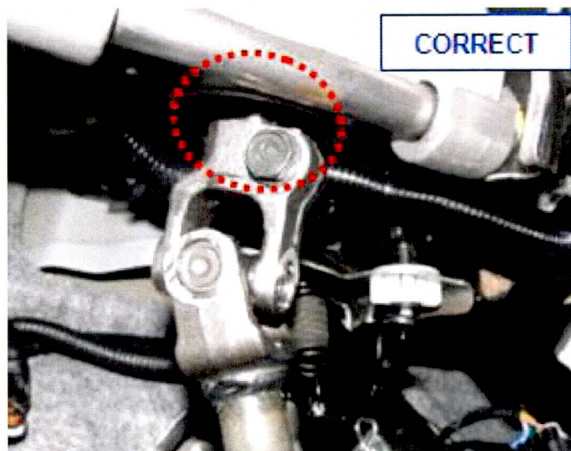
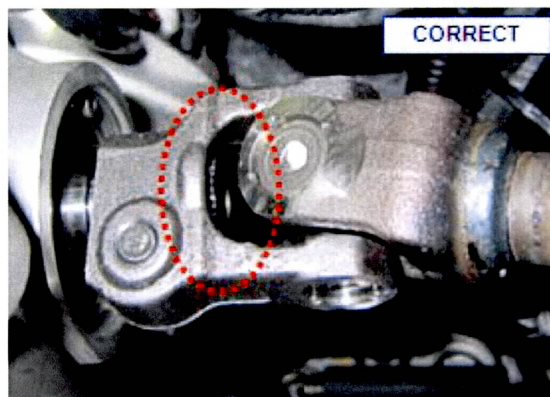
2. Visually check that the steering column and the U joint are properly connected as shown in the picture on the right.

NOTE: Look to verify that the end of the steering shaft protrudes about 1/8" into the void of the U-joint (see image). It is not seated properly if it does not protrude slightly.

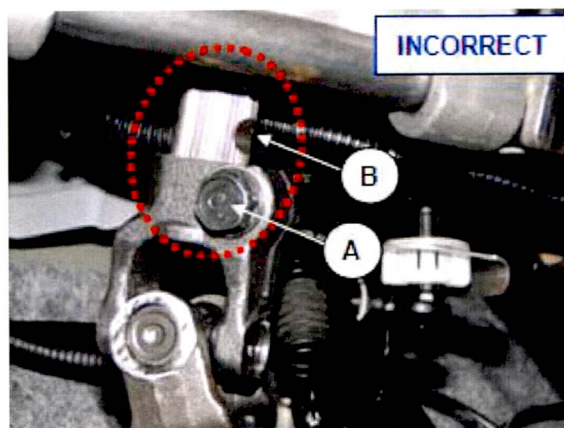
3. If the steering column and the U joint are improperly connected as shown in the picture on the right, re-connect the U joint to the steering column according to the steps below. If properly connected, go to step 8.

NOTE: The steering column-to-U joint bolt (A) must be fastened through the groove (B) in the end of the steering column.

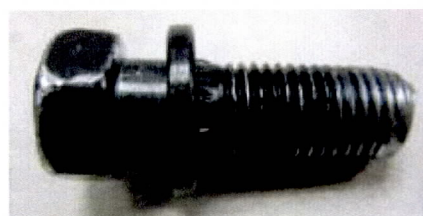
5. Inspect the bolt for damage/ stripping/cross-threading. Inspect the corresponding threads in the U-joint. Replace both if damage is found.

NOTE: If the bolt and intermediate shaft are replaced, submit a claim (in addition to the campaign claim) under normal warranty.

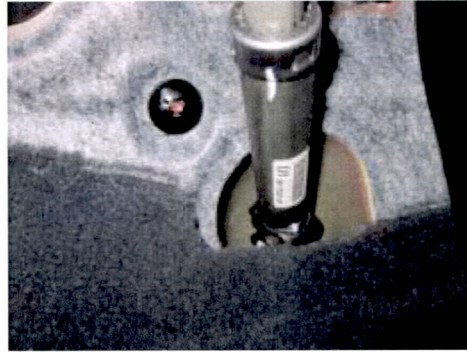
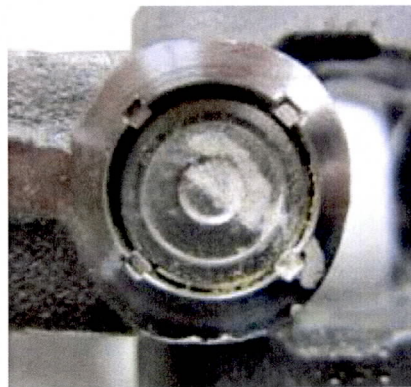
1. Pull back carpet to access lower end of steering intermediate shaft.
2. Inspect all 4 U-joint bearing caps. Turn the steering wheel to visually access them. Ensure they are properly fixed in the yoke by the four indentations. If the caps are loose, replace the steering intermediate shaft assembly.

NOTE: If the shaft is replaced, submit a claim (in addition to the campaign claim) under normal warranty.

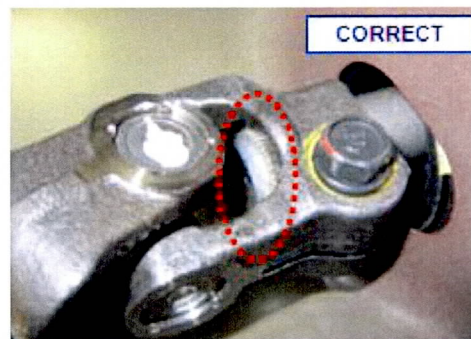
3. Visually check that the steering pinion splined shaft and the U joint are properly connected as shown in the picture on the right.

NOTE: Look to verify that the end of the splined shaft protrudes about 1/4" into the void of the U-joint (see image). It is not seated properly if it does not protrude slightly.

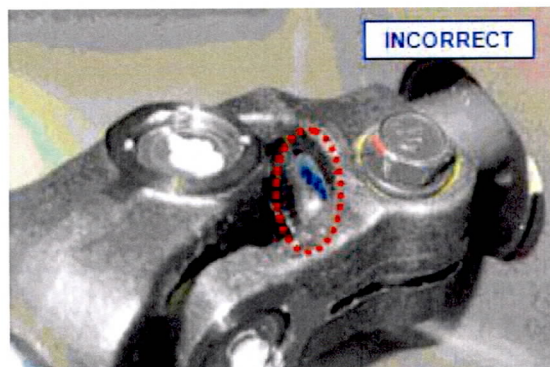
4. If the splined shaft and the U joint are improperly connected as shown in the picture on the right, re-connect the U joint to the steering column according to the below steps. If properly connected, go to step 9.

NOTE: The steering pinion splined shaft-to-U joint bolt must be fastened through the groove in the end of the splined shaft.

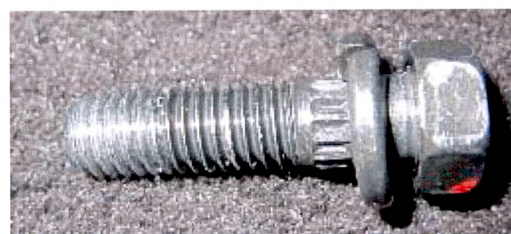
6. Inspect the bolt for damage/ stripping/cross-threading. Inspect the corresponding threads in the U-joint. Replace both if damage is found.

NOTE: If the bolt and intermediate shaft are replaced, submit a claim (in addition to the campaign claim) under normal warranty.
