Campaign Service BULLETIN

BULLETIN NUMBER:
SB10-11-S002B

Regional Safety Recall 10V-436

Corrosion Affecting the Forward Mounting Point for Rear Suspension Lower Link Brackets

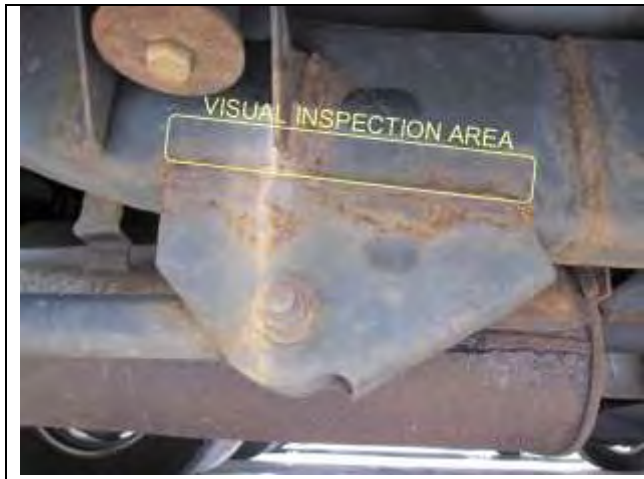
2. Using a 3/16 flat punch and a 12-16 oz. hammer, hammer on the locations identified with an "X" in Figure 2. Swing the hammer 10 to 12 inches to be sure enough force is applied to the punch. If a hole is created, go to Step 4. If no hole is created, visually inspect the Rear Lower Trailing Link Front Mounting Bracket inspection area. Use the Visual Comparison Photo (P/N 2-90SVA-003-0) or Figure 1 for reference. If most of the frame coating is still in place and very little surface rust is present, apply Noxudol 300 (Go to "Condition One: Apply Noxudol 300" in this bulletin). If most of the frame coating is missing and excessive rust is present go to the next step.

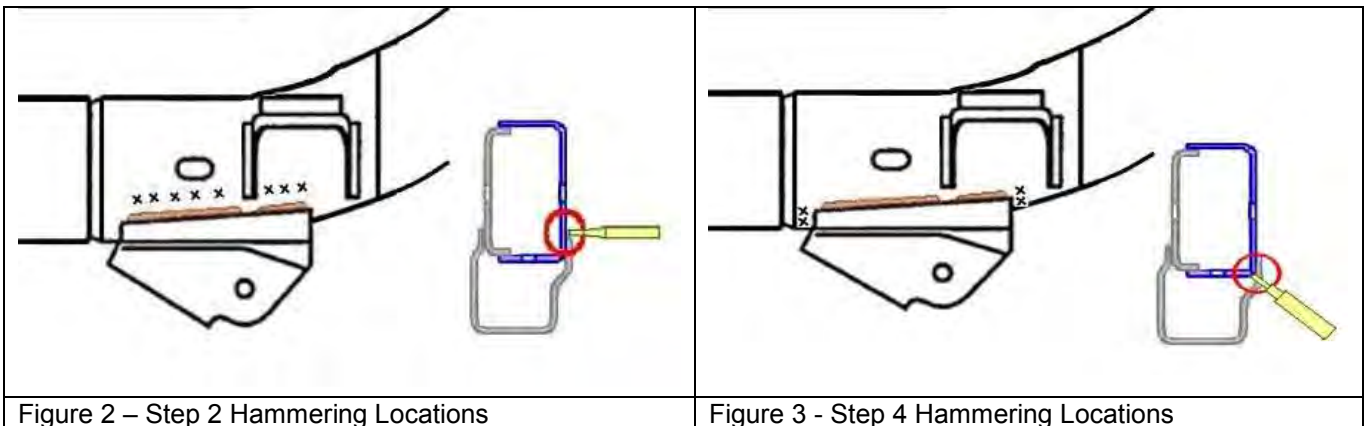
3. Apply Noxudol 700 and Noxudol 300 (Go to “Condition Two: Apply Noxudol 700 and Noxudol 300” in this bulletin).
4. Using a 3/16 flat punch and a 12-16 oz. hammer, hammer on the locations identified with an “X” in Figure 3.
 - a. If no hole is created, continue to “Condition Three: Reinforcement Bracket Type “A” Installation” in this bulletin.
 - b. If the flat punch creates a hole in any one location, continue to “Condition Four: Reinforcement Bracket Type “B” Installation” in this bulletin.
