Campaign Service

BULLETIN NUMBER:
SB10-11-S002A

Regional Safety Recall 10V-436

Corrosion Affecting the Forward Rear Suspension Lower Link Brackets

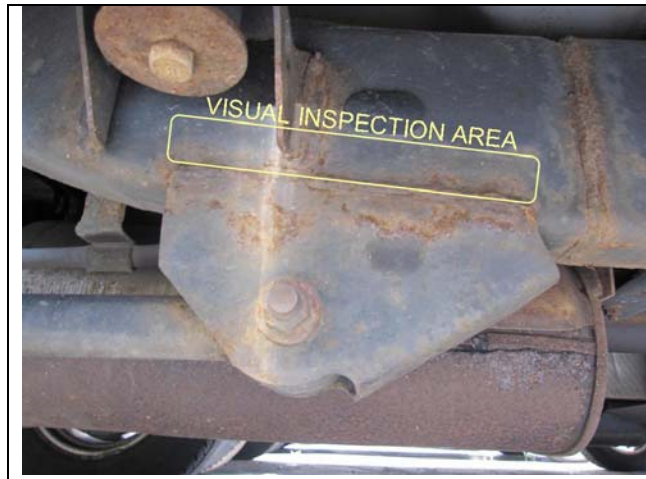
1. Raise the vehicle. When placing the lift points, be sure to keep the rear lifting points at least 300mm (12 inches) ahead of the rear lower trailing link front mounting bracket. This spacing is necessary for inspection and repair accessibility.
2. Visually inspect the Rear Lower Trailing Link Front Mounting Bracket inspection area. Use the Visual Comparison Photo (P/N 2-90SVA-003-0) or Figure 1 for reference. If most of the frame coating is still in place and very little surface rust is present, apply Noxudol 300 (Go to "Condition One: Apply Noxudol 300" in this bulletin). If most frame coating is missing and excessive rust is present go to the next step.

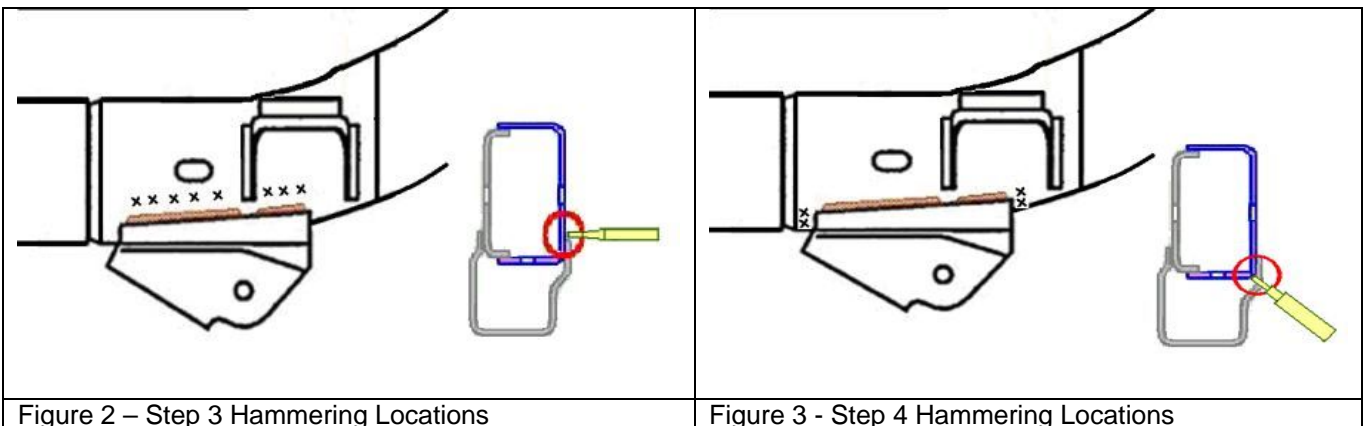
3. Using a 3/16 flat punch and a 12-16 oz. hammer, hammer on the locations identified with an "X" in Figure 2. Swing the hammer 10 to 12 inches to be sure enough force is applied to the punch. If no hole is created, apply Noxudol 700 and Noxudol 300 (Go to "Condition Two: Apply Noxudol 700 and Noxudol 300" in this bulletin). If, however, the flat punch creates a hole in any one location, go to the next step.
4. Using a 3/16 flat punch and a 12-16 oz. hammer, hammer on the locations identified with an "X" in Figure 3.
 - a. If no hole is created, continue to "Condition Three: Reinforcement Bracket Type "A" Installation" in this bulletin.
 - b. If the flat punch creates a hole in any one location, continue to "Condition Four: Reinforcement Bracket Type "B" Installation" in this bulletin.

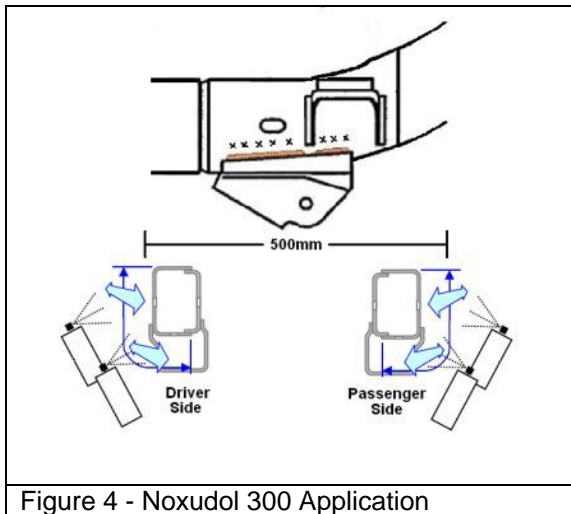
Figure 4 - Noxudol 300 Application

3. Spray one coat of Noxudol 300 onto both driver and passenger side shown in Figures 4 and 5. Be careful not to overspray onto the exhaust system or body painted areas. See Figure 4.
4. Apply the campaign label (see "Applying the Campaign Label" on page 20 of this bulletin).

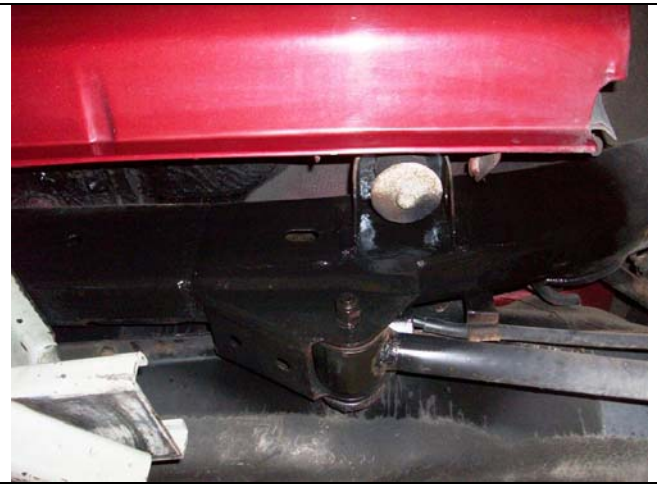
Figure 5 - Noxudol 300 Applied

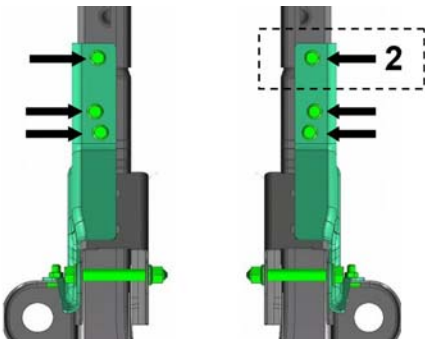
<p>Figure 17 Drilling Locations [2. This location has welded nut on some models –</p>	<p>Figure 18 Drill guide and bracket</p>	<p>Figure 19 1/4" holes</p>

NOTE: Some 2000MY vehicles' frames already have a nut welded into the driver side frame at location 2 in Figures 16 and Figure 17. For 2001 and 2002MY vehicles this location is for the fuel tank protector. DO NOT DRILL THIS LOCATION IF A WELDED NUT IS PRESENT

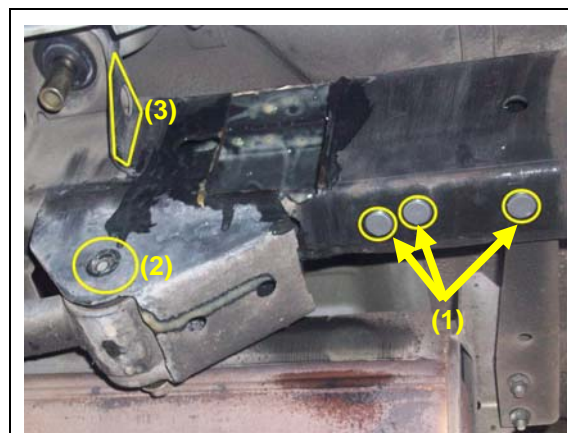
Figure 24
Masking Locations for Bracket Type "A"
 1. 3/4" round labels.
 2. Mask over mounting bolt/nut location.
 3. Mask both sides at #4 body mount for stud and nut location.

12. Using the 3/4" round labels provided in the service kit, mask off the Pop-nuts. Use tape to mask off other related bracket mounting locations highlighted in Figure 24. This is required to inhibit Noxudol chemicals from coating the bracket mounting surfaces.

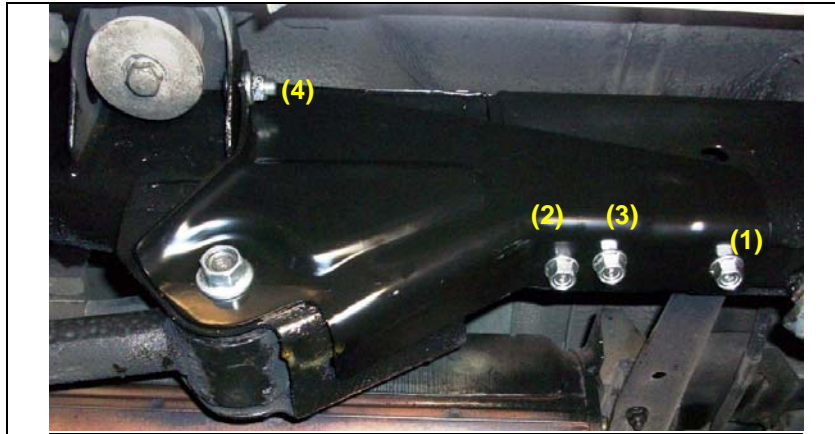
Figure 25
 1. ~ 3. Bracket bolts torque to 25-30Nm (18-22 lbf ft.)
 4. Body mount stud and nut torque to 50 – 55Nm (37-41 lbf ft.)

16. Install the passenger side reinforcement bracket using the new hardware provided in the kit.
 17. Torque bolts in the sequence and to the specifications shown in Figure 25.

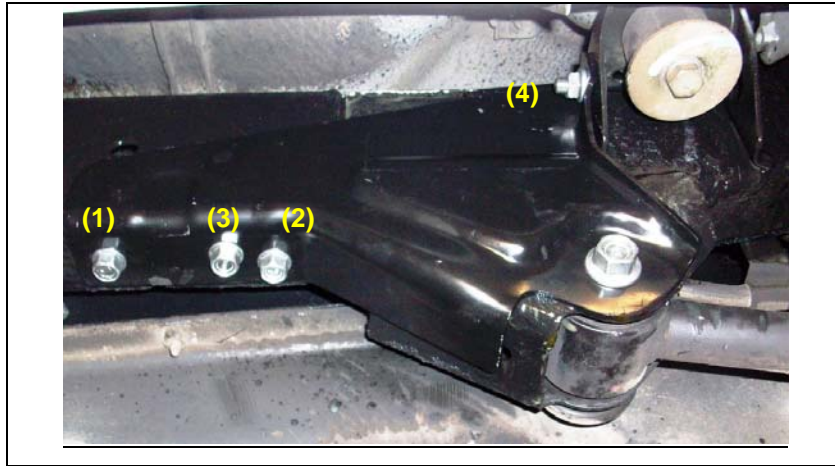
Figure 29
 1. ~ 3. Bracket bolts torque to 25-30Nm (18-22 lbf ft.)
 4. Body mount stud and nut torque to 50 – 55Nm (37-41 lbf ft.)

20. Torque bolts in the sequence and to the specifications shown in Figure 29.

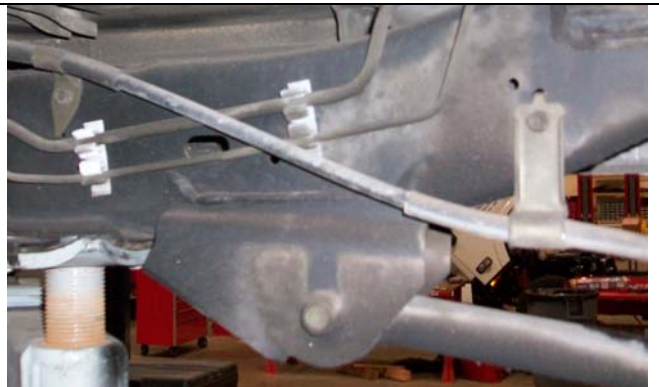
Figure 41
Passenger side bracket before removal

12. Raise the vehicle into the air.
13. Remove the rear trailing link front mount. See Figure 40 for reference.
 - a. Using a cutting wheel cut just below or through the weld to remove the bracket.
 - b. Use a disk grinder to remove any excess material and smooth out the frame.

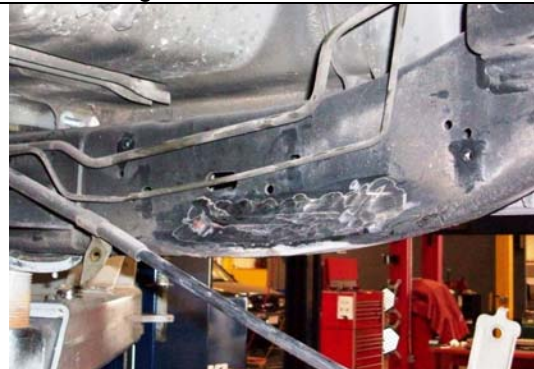
Figure 42
Frame after bracket removal

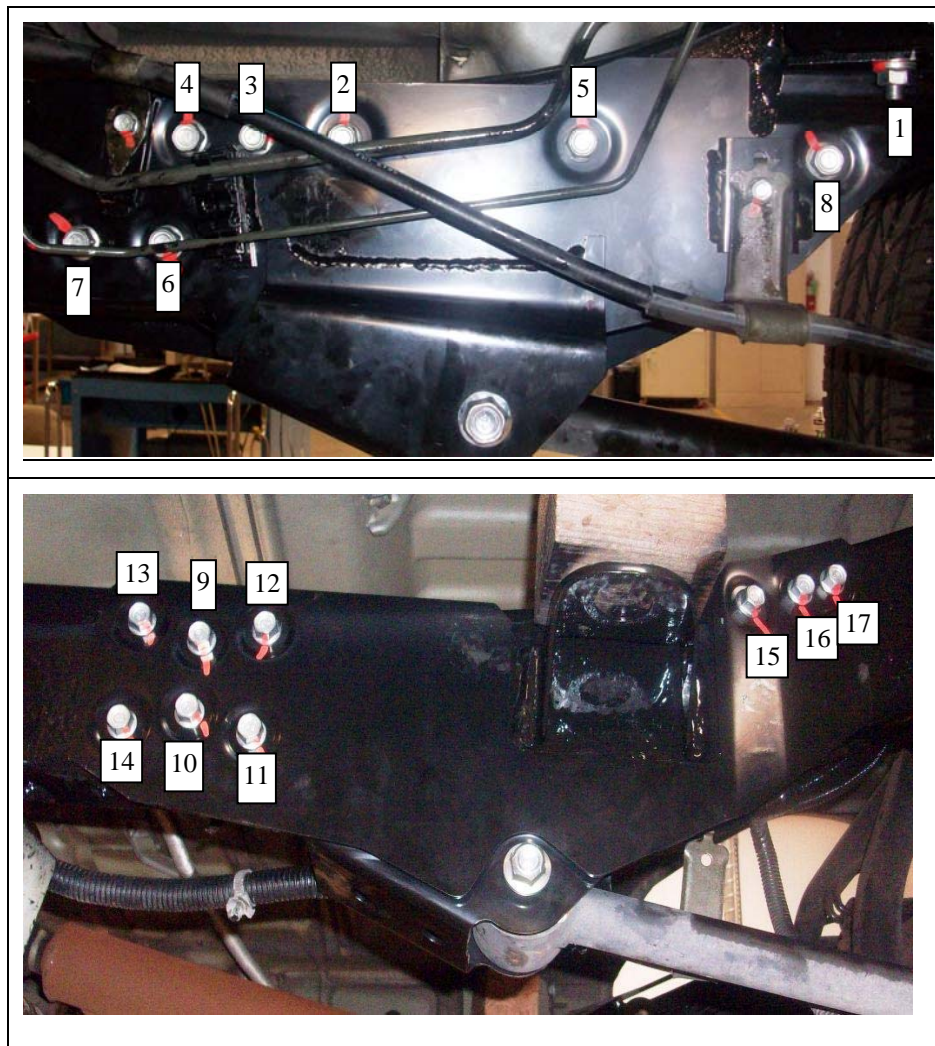
Figure 53
 1. Body mount stud and nut torque to 50 to 55Nm (37-40 lbf ft.)
 2. ~ 17. Bracket bolts torque to 25 – 30Nm (18-22 lbf ft.)

- 33. Install both Type “B” brackets using the stud and nut from step 15 together with 32 new mounting bolts (P/N 8-98174-544-0) provided in the bracket kit.
- 34. Torque bolts according to the sequence and specifications shown in Figure 53.
