This Service Information bulletin supersedes SI B34 04 10 **dated December 2010**.

Recall Campaign 10V- 446: Inspect Brake Booster Vacuum Supply Line

E60 (5 Series) with N62 or N62TU engines produced from August 8th, 2003 to November 30th, 2009

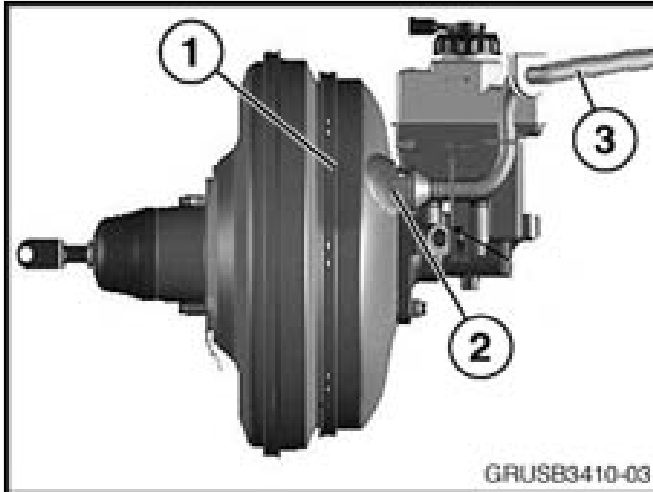
1. Remove the brake booster vacuum supply line (3) together with the non-return valve (2) from the brake booster (1).

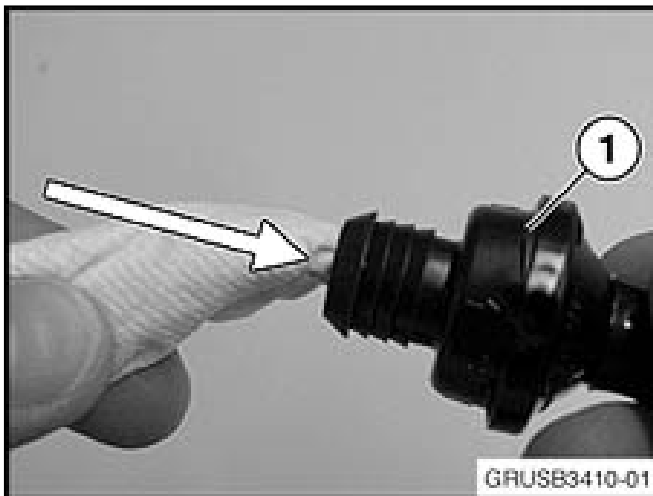
2. Check the brake booster vacuum supply line at the non-return valve upstream from the brake booster for contamination of oil. Insert a tightly rolled up corner of a non-reusable lint free white shop towel (see arrow) into the non-return valve (2). If the towel does not indicate any engine oil residue, proceed to step 4.

3. If the line exhibits contamination with engine oil, proceed to step 5.
