SI B34 04 10
Brakes

RECALL CAMPAIGN 10V-446: INSPECT BRAKE BOOSTER VACUUM SUPPLY LINE

This Service Information bulletin replaces SI B34 04 10 **dated April 2011**

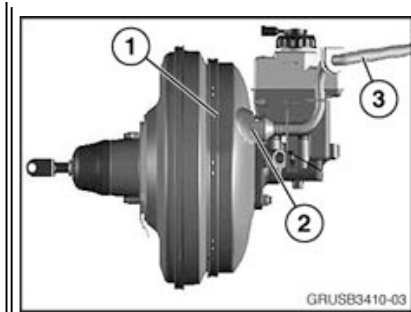
1. Remove the brake booster vacuum supply line (3) together with the non-return valve (2) from the brake booster (1).

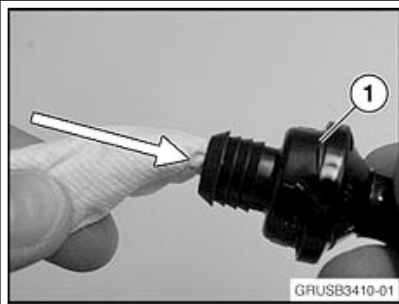
2. Check the brake booster vacuum supply line at the non-return valve upstream from the brake booster for contamination of oil. Insert a tightly rolled up corner of a non-reusable lint free white shop towel (see arrow) into the non-return valve (2). If the towel does not indicate any engine oil residue, proceed to step 4.

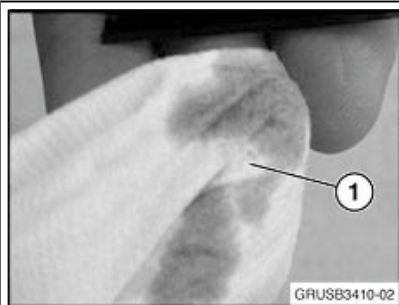
3. If the line exhibits contamination with engine oil, proceed to step 5.

5. Replace the following components only if oil contamination is found. Refer to the applicable parts list for each model.
