PRODUCT SAFETY RECALL

SUBJECT: Power Steering Fluid Leak – Replace Power Steering Line

MODELS: 2010 Cadillac SRX

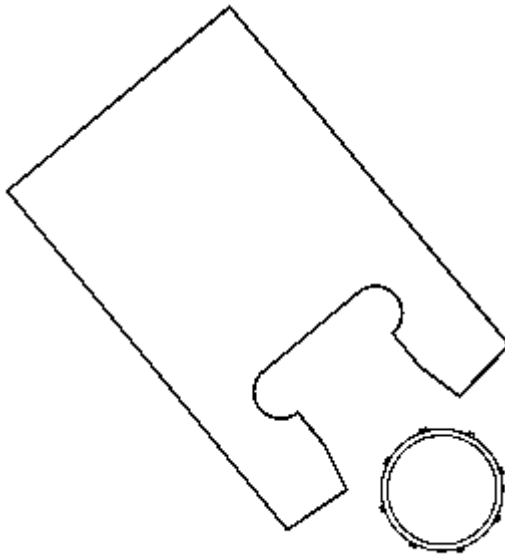
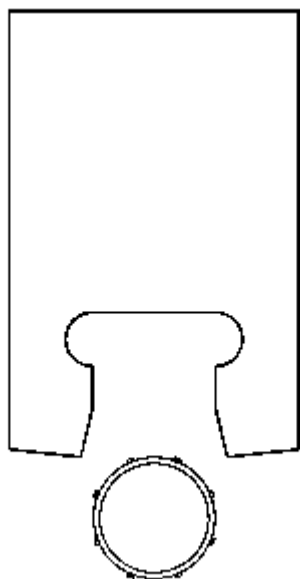
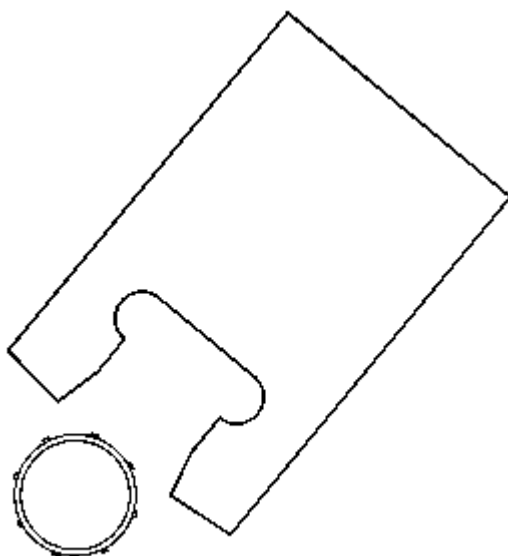
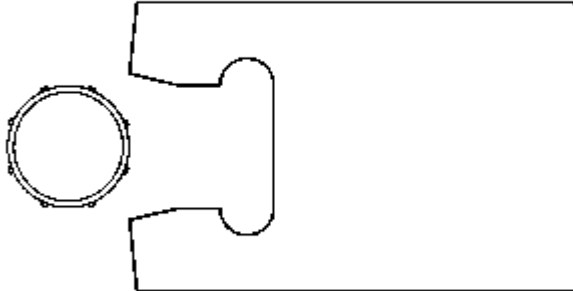
This procedure includes an inspection to gauge check the diameter of the hose mid crimp body. Over crimping (an undersized crimp diameter) may have damaged the structure of the hose.

Because the crimp can be tapered (smaller diameter at one end) and oblong in shape, the gauge check must be performed at four locations around the diameter at each end of the crimped section.

Note: An undersized crimp at just one of the eight positions is considered an unacceptable crimp

4. Use *CH-50623* to check the crimp diameter at all 4 crimp diameter pairs at each end (identified with arrows in the above illustration) of the crimped section. Attempt to slide the *CH-50623* over the crimp at 4 different locations, working your way around the crimp for a total of 8 checks (4 checks at each end).
