## Suspension Hitting LP Pipe

2011 Caliber models within the VIN range of 5SFNB3523BE224085-5SFNB3126BE227987.

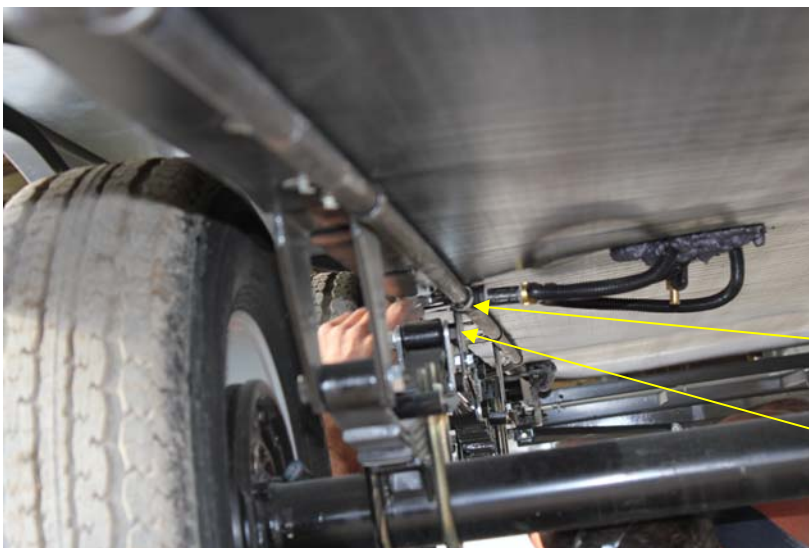
1. Verify the distance of the LP pipe in relation to the equalizer on the suspension. If the LP pipe is mounted on the outside of the I-Beam no repair is needed. File claim for inspection.

Location of LP pipe mounted on frame.

Location of equalizer with potential to hit LP pipe.

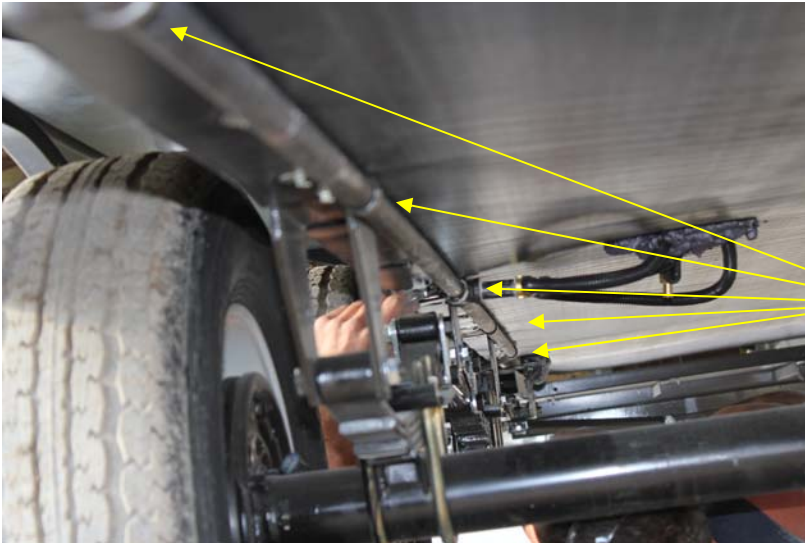
Location of hanger brackets

2. If LP pipe needs moved, remove the hanger brackets located along the frame before and after the axle area. If the LP pipe is damaged and needs replaced you must contact customer service before the repair. Add warranty code 04-06-02 B to your claim for .30 hrs.

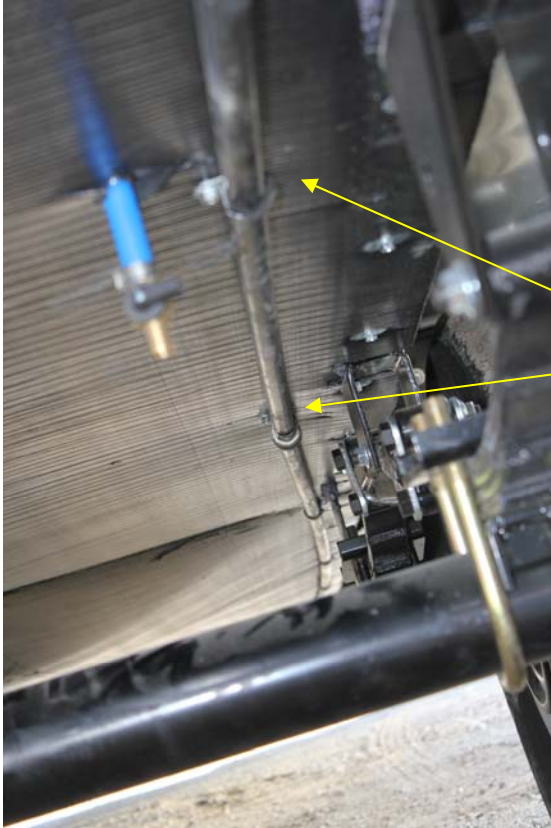
Location of frame tabs.

3. Using the provided floor plan print locate the tabs mounted on frame under the underbelly.

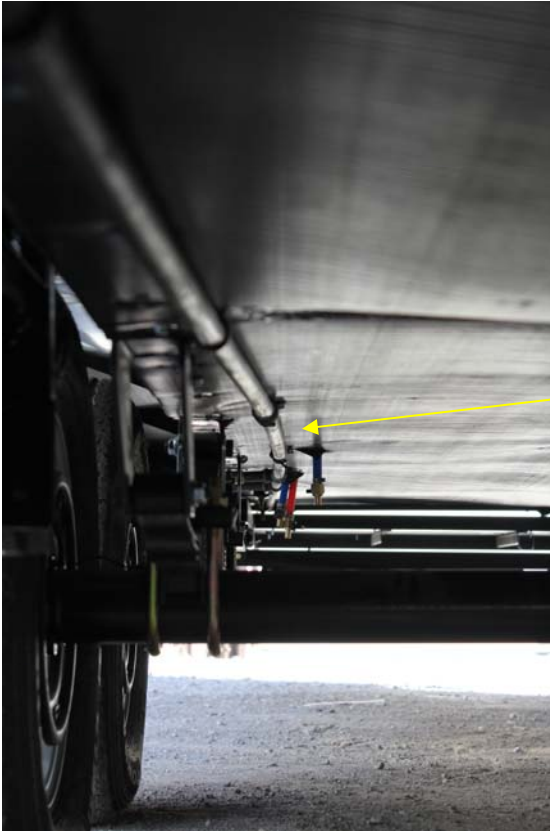
Corrected location of LP line.

4. Pull the LP pipe away from the frame and re-secure using the same bracket and screw to the metal tabs on frame.
