TSB	Model	Sonata(YF)(2011)
	Group	Steering System(61)
	TSB No.	HRE10-61-P120-YF
Subject STEERING COLUMN INTERMEDIATE SHAFT CONNECTIONS INSPECTION	Published	10/7/2010
	Area & Distributor	GUAM (A31AA), PUERTO RICO (B35AA), PUERTO RICO (B35AB), PUERTO RICO (B35AC)

1. Description

This bulletin provides the procedure for inspecting to ensure that the steering column and the upper intermediate shaft universal joint (U joint), and the steering pinion splined shaft and the lower intermediate shaft U joint are properly connected and that both attaching bolts are tightened to the specified torque. Additionally, a procedure is provided to update the MDPS software.

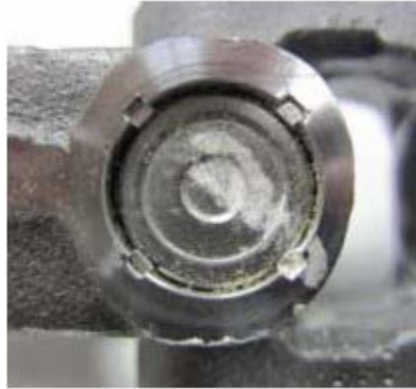
1. Inspect all 4 U-joint bearing caps.
Turn the steering wheel to visually access them. Ensure they are properly fixed in the yoke by the four indentations. If the caps are loose, replace the steering intermediate shaft assembly.

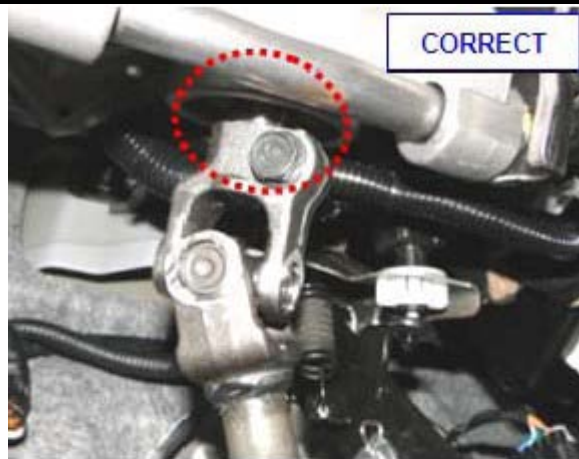
2. Visually check that the steering column and the U joint are properly connected as shown in the picture on the right.

NOTE: Look to verify that the end of the steering shaft protrudes about 1/8" into the void of the U-joint (see image). It is not seated properly if it does not protrude slightly.

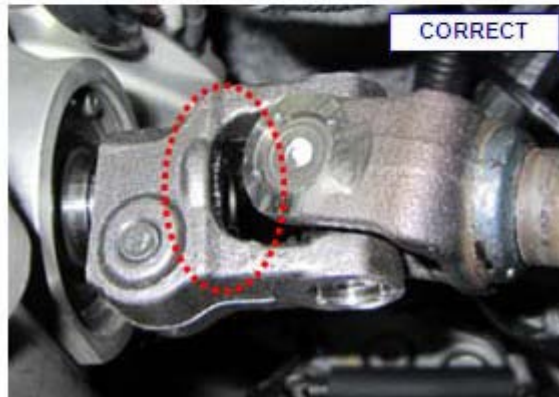
3. If the steering column and the U joint are improperly connected as shown in the picture on the right, re-connect the U joint to the steering column according to the steps below. If properly connected, go to step 8.

NOTE: The steering column-to-U joint bolt (A) must be fastened through the groove (B) in the end of the steering column.

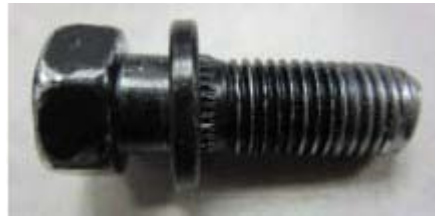
5. Inspect the bolt for damage/stripping/cross-threading. Inspect the corresponding threads in the U-joint. Replace both if damage is found.

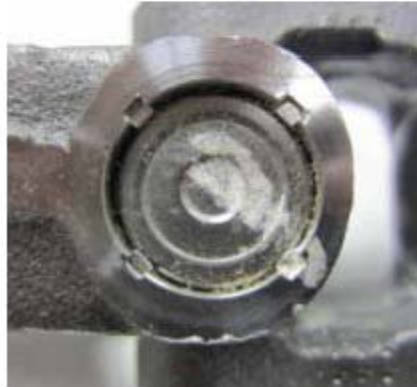
1. Pull back carpet to access lower end of steering intermediate shaft.
2. Inspect all 4 U-joint bearing caps. Turn the steering wheel to visually access them. Ensure they are properly fixed in the yoke by the four indentations. If the caps are loose, replace the steering intermediate shaft assembly.

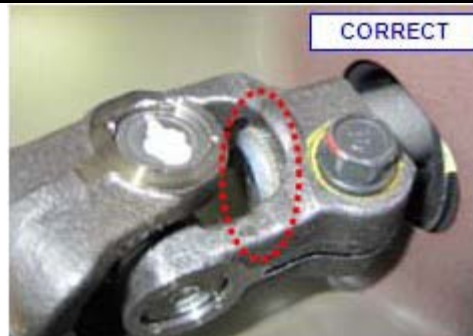
3. Visually check that the steering pinion splined shaft and the U joint are properly connected as shown in the picture on the right.

NOTE: Look to verify that the end of the splined shaft protrudes about 1/4" into the void of the U-joint (see image). It is not seated properly if it does not protrude slightly.

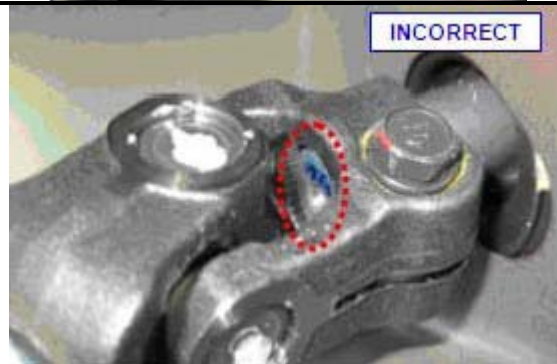
4. If the splined shaft and the U joint are improperly connected as shown in the picture on the right, re-connect the U joint to the steering column according to the below steps. If properly connected, go to step 9.

NOTE: The steering pinion splined shaft-to-U joint bolt must be fastened through the groove in the end of the splined shaft.

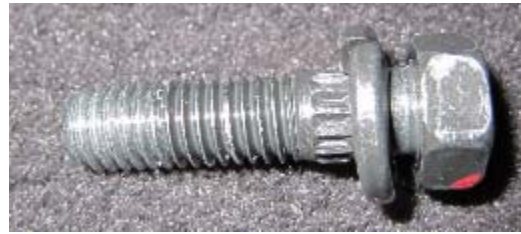
6. Inspect the bolt for damage/stripping/cross-threading. Inspect the corresponding threads in the U-joint. Replace both if damage is found.
