Customer Service Notice

Date: October 25, 2010

Units Affected: WC126 and WC166 Chippers built after January 2008 and
All WC126A and WC166A Chippers

Frame and Axle Inspection

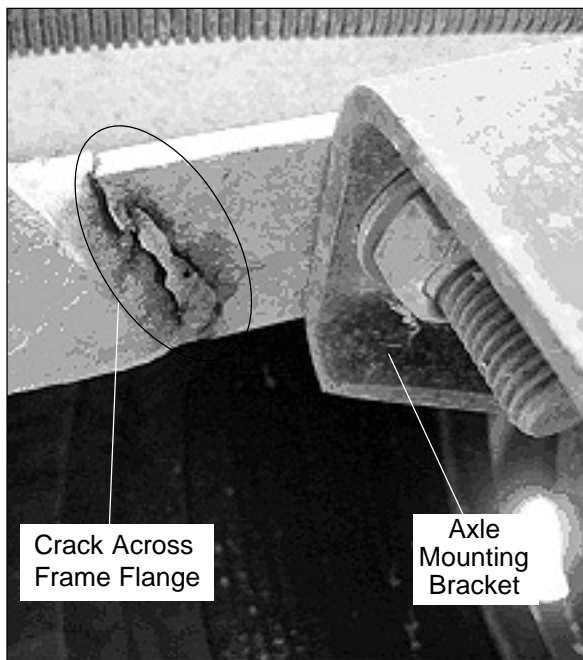
Figure 4 — Cracks Across The Bottom Of The Frame

5. Inspect each side of the frame near the fender mounting points for evidence of cracks (refer to Figure 4).
6. If there is a crack in the frame and it extends only across the flange of the frame rail and NOT across the web or along the corner of the frame rail (refer to Figure 5), the chipper can continue to be used, but a Frame Reinforcement Kit must be installed. The frame must be inspected at the beginning of each shift for growth of the crack. If the crack extends through the smaller (outer) flange of the mounting completely away from the axle tube, take the unit out of service immediately. To return the unit to service temporarily, the cracks may be welded closed by a qualified welder. Daily inspections of this area must continue until Altec has made the final repair.

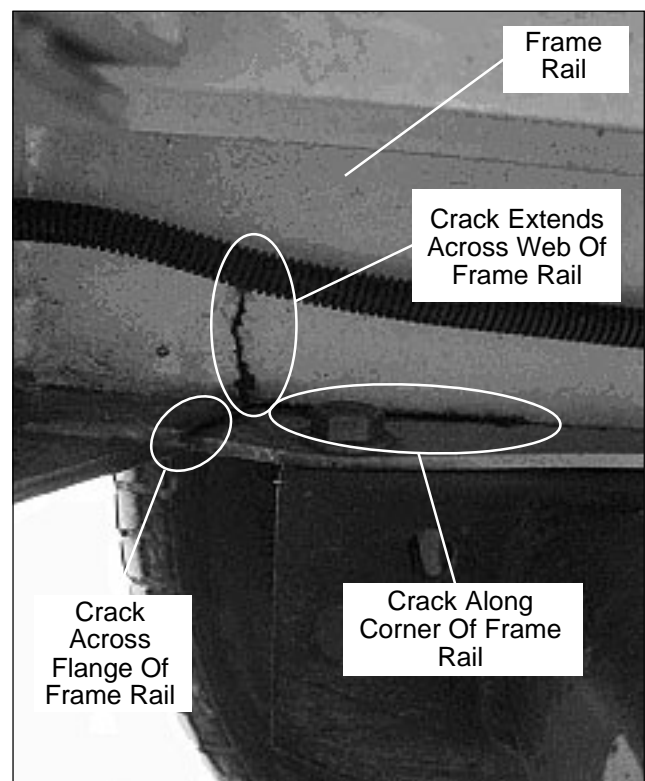
Figure 5 — Cracks Across The Web Of The Frame
