Windshield Wiper System Recall Repair Procedures
Recall Numbers 10V466000 US and 2010-330 CA
Monaco File R10009

Holiday Rambler: 2010 - 2011 Admiral

Monaco: 2009 - 2011 Monarch

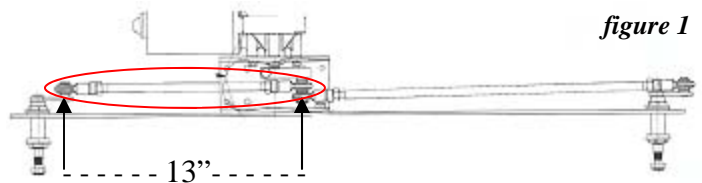
figure 1

1. Park the vehicle in an area that is accessible to a hose and water supply.
2. Prior to operating the windshield wiper system, make sure the windshield is wet. Re-wet as necessary for proper windshield wiper operation during inspection and testing.
3. Lift and secure the front hood to access the wiper motor assembly.
4. With wipers running, verify that the wiper system has adequate space for the mechanism and all linkages to move without impairment. Adjust and/or remove any impairment if necessary.
5. Verify that the passenger's side linkage is 13" long from center to center of the gimbals (pivot points) - see figure 1. (*12 3/4" is not sufficient.*) Adjust if necessary.

To adjust the length of the linkage:

- Remove the passenger's side wiper arm by removing the nut cover and then removing the nut with a 17mm wrench—see figure 2.
- There is a jam/locking nut at each end of the linkage against the gimbaled end, loosen each nut with a 17mm wrench. The gimbals have a flat area that is also 17mm and using two wrenches makes loosening easier. The threads on the shaft can be either right hand or left hand depending on which side of the system that you are adjusting, please check the thread pattern to see which way to loosen the nuts.

- Once the jam nut has been loosened the linkage can be rotated either by hand or with a 10mm wrench applied on the flat spots of the middle of the shaft. Turning the shaft will either lengthen or shorten the overall linkage length depending on the direction turned. Adjust to 13" long from center to center of the gimbals (pivot points).

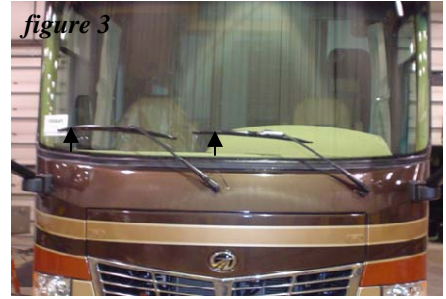
6. Verify that both the driver's and passenger's side wiper blades park 5" above the lower windshield gasket—see figure 3. Adjust if necessary.

To adjust the wiper blade park position:

- Remove the wiper arm(s) by removing the nut cover and then removing the nut with a 17mm wrench—see figure 2.
- Reposition the arm(s) so the wiper blade is 5" above the lower windshield gasket.
- Tighten by following the instructions in the next section.
